PRELIMINARY STORM DRAINAGE
INVESTIGATIONS AND
RECOMMENDATIONS FOR
EMERGENCY REMEDIAL MEASURES
UNIVERSITY OF CALIFORNIA
AT BERKELEY

Re: Preliminary storm drainage investigations
and emergency remedial measures at the
University of California at Berkeley.

Re: Preliminary evaluation of storm drainage
conditions at the University of California
at Berkeley.

UNIVERSITY OF CALIFORNIA AT BERKELEY
 STORM DRAINAGE STUDIES
 ZONE I - CHICKEN CREEK AREA
 LENNERT AND ASSOCIATES
 310 Forest Street
 Oakland 9, California

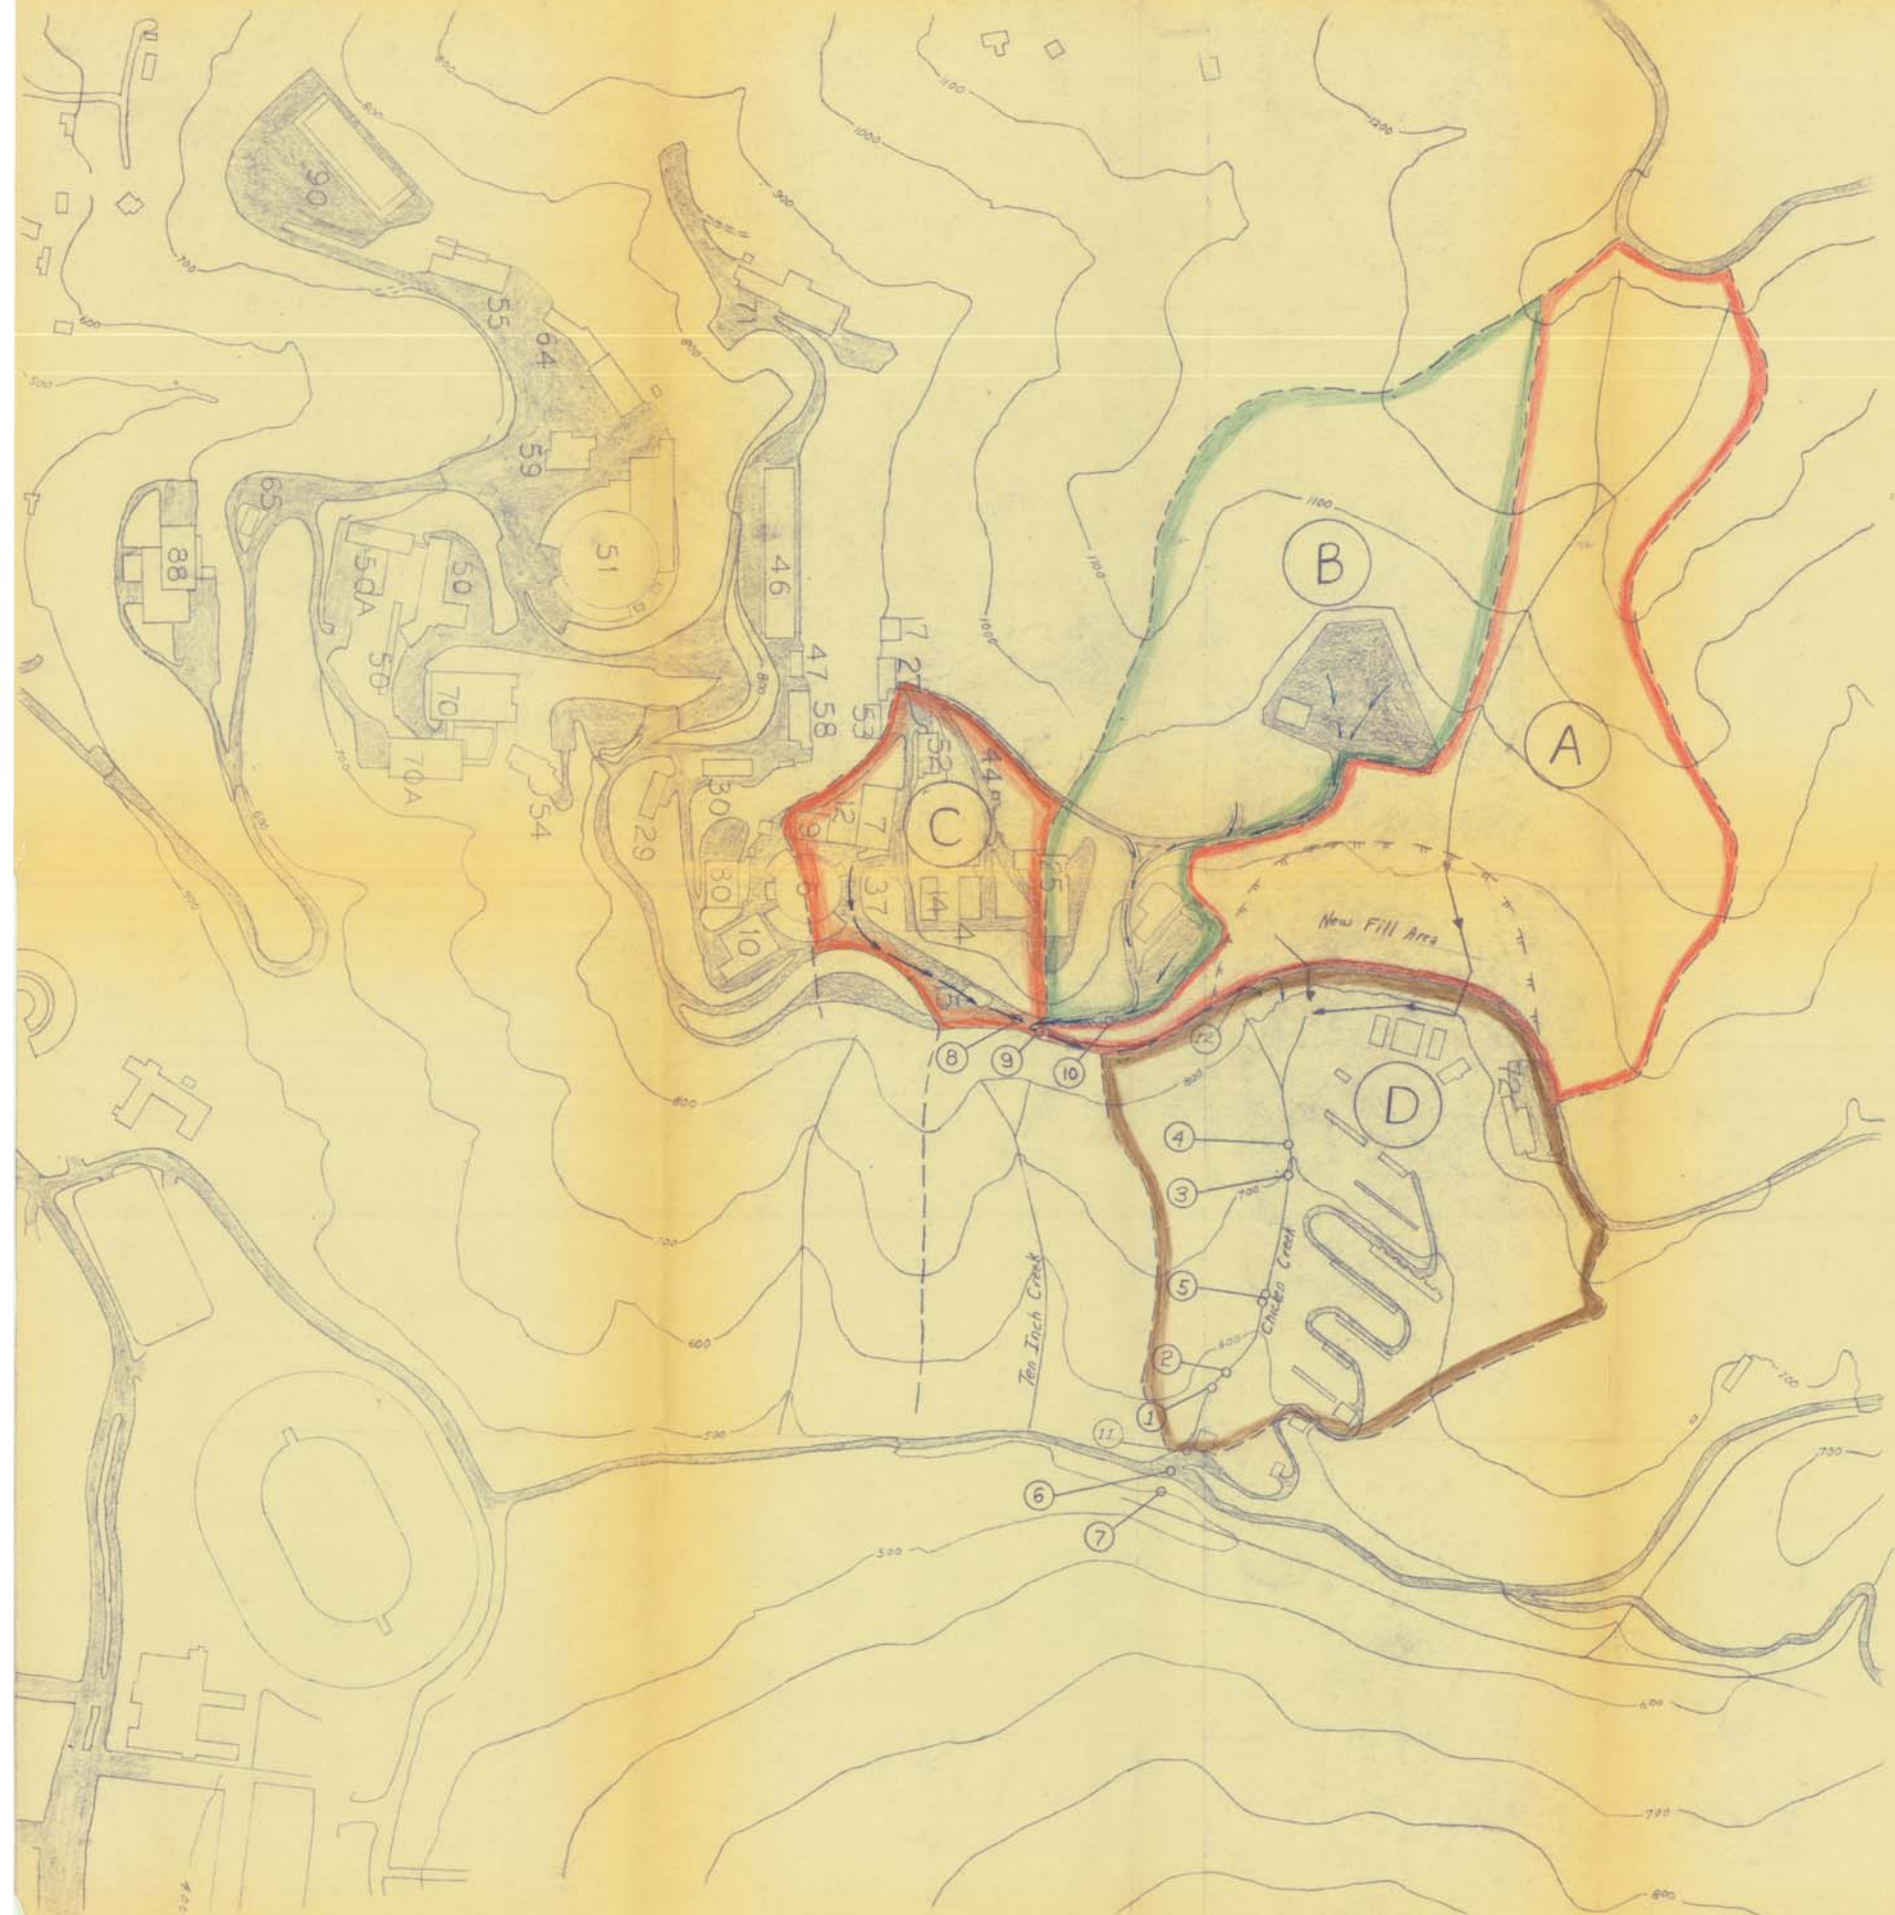
Chicken Creek has been changed by the developments above from a heavily brushed canyon with low peak runoff flows and an essentially stable bed with little erosion, to an hydraulically overloaded water course, with severe erosion and resulting transport of bed and float-loads. Peak flows have increased at least ten-fold from the original stable condition, and the canyon is incapable of transmitting this water without severe erosion. This condition will worsen with time, rather than improve, due to the progressive undercutting of the side-slopes. There is no natural "hard bottom" over most of the length of Chicken Creek to limit encisement and erosion.

The inlet structure and culvert in Chicken Creek at the Poultry Building are both completely inadequate for the present flow conditions or for the future reduced flows as planned by this office. In addition, the existing culvert was undercut and "eroded out" during the last storm, and the bottom of the pipe is now gone in at least two places. As we believe that this entire unit must be replaced by new construction of totally different design, and as this construction may not be done this winter, we feel that heavy flows by the Poultry Building must be handled in a surface channel (as in the last storm) and have so recommended.

On the above basis we have set up a series of twelve emergency measures to be taken in the Chicken Creek watershed area. These are shown in drawing and note form on the sketches and text appended hereto, keyed to numbers shown on the plan. We have made these recommendations as explicit as time limitations will allow, and will supplement them with field control and supervision of the work.

- (5) Repair two existing masonry groins with bagged concrete and/or mortared masonry, as directed in the field by this office.
- (6) Cross-fall North Canyon Road from Poultry Building parking area to south side of road at ten (10) percent fall. Use a new section 120 feet in length faired to existing road grades. Create a swale of ten (10) feet bottom width in line with the outfall from Chicken Creek by the Poultry Building and the channel into Strawberry Creek. Grade subgrade to required line-and-grade, place a minimum thickness of six (6) inches of U.R.B. and two (2) inches of P.M.S. Fair base course and surfacing to existing road grades. See Supplemental Sketch, herewith.
- (7) Cross-fall the existing dirt road to at least ten (10) percent fall with a swale width of ten (10) feet, fairing to the swale in North Canyon Road and to the channel below.

See the Supplemental Sketch, herewith.
- (8) Stockpile sand bags at this location so that in case of extreme emergency conditions in Chicken Creek or at the entrance to the Big Inch storm sewer the flow from Watershed Area C can be diverted into Ten Inch Creek by sand-bagging across this road.

- (9) Stockpile sandbags at this location so that in case of extreme emergency conditions in Chicken Creek or at the entrance to the Big Inch storm sewer the flow from Watershed Area B can be diverted into Ten Inch Creek by sand-bagging across this intersection.

- (12) Extend the two new culverts from Building 77, which extend down the slope of Canyon Road and now "dump" on the slope or in front of the poultry sheds, northerly to the north fork of Chicken Creek. Place a heavy rubble apron for erosion protection at the outfall of the culverts.

Cut a cross-swale in North Canyon Road above the North Fork of Chicken Creek so as to dump flood-flow of the Rad. Lab. area, coming down the road by the South Gate from Areas B and C, over the shoulder of the road and into the creek at this point, rather than letting the high intensity storm flows over-flow at the low-point in the road above the chicken sheds. Restore the road grade with base course and asphaltic surfacing equivalent to the existing section. Obtain a final cross flow channel of at least one foot depth with respect to the inside gutter. See Emergency Remedial Measure #6 for a typical procedure.

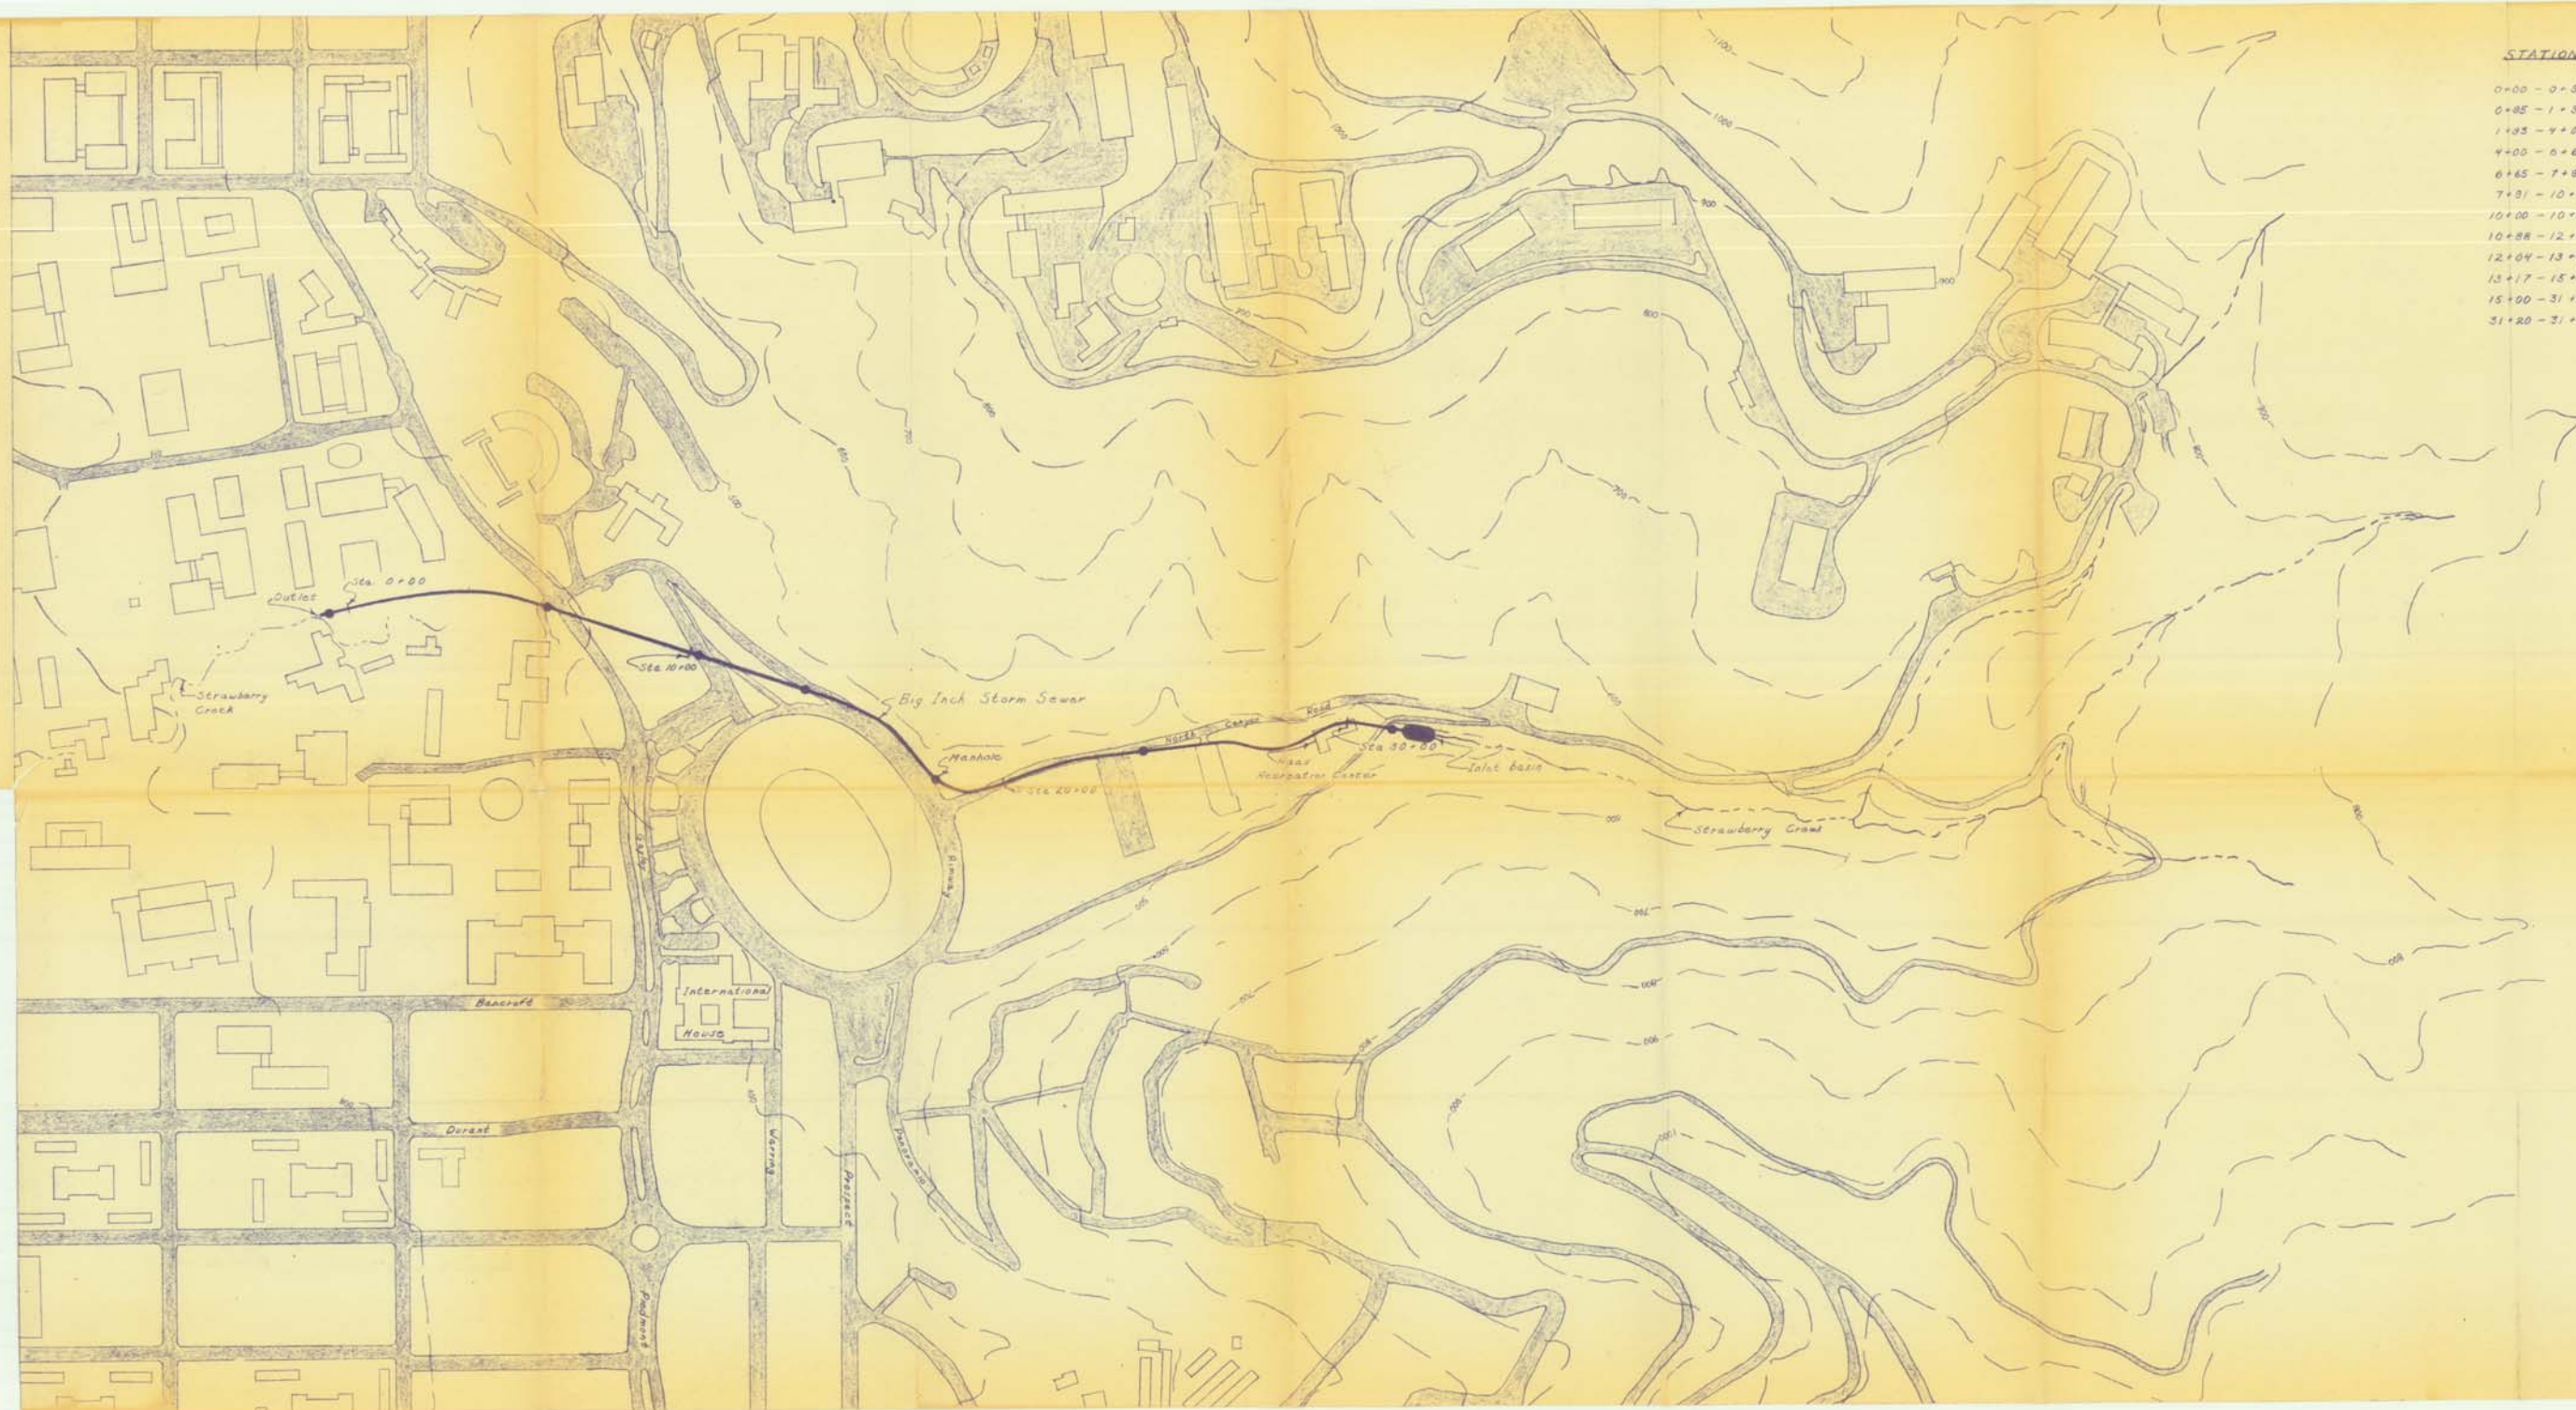
The upper (flat) portion of the sewer will "plug" with bed load materials at the "tail end" of a peak runoff period, as lowering quantities of flow reduce the transport capability of the pipe. We do not feel that this will be serious, however, if artificial clearing of the basin at the end of a storm does not inject large quantities of bed load material at this time. We believe that the recent plugging of the pipe, and very costly removal of the material, was due largely to efforts to clear the inlet of the pipe after the peak runoff on October 13; and while this effort was absolutely necessary as a precaution against another peak runoff period during that storm, we doubt that this situation will be repeated.

This office feels that recent events have conclusively proven that the existing inlet system is grossly inadequate to present conditions, and that this inadequacy will worsen with time. We feel that the existing inlet system should be replaced with a system which will solve the problem of plugging during peak flows, will increase the hydraulic capacity of the flat section of the sewer by providing an effective surcharge pressure, and will increase and balance the inlet capacity of the system with the flow capacity of the pipe. Further comments in this regard are given in "Emergency Remedial Measures", hereafter.

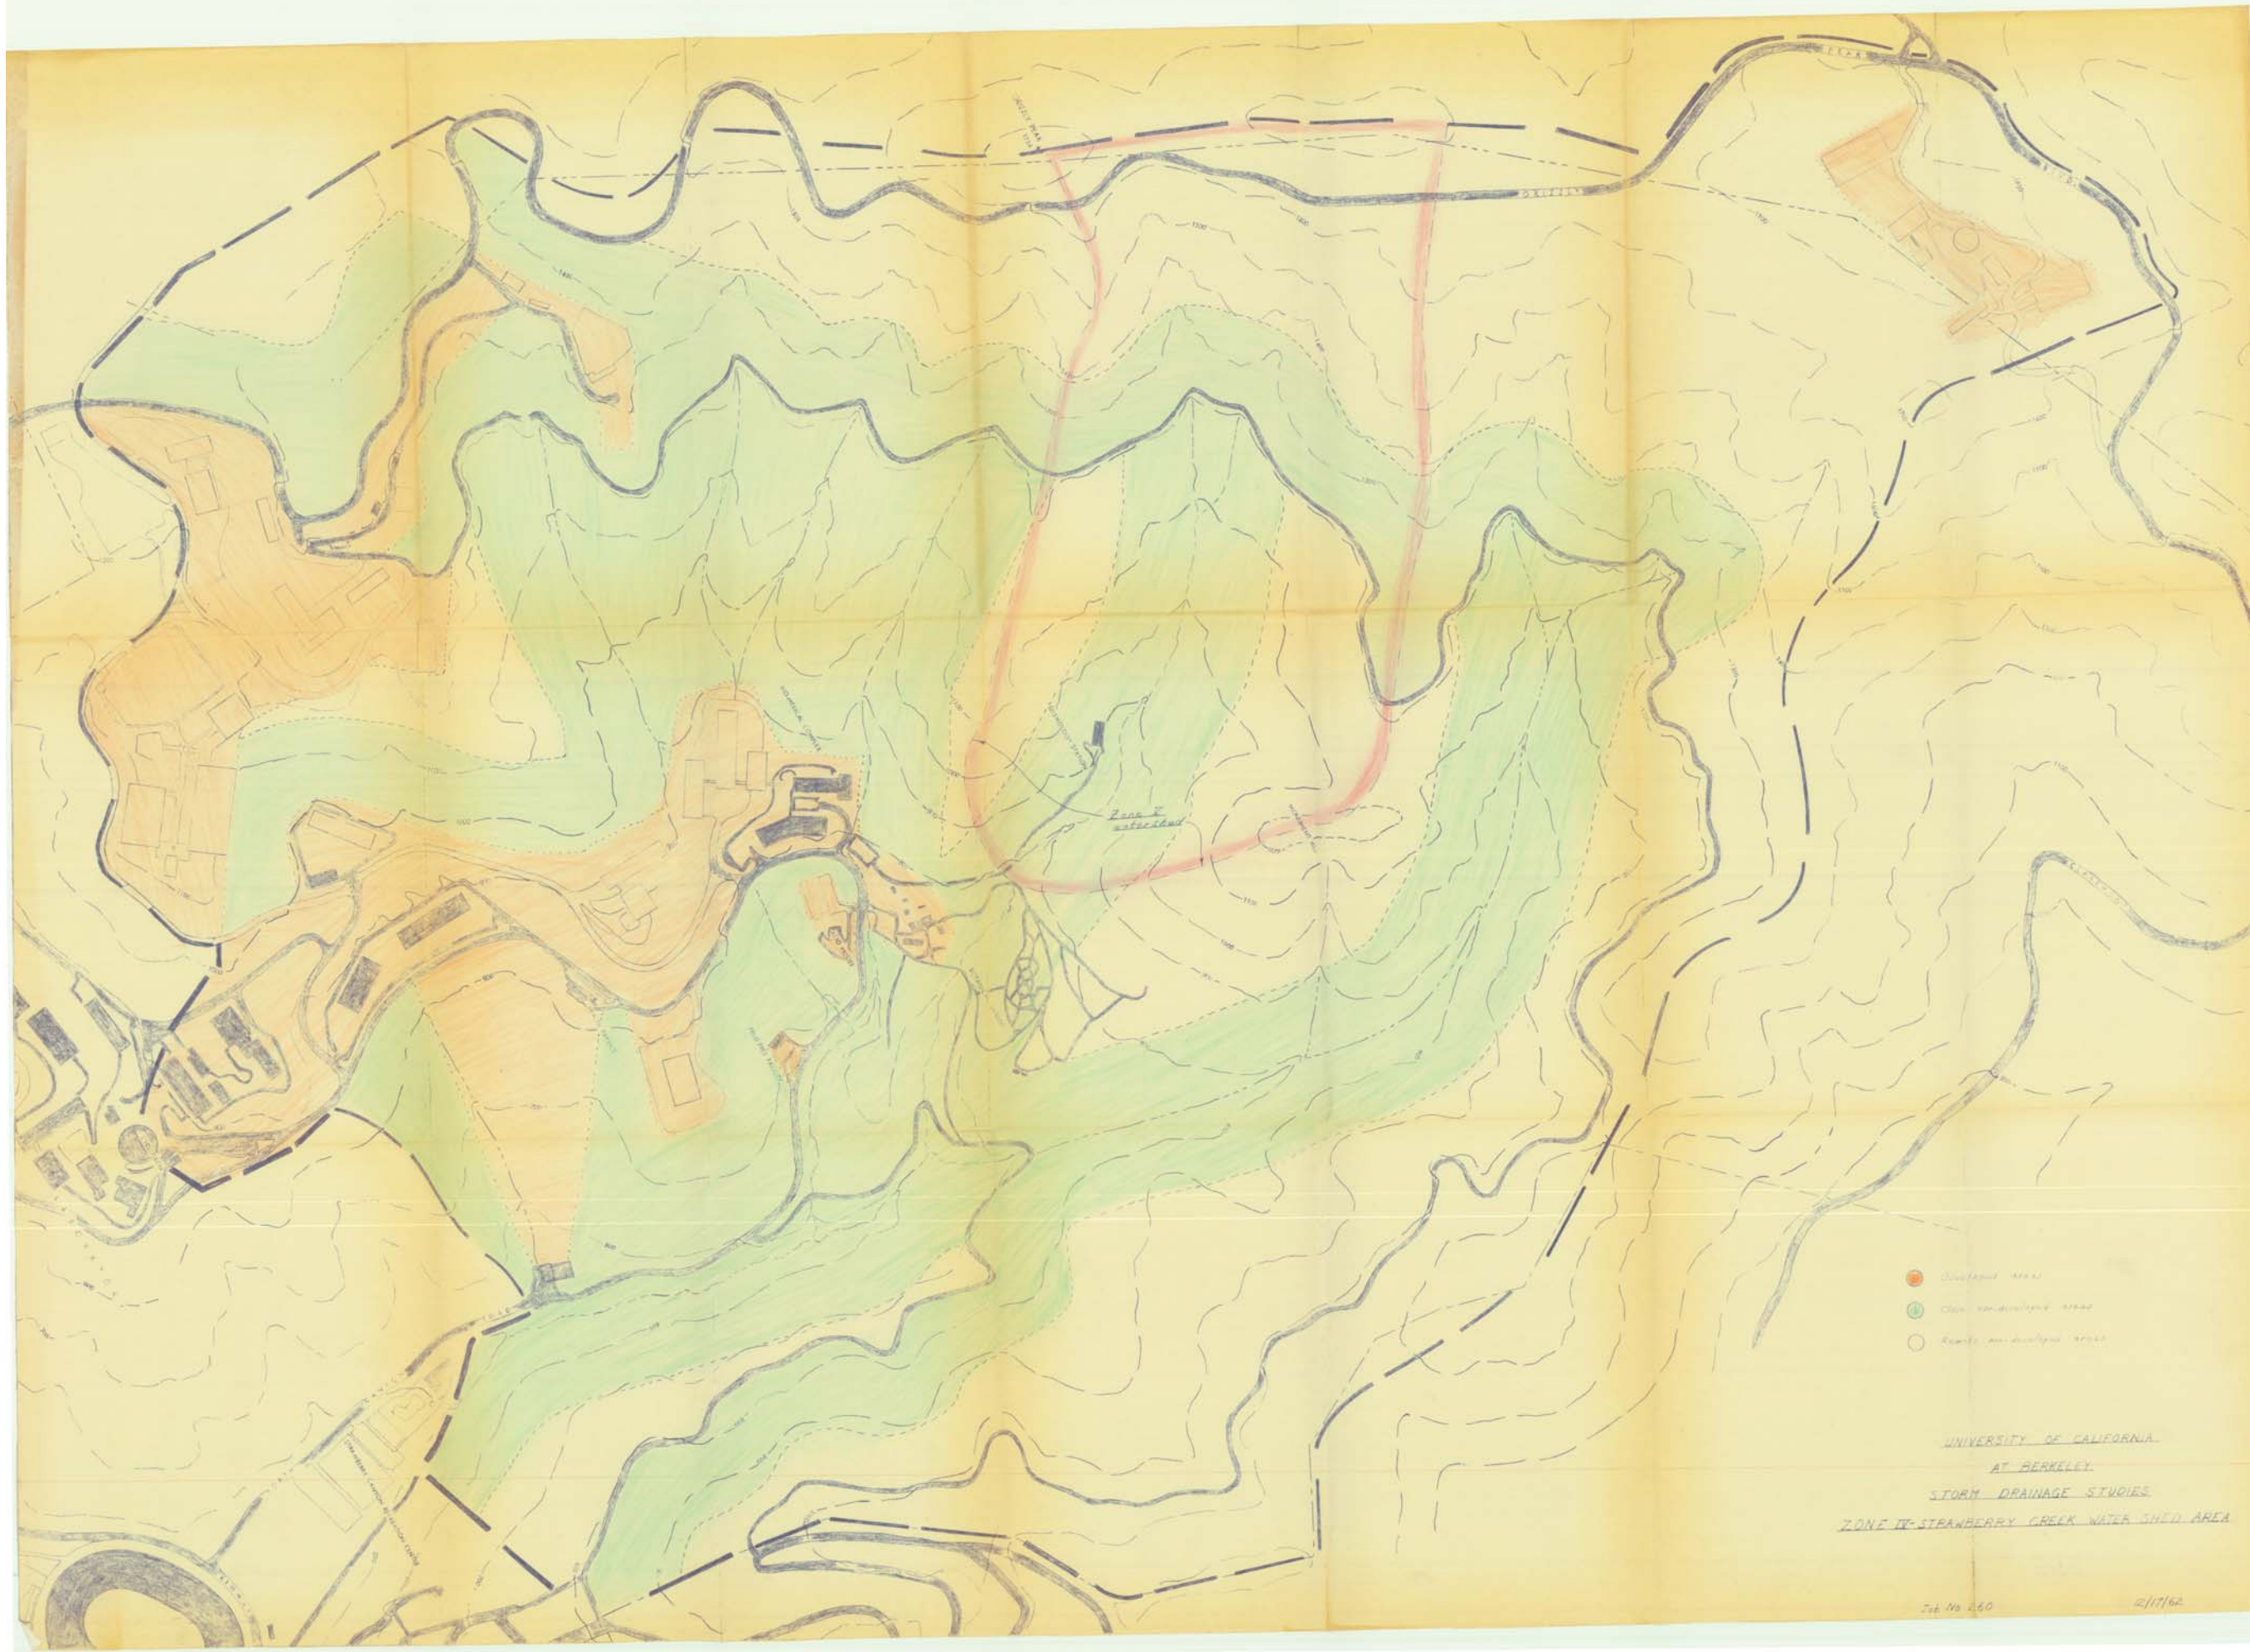
UNIVERSITY OF CALIFORNIA
AT BERKELEY
STORM DRAINAGE STUDIES
ZONE IV STRAWBERRY CREEK WATER SHED AREA

No recommendations for emergency remedial measures are made for Zone IV as we do not feel that "emergency" measures are justified at this time. This is not to imply that the Zone IV area does not require extensive improvements with respect to storm drainage at this time, as it most certainly does; but we do not feel that any measures can be taken this winter which would be justified in consideration of the costs and risks involved. Remedial measures in the Zone IV area must be based upon a campus master drainage plan and closely correlated with the upgrading of storm drainage capabilities in Zones II and III.

On a long-term basis we feel that storm drainage measures in Zone IV will basically involve the solution of bed and float problems, the artificial maturation of storm runoff channels in correlation with development of the watershed, the proper distribution of runoff in the various available channels, and the minimizing of peak runoff rates in the lower campus area by the wise use of all potential storage in the upper watershed and the maximizing of accumulation times with respect to the lower campus area. This problem is so complex, and its proper solution is so important with respect to final costs of storm drainage facilities for the campus, that we do not wish to comment further on this matter in this report, even though we have developed many ideas in the matter during the course of our work. The final solution of storm drainage problems in and resulting from Zone IV is intimately related to the final solutions for the entire campus, and can only be based upon a thorough, integrated solution to the storm drainage problems of the entire campus.
