To: Strawberry Creek Committee Members  
Re: Philip Williams & Assoc. Bank Stabilization Study / Erosion control.  
From: Bob Charbonneau SC

STRAWBERRY CREEK  
BANK STABILIZATION STUDY  
UNIVERSITY OF CALIFORNIA AT BERKELEY

Jeffrey Haltiner, Ph.D., P.E.  
Philip Williams and Associates

June 1988

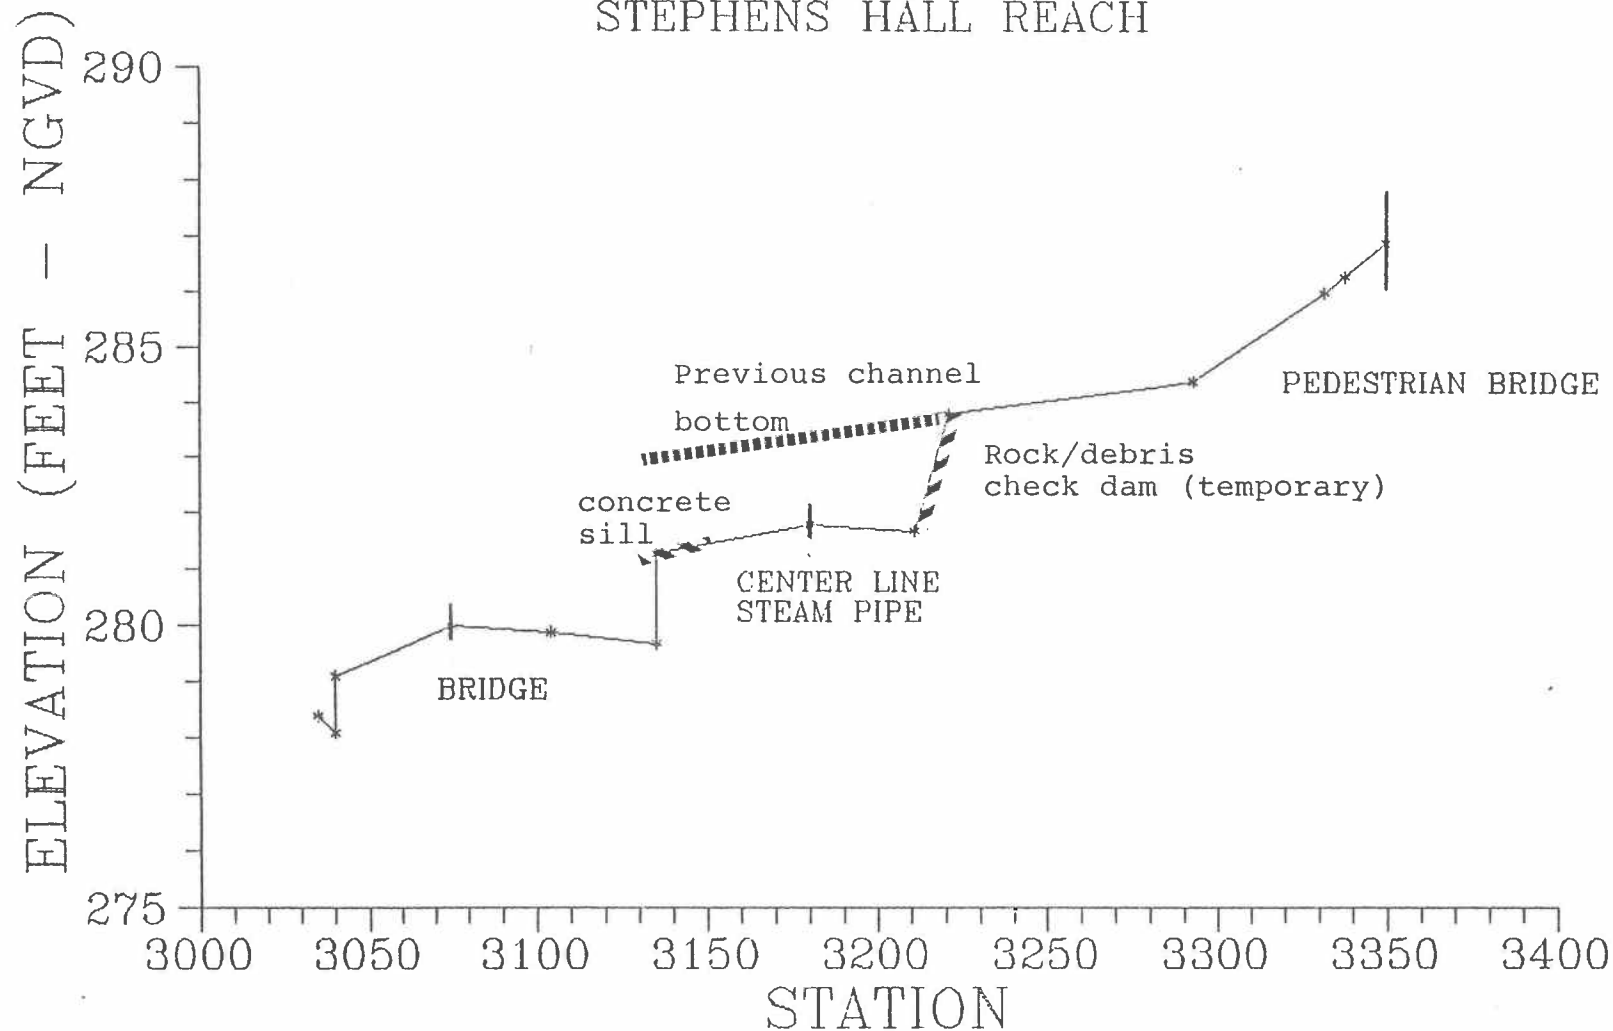
FIG.  
2

These problems resulted from channel incision and downcutting of 1 to 3 feet in this reach. Figure 2 is a profile of the creek channel bottom through the proposed work area (from the Stevens Hall Bridge upstream under the steampipe to the next pedestrian bridge 300 feet upstream). It can be seen that the channel rises in two "steps" going upstream, each about 1.5 to 2.0 feet high. The lower step is currently stabilized by the remnant piece of concrete channel bottom, while the upstream one is maintained by some large rocks and debris. Neither of these are permanently stable. It is also apparent that the channel bottom through this reach was several feet higher when the

Existing channel  
profile

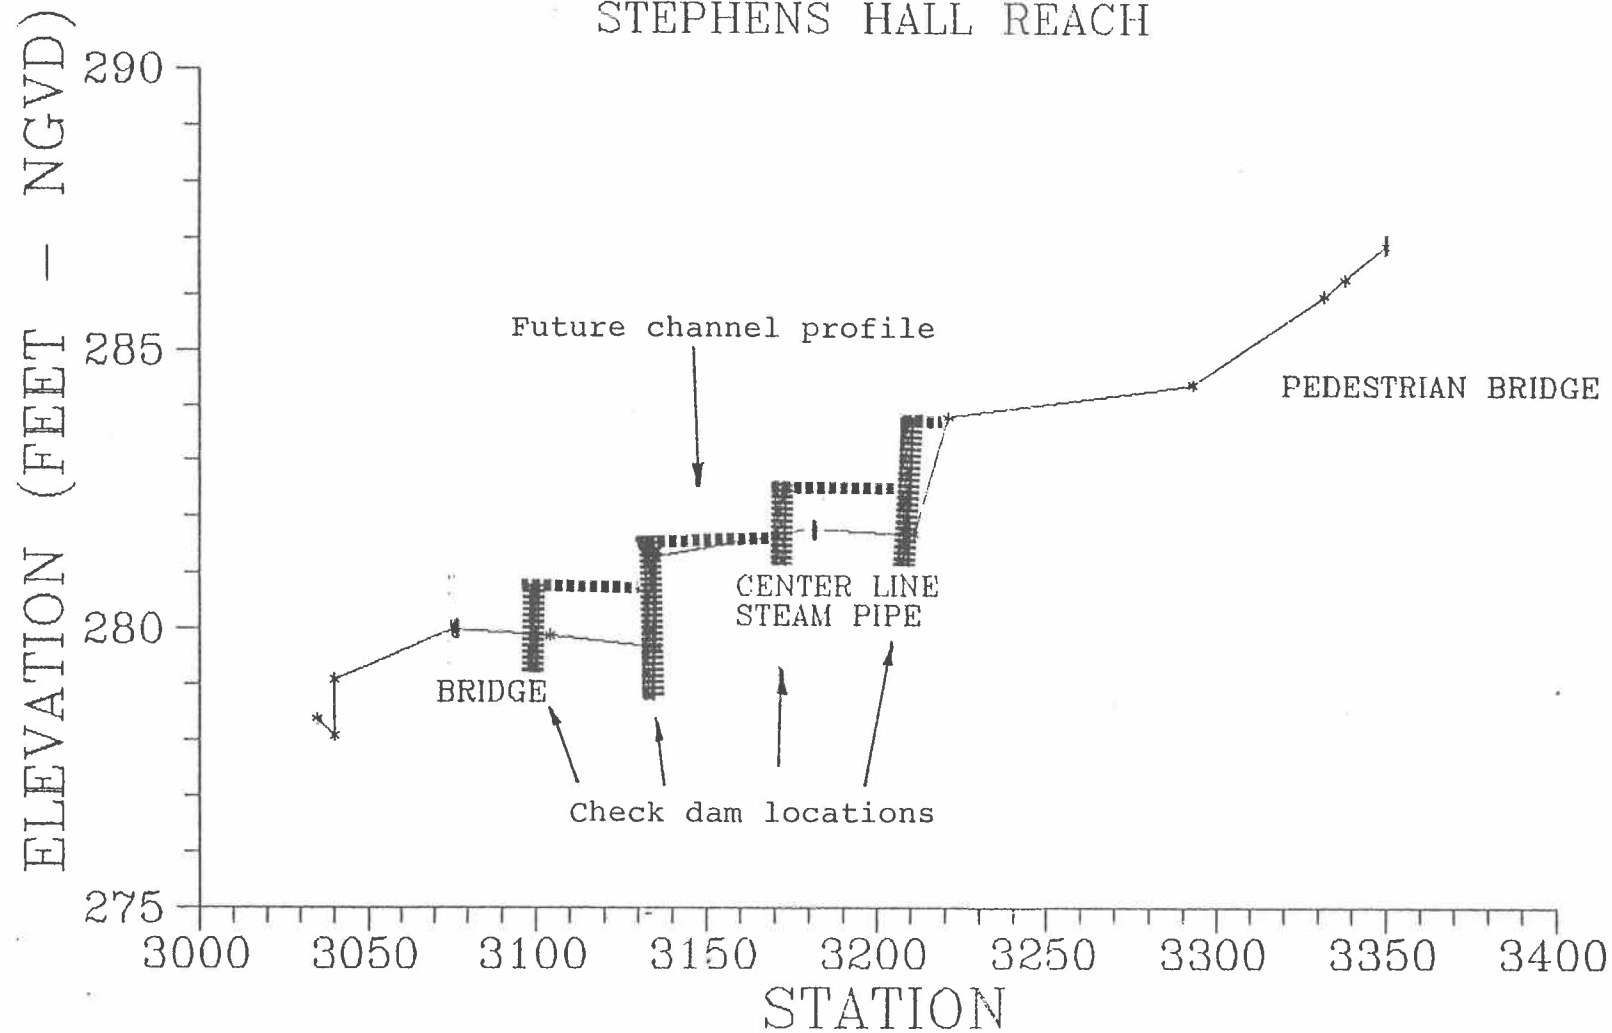
Fig.  
3

Proposed check dam  
locations

Therefore, as a Phase II recommendation, it is essential that additional channel stabilization be provided in this reach once the retaining walls are repaired and the crib wall is in place. We recommend construction of a series of three or four small check dams through this reach as shown on Figure 3. Each of these would stabilize a drop of about one foot. They should be keyed into the banks and bed to prevent undercutting, and provided with a scour pool which provides both energy dissipation and aquatic habitat. As part of the recommended Phase 1 work, the existing temporary check dam can be reconstructed at the same location (about 3210) using the large boulders which are currently in the channel near this location. These could quite easily be incorporated into a permanent check dam at this location.
