## MEMORANDUM

**Date:** July 23, 2007  
**To:** Kate Bolton  
**Organization:** UC Berkeley Capital Projects  
**From:** Jorgen Blomberg  
**PWA Project #:** 1799.01  
**PWA Project Name:** Winter Creek Temporary Stabilization Project  
**Subject:** Project Status: 2007 Monitoring  
**Copy(ies) To:** Mark Cederborg (Hanford ARC)

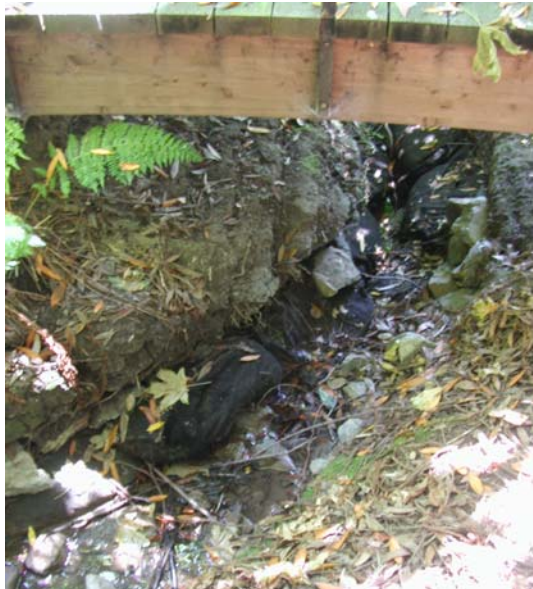
<p>A photograph showing a dense thicket of green vegetation and trees, with a geogrid basket structure visible in the background.</p>
<p>Undercut Bank at Footbridge</p>	<p>Structure 7 (Geogrid Basket)</p>

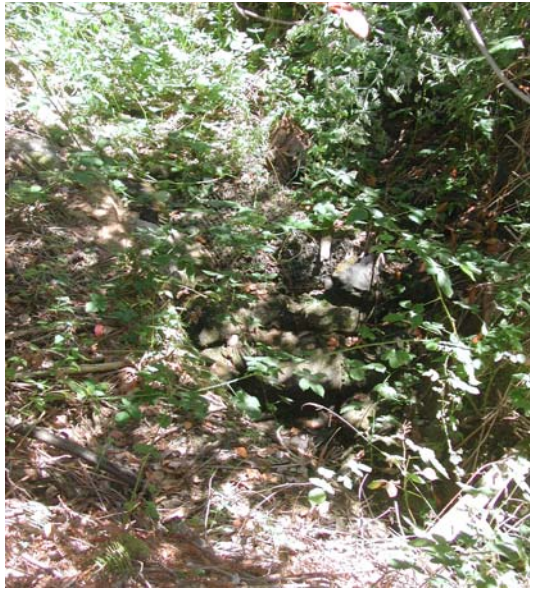
Geogrid Structure 7	<p>No degradation or change to the structure was noted.</p> <p><u>Action:</u> No action recommended or required.</p>
