Technical Memorandum

Date: March 6, 2012

RE: **UC Berkeley Stanley Hall Diesel Spill - Natural Resource Damage Assessment December 2011 Water and Sediment Sampling Summary**

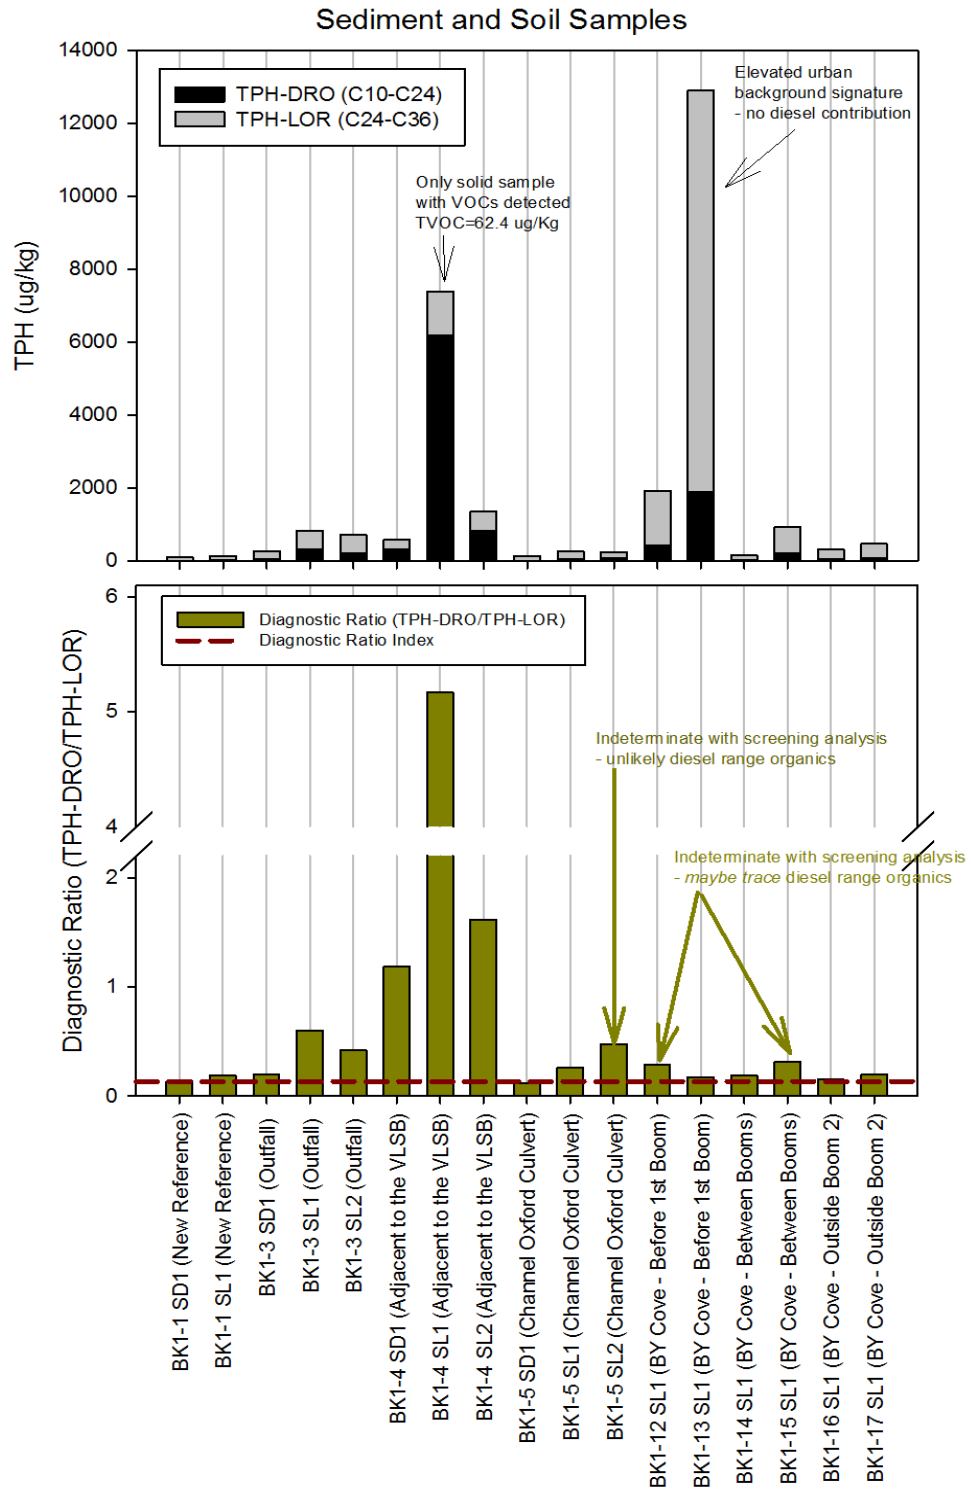
TPH-DRO and TPH-LOR were detected in all Source location/outfall sediment and soil samples (BK1-3-SD1, BK1-3-SL1, BK1-3-SL2; Figure 4 – top). The diagnostic ratio for the sediment sample was only slightly higher than the reference location (Table 4; Figure 4 - top). The diagnostic ratio for the soil samples collected in the left and right banks at the wetted perimeter were approximately three to four times higher than reference. Upon inspection of the diagnostic ratios (Figure 4 – bottom) and the FID chromatograms (Figures 7 and 8), it was evident that only the left bank sample BK1-3-SL1, and to a lesser extent the right bank sample BK1-3-SL2, displayed a diesel fingerprint. The FID chromatogram for the sediment sample was characteristic of the reference conditions (Figure 9).

VOCs were detected in one soil bank sample from BK1-4-SL1 (Table 4; Figure 4 – top). This is the only sediment/soil sample in the survey with detectable levels of VOCs. TPH-DRO and TPH-LOR also were detected in all sediment and soil samples from this location (BK1-4-SD1, BK1-4-SL1, BK1-4-SL2; Table 4; Figure 4 – top). The diagnostic ratio for all three samples was much higher than the reference ratio with the highest value measured in the left bank sample, BK1-4-SL1. Upon inspection of the FID chromatograms (Figures 11-13) and diagnostic ratios (Figure 4 – bottom), it was evident that all non-water samples from this location displayed a diesel fingerprint. We recommend analyzing the deeper sections of the cores for these soil and sediment samples to determine if the diesel concentrations penetrate deeper than 1 cm. These data would be useful to understand the potential impact to the subsurface zone in this area.

TPH-DRO and TPH-LOR were detected in all sediment and soil samples (BK1-5-SD1, BK1-5-SL1, BK1-5-SL2; Table 4; Figure 4 – top). The sediment concentration of TPH-DRO was approximately two times the average value of the reference locations. Soil concentrations of the TPH-DRO were six and seven times higher than the average of the reference concentrations, and approximately 30 times less than concentrations measured at the VLSB site (BK1-4-SL1 and BK1-4-SL2; Table 4; Figure 4). Upon inspection of the FID chromatograms for the soils (Figures 15 and 16) and diagnostic ratios (Figure 4 – bottom), it was evident that the elevated diagnostic ratio values were not likely diesel related due to the heavier than diesel boiling range of the TPH signature. As noted above, the TPH signature gives a general indication of hydrocarbon characteristics. In this case, the chromatographic signature provided evidence that the elevated diagnostic ratios for these samples were not due to a diesel source. No diesel contribution is evident in the sediment sample BK1-5-SD1 (Figure 17).

TPH-DRO and TPH-LOR were detected in both sediment/ soil samples from this location (BK1-12-SL1, BK1-13-SL1; Table 4; Figure 4 – top). The diagnostic ratio for the left bank sample (BK1-12-SL1) was twice the level of the reference ratio. Upon inspection of the FID chromatogram for BK1-12-SL1, it was evident that there may be a trace level of diesel range organics in the sample. However, the potential diesel components are so low that they may not result in detectable signals in subsequent Tier 2 analyses (Figure 18). Upon inspection of the FID chromatogram for the right bank sample BK1-13-SL1, it was evident that the high TPH signature was not related to diesel range organics, but derived from the urban background (Figure 19). This is consistent with the diagnostic ratio for this sample which was nearly the same as the upstream reference location (Figure 4 – bottom).

TPH-DRO and TPH-LOR were measured in both sediment samples from this location (BK1-16-SL1, BK1-17-SL1; Table 4; Figure 4 – top). Upon inspection of the FID chromatograms and diagnostic ratio values for both solid samples, it was evident that the respective TPH signatures were not related to diesel range organics, but derived from the urban background (Figures 22 and 23).

Sediment and Soil TPH Concentrations and Diagnostic Ratio Values

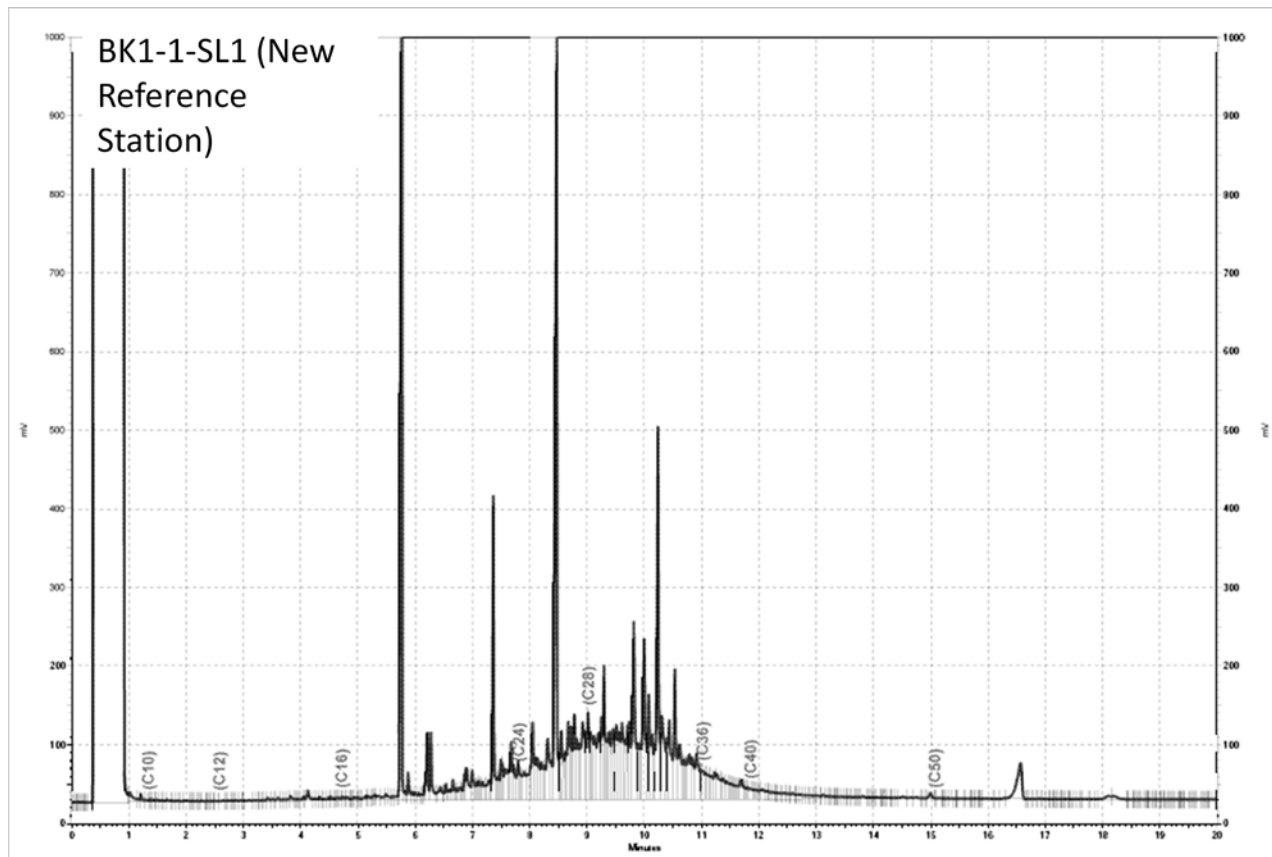
Sediment sample BK1-1-SD1 had a TPH-DRO concentration of 13 µg/Kg, and a TPH-LOR concentration of 100 µg/Kg. Soil sample BK1-1-SL1 had a TPH-DRO concentration of 22 µg/Kg, and a TPH-LOR concentration of 120 µg/Kg. The diagnostic ratio value was 0.13 for the sediment sample, and 0.18 for the soil sample. The TPH chromatograms were inspected, and indicated a hydrocarbon boiling range not related to diesel oil (Figures 5 and 6). The average diagnostic ratio value for these reference sediments served as the diagnostic ratio index to compare samples collected downstream of the Source in an effort to tease out urban background characteristics (Figure 4 - bottom). The urban background sources in these samples are characterized by a chromatographic TPH profile that peaks well beyond the boiling range of diesel range organics.

Figure 5 FID Chromatogram for Station BK1-1, "New Reference" Station, Left Bank Soil Sample

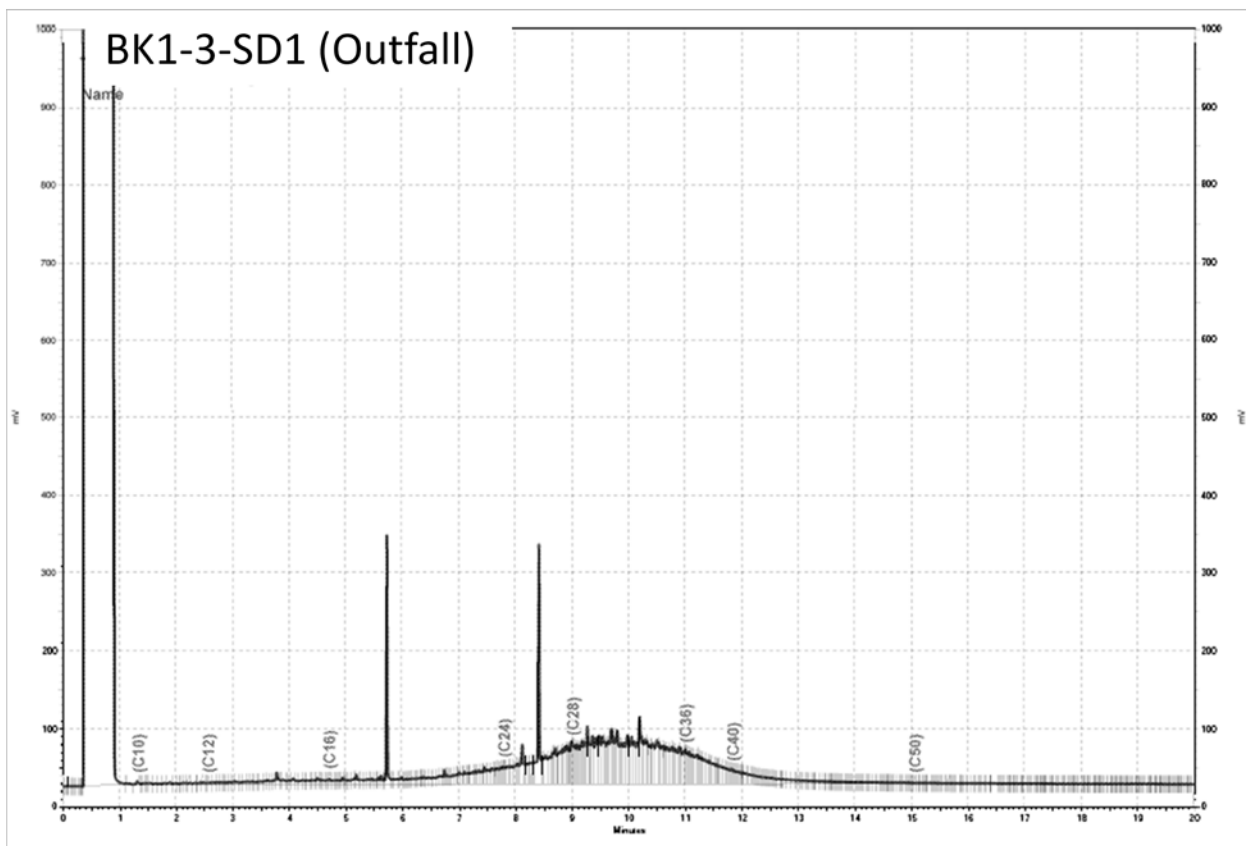
Figure 9 FID Chromatogram for Station BK1-3, Source/outfall Station, Sediment Sample

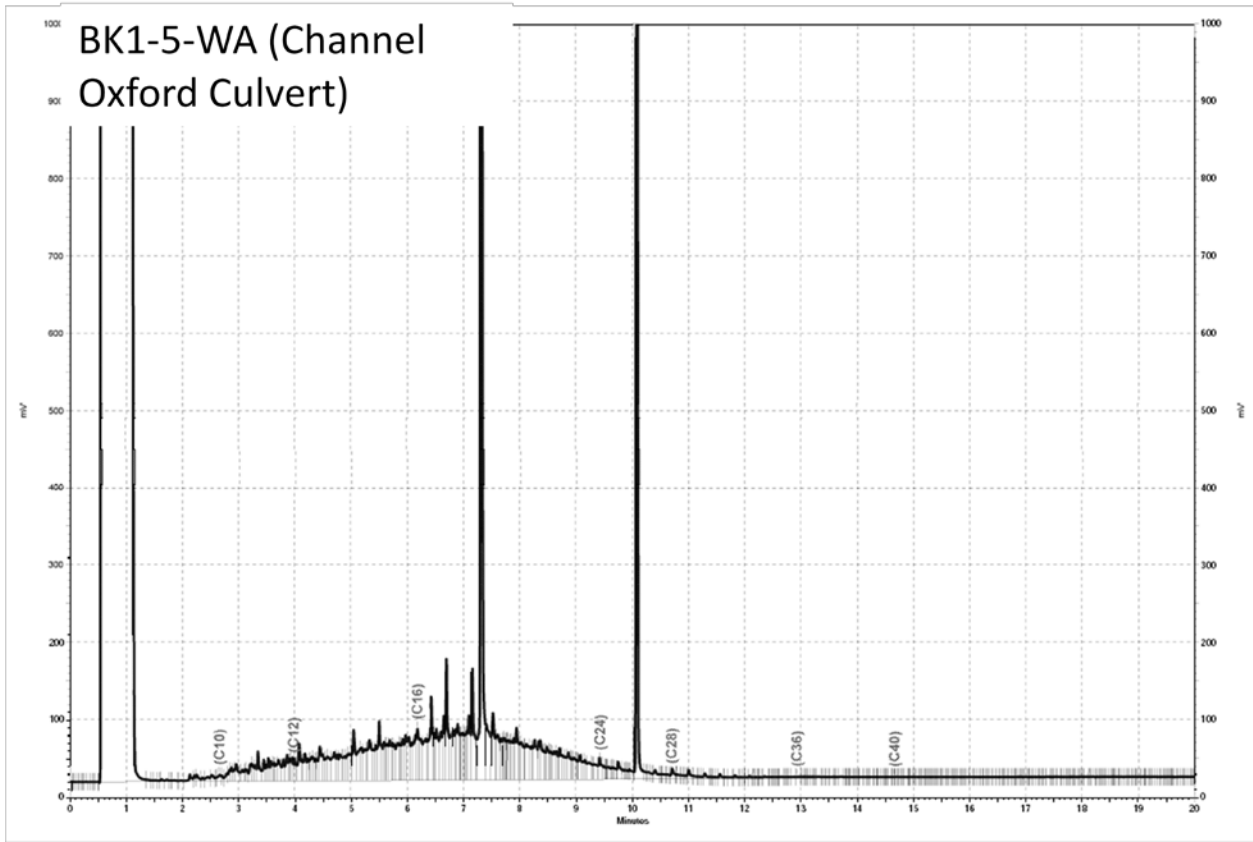
Sediment, soil, and water samples were collected just upstream of the channel near Oxford Culvert. The field team observed a strong diesel odor at this location. VOCs were not detected in water, sediment or soil samples (Tables 3 and 4). TPH-DRO was detected in the water sample (BK1-5-WA; Table 3). The FID chromatogram of the water sample exhibited a slightly right skewed TPH signature possibly attributed to a lightly weathered diesel (Figure 14).

Figure 14 FID Chromatogram for Station BK1-5, Oxford Culvert, Water Sample

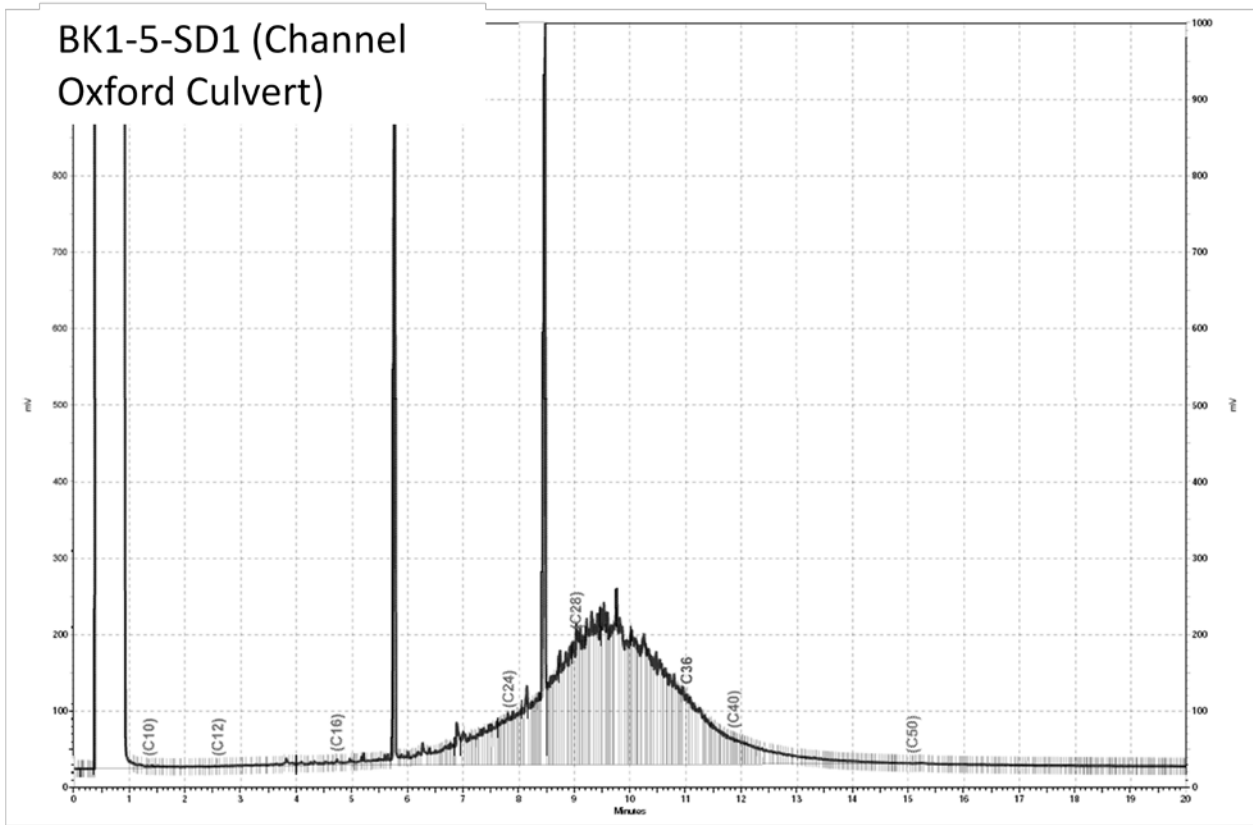
Figure 17 FID Chromatogram for Station BK1-5, Oxford Culvert, Sediment Sample

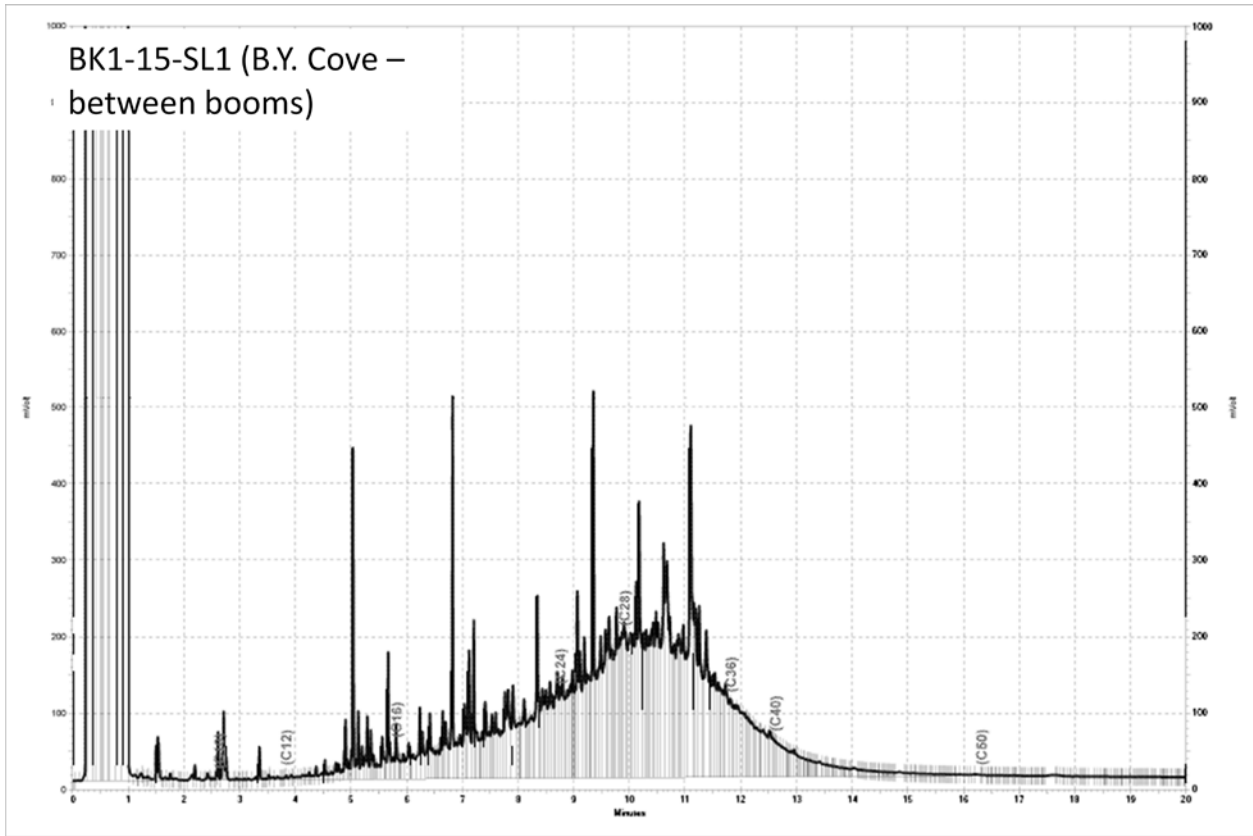
Sediment samples were collected at the Brickyard Cove mudflat between the installed booms (Figure 3). As with all Brickyard Cove locations, the field team did not observe any sheen or diesel odor in this location. VOCs were not detected in the sediment samples (Table 4). TPH-DRO and TPH-LOR were detected in both samples from this location (BK1-14-SL1, BK1-15-SL1; Table 4; Figure 4 – top). The diagnostic ratio for the left bank sample (BK1-14-SL1) was approximately equal to the reference location, whereas the diagnostic ratio for the right bank sample (BK1-15-SL1) was twice the average value of the index ratio at the reference location. Upon inspection of the FID chromatogram for BK1-14-SL1, it was evident that, as seen with the reference locations, the TPH signature was high boiling, and not related to diesel range organics (Figure 20). Inspection of the FID chromatogram for BK1-15-SL1 showed that there may be a trace level of diesel range organics in the sample. However, the potential diesel components are so low in the sample that they may not result in detectable signals in Tier 2 analyses (Figure 21).

Figure 21 FID Chromatogram for Station BK1-15, Brickyard Cove in between Booms, Right Bank Sediment/Soil Sample

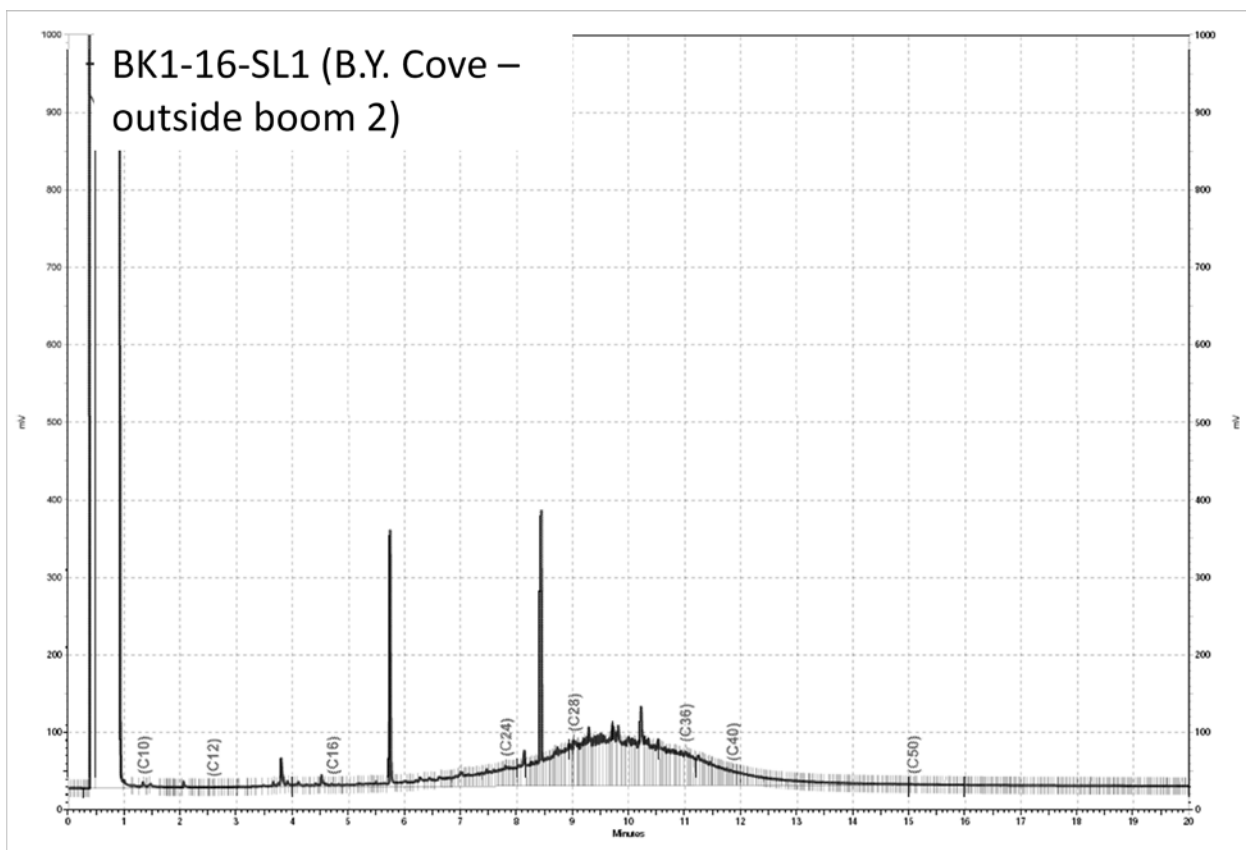
Figure 22 FID Chromatogram for Station BK1-16 outside Last Boom, Brickyard Cove, Left Bank Sediment/Soil Sample

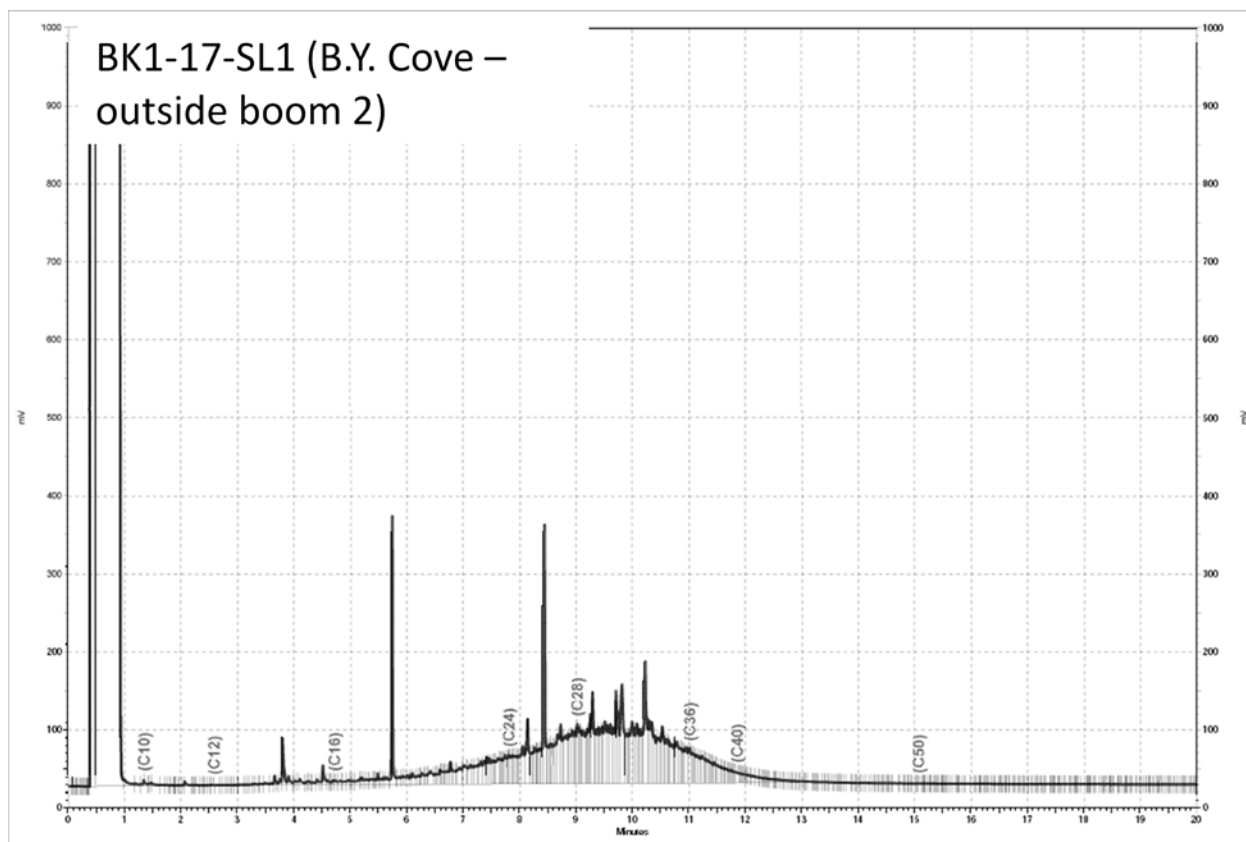
Figure 23 FID Chromatogram for Station BK1-17 outside Last Boom, Brickyard Cove, Right Bank Sediment/Soil Sample (same location as CDFG sediment sample)

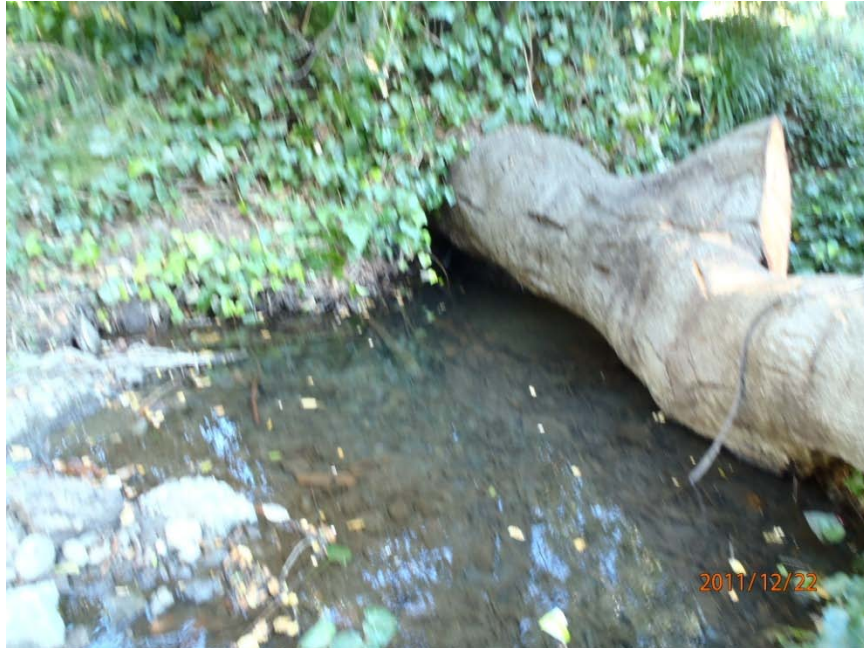
Sediment, soil and water samples were collected adjacent to the VLSB above the culvert (BK1-4). Although sheen was visible in the pooled water present at the location, along with a slight diesel odor, VOCs were not detected in water samples (Table 1). As noted above, this result suggests that diesel related hydrocarbons were at undetectable concentrations in the water column below the diesel sheen. In light of the visual confirmation of sheen at this location, sheen sample collection could have yielded chemical detections. TPH-DRO was measured in the water sample BK1-4-WA1 at a low level (68 µg/L) however upon more detailed inspection of the FID chromatogram there was no evidence of any hydrocarbons measured for this sample (Figure 10). As noted above, TPH-DRO measurements do not necessarily indicate the contribution of diesel to the sample. In this case, the chromatographic signature provided evidence that the measured TPH-DRO concentration was not due to a diesel source.

BK1-4 Water Sample Location near the Valley Life Sciences Building

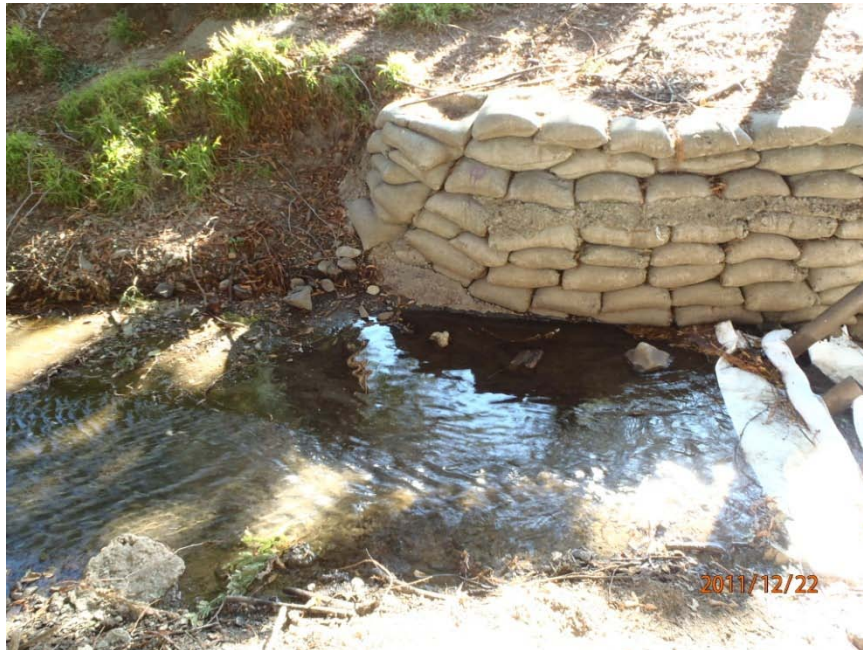
BK1-5 Water Sample Location upstream of Oxford Culvert
