2012 (Year 5)
Habitat Monitoring Report
Village Creek Restoration Project
(University Village Albany Step 2, #12810A)
University of California, Berkeley

November 2012

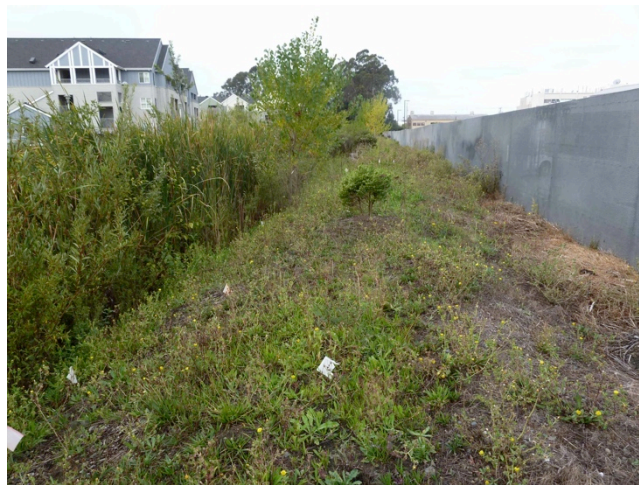
Photo 1a. Year 5 (2012). Typical vegetation cover, upper and lower creek banks

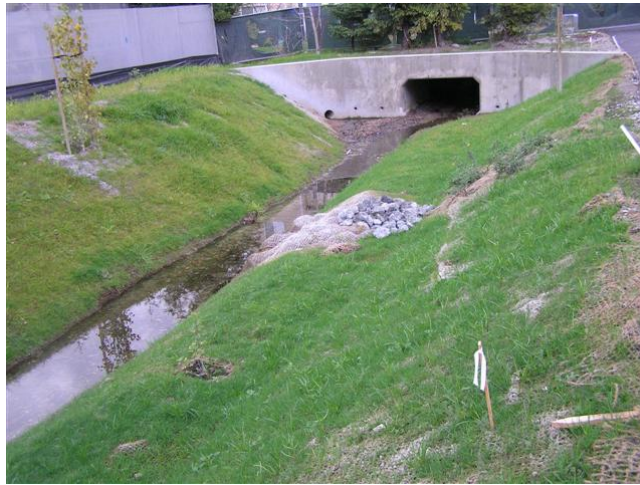
Photo 1b. Baseline (January 2008). Typical vegetation cover, upper and lower creek banks after planting

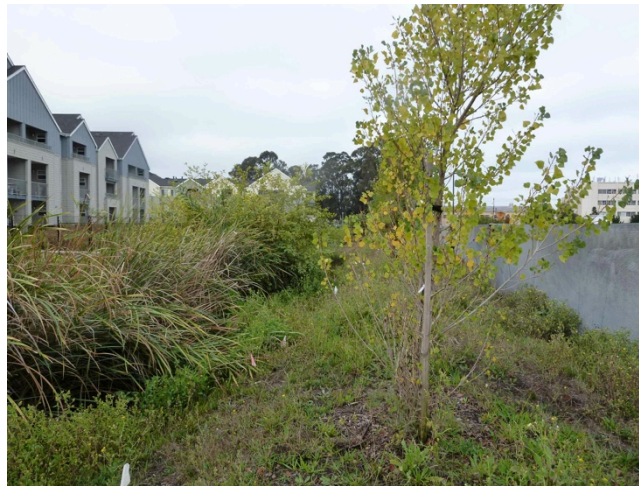
Photo 2a. Year 5 (October 2012) site conditions.

Typical Fremont's cottonwood average tree height (est. at 9-30 feet for cottonwoods).
Note Height increase, robust growth and excellent condition of cottonwood trees.

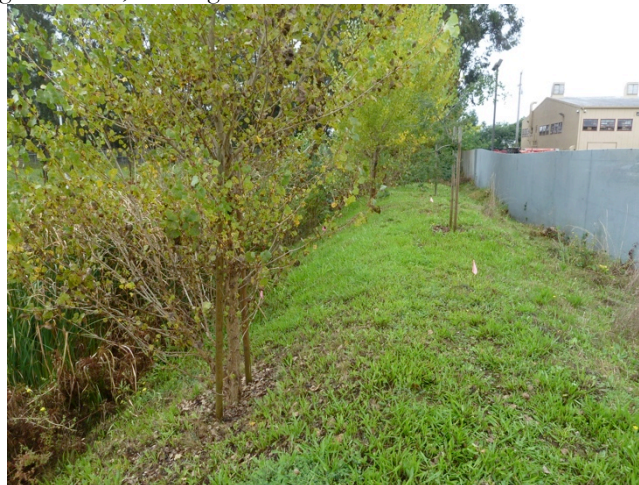
Photo 2b. Year 4 (October 2011) site conditions.

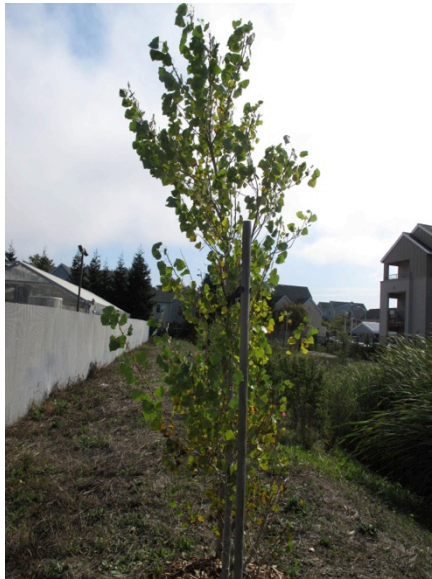
Photo 2c. Year 3 (September 2010) site conditions.
 Typical Fremont's cottonwood average tree height (est. at 9-17 feet for cottonwoods).
 Note height increase, robust growth and excellent condition of cottonwood trees.

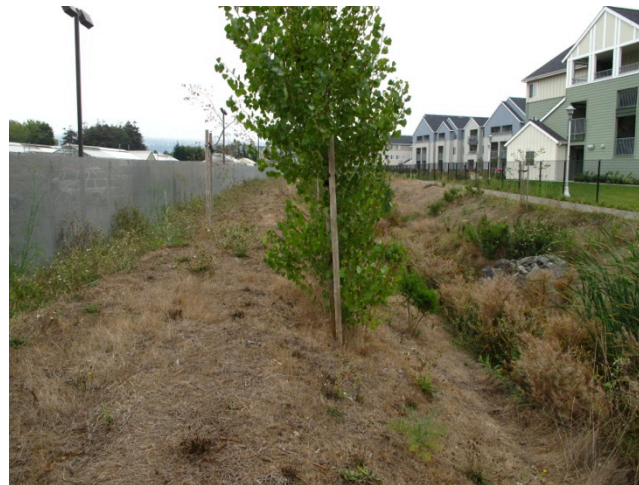
Photo 2d. Year 2 (September 2009) site conditions.
 Comparison Photo, Typical Fremont's cottonwood (est 12 feet in 2009)

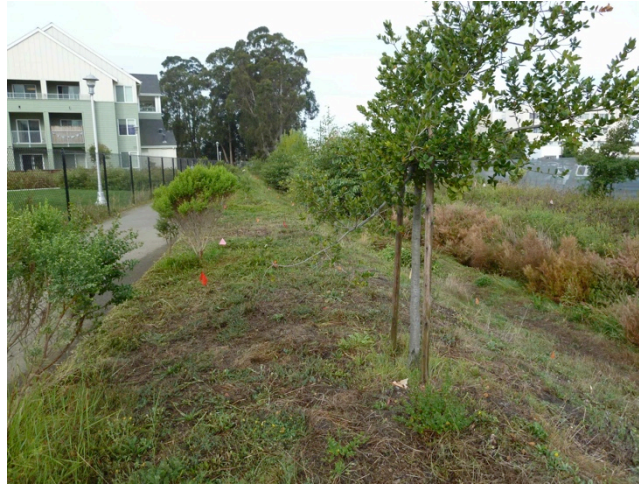
Photo 3a. Year 5 (October 2012) site conditions.
Typical original coast live oak planting showing average tree height (est. at 9-15 feet),
replacement oak plantings 1.5-5 feet.

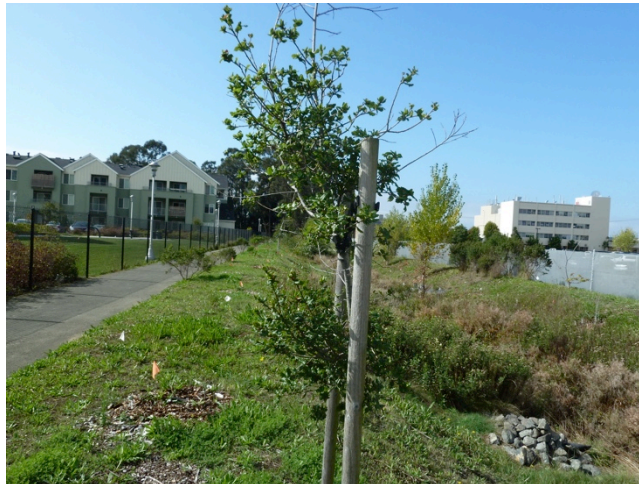
Photo 3b. Year 4 (October 2011) site conditions.
Typical coast live oak planting showing average tree height (est. at 8-13.5 feet).

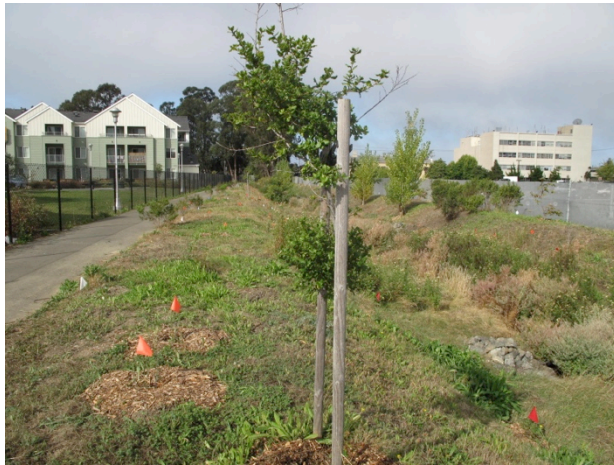
Photo 3c. Year 3 (September 2010) site conditions.
Typical coast live oak planting showing average tree height

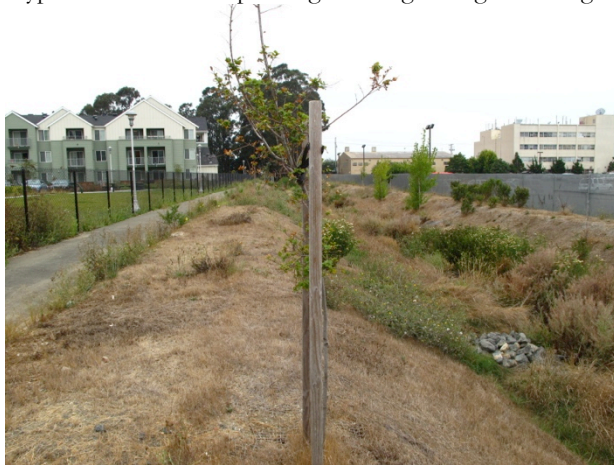
Photo 3d. Year 2 (September 2009) site conditions.
Comparison photo: Typical coast live oak planting 2009

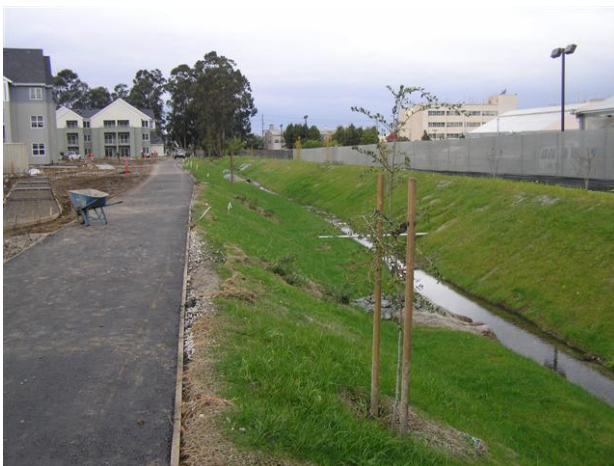
Photo 3e. Baseline (January 2008) site conditions.
Typical coast live oak planting showing baseline for average tree height (est. at 7 to 9.5 feet in 2008).

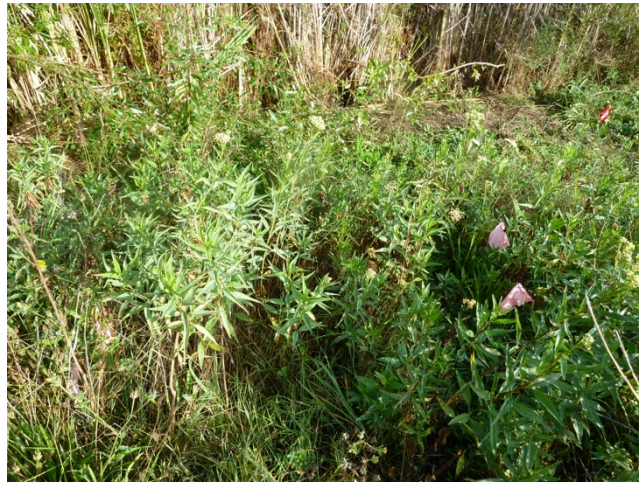
Photo 4. Year 5 (2012). Replacement planting (mugwort, marsh baccharid) showing natural regeneration (outward spread) from original planting site.

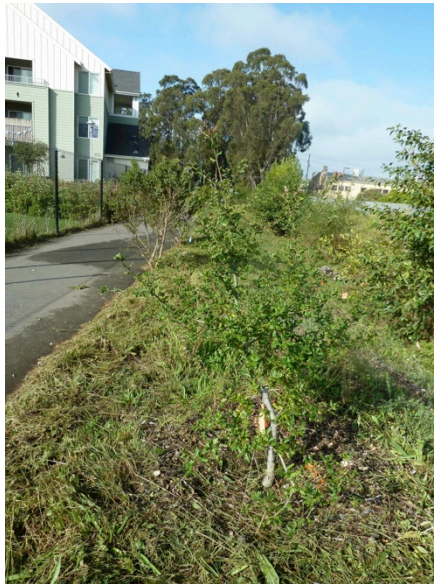
Photo 5. Year 5 (2012).
Photo depicting increase in height of both shrubs (coyote bush, background) and trees (coast live oak-foreground, alder- left)

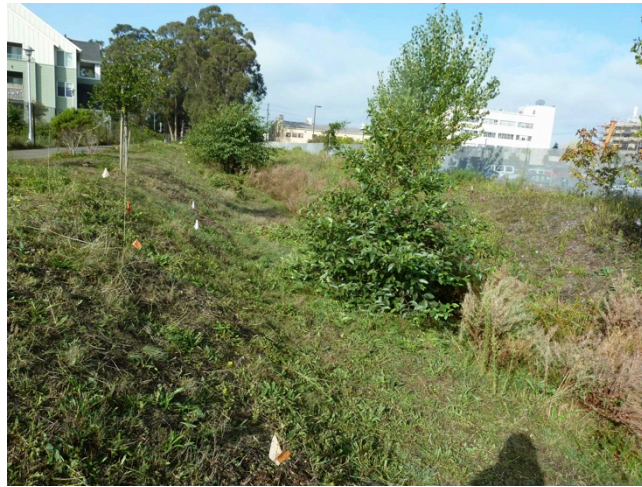
Photo 6b. Substantial increase in number and size of alders in 2012
(compare with Photos 6b below).

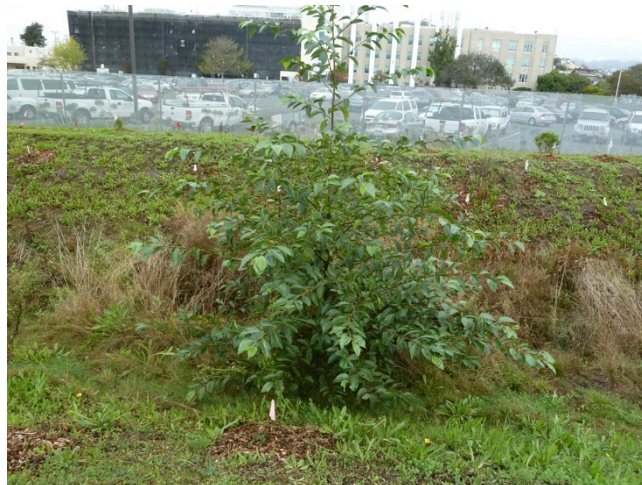
Photo 6b. Substantial increase in number and size of alders in 2011.

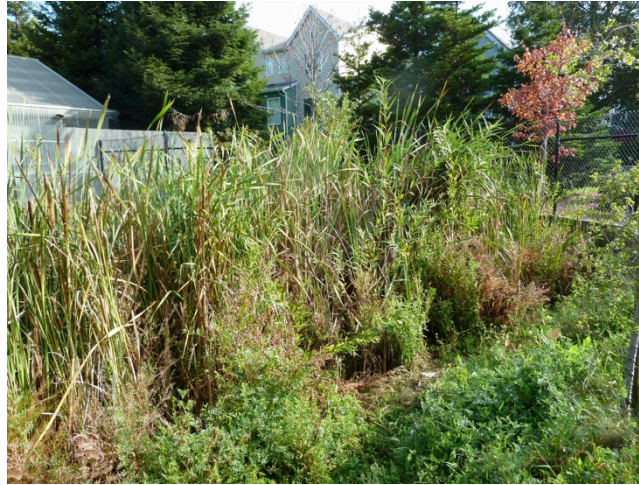
Photo 7a. Creek channel showing excessive growth of cattails and other aquatic vegetation (2012).
(Compare with Photo 7b below)

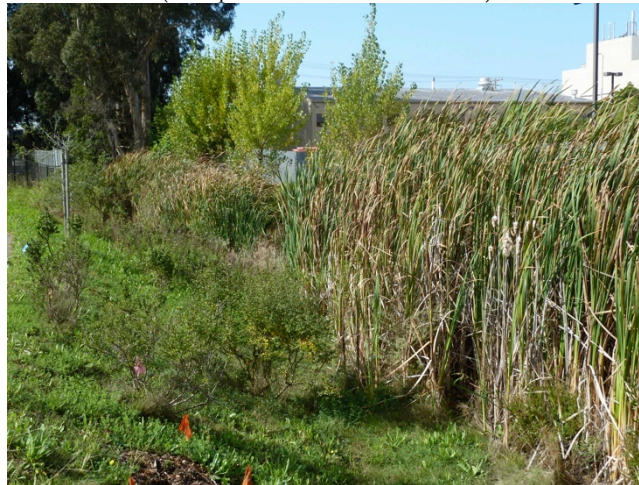
Photo 8. Typical channel conditions in 2011-cattails covering most of creek channel bottom.
