FINAL REPORT
2014 Supplemental Monitoring Report
Village Creek Restoration Project
(University Village Albany Step 2, #12810A)
University of California, Berkeley

December 2014

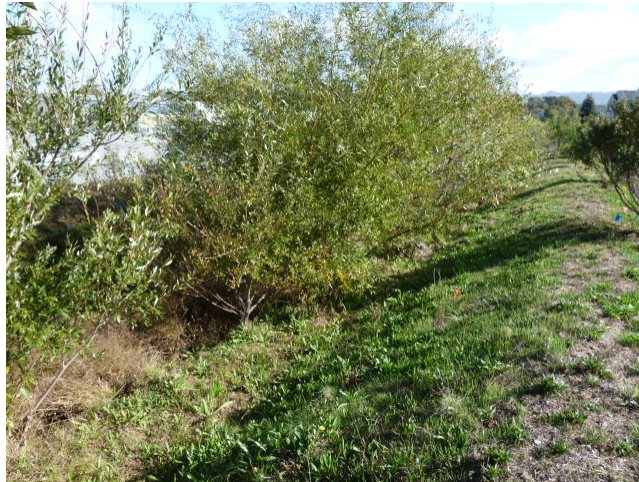
Photo 1a. (2014) Typical vegetation cover, upper and lower creek bank. Note abundant willow growth in creek channel

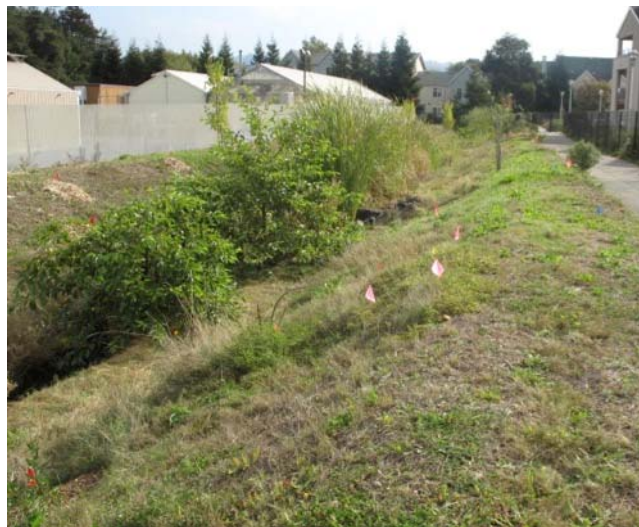
Photo 1b. Comparison, Typical vegetation (2011) upper and lower creek banks immediately after supplemental willow plantings

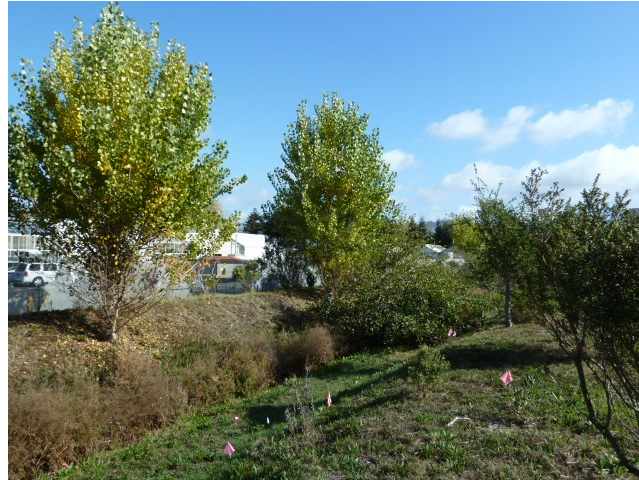
Photo 2a. Typical Tree height – Fremont’s cottonwood (November 2014) site conditions.
Note height increase, robust growth and excellent condition of cottonwood trees.

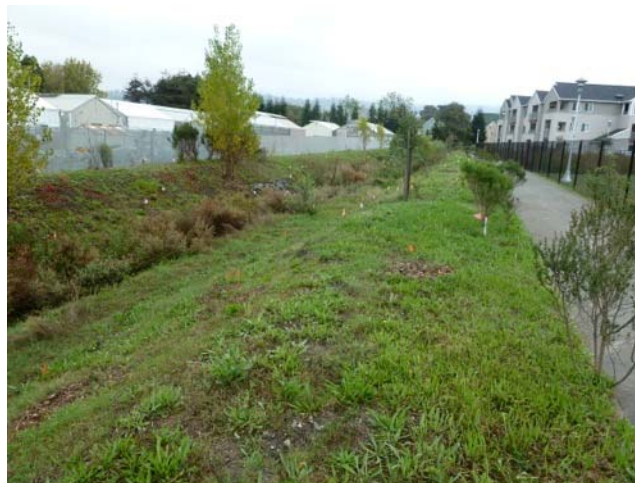
Photo 2b. Comparison photo-Typical tree height- Fremont’s cottonwood (2011)

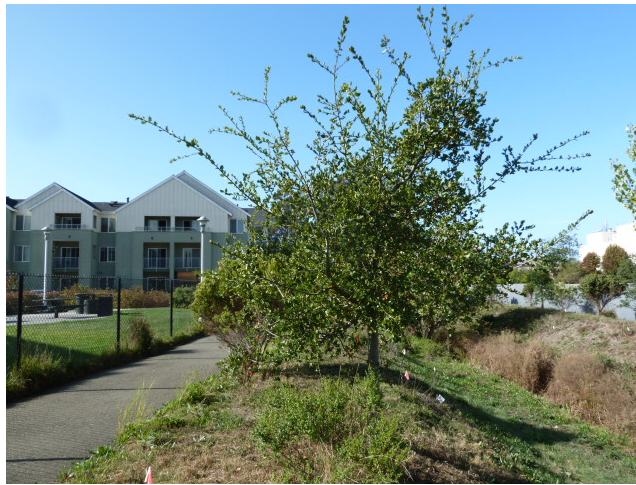
Photo 3a. Typical coast live oak planting (November 2014)

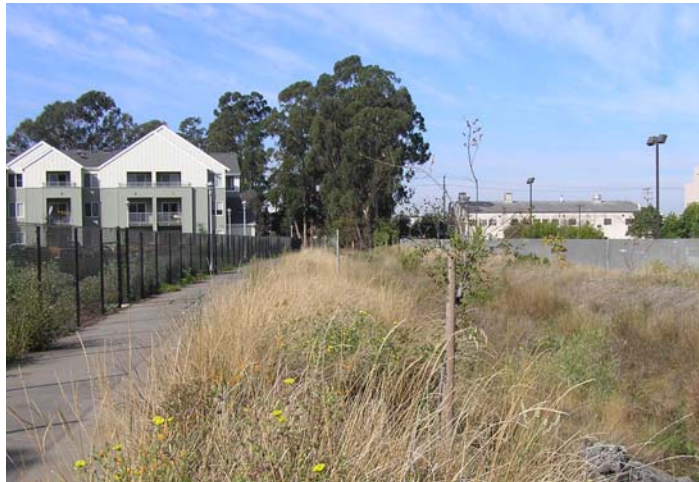
Photo 3b. Comparison Photo, typical coast live oak (2009) site conditions.

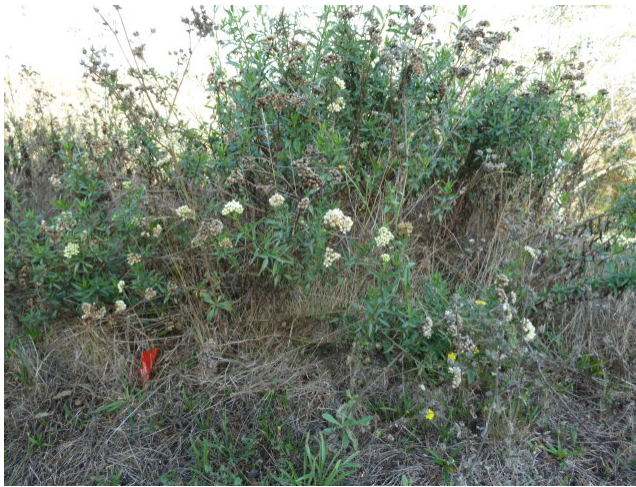
Photo 4. Replacement planting (marsh baccharis) showing natural regeneration (outward spread) from original planting site (2014)

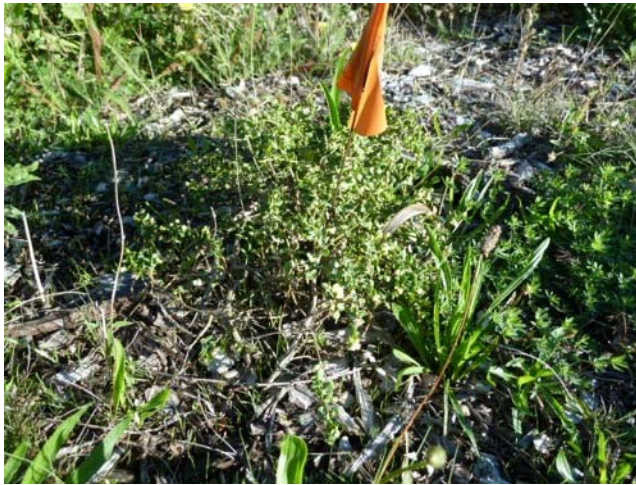
Photo 5.
Photo depicting increase in height of shrubs (coyote bush) (2013)

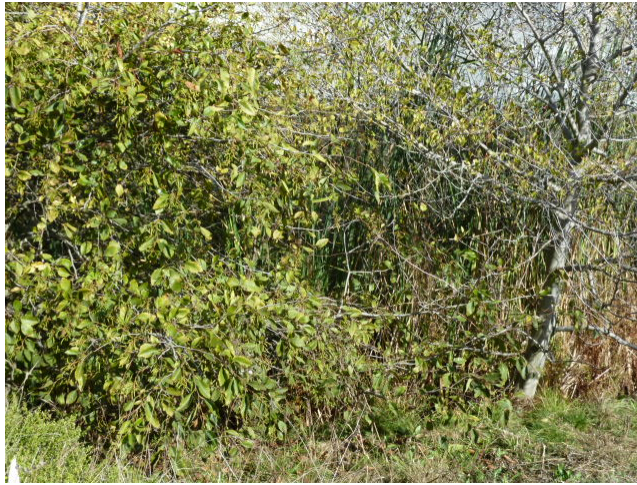
Photo 6a. Substantial increase in number and size of alders in 2014
(compare with Photo 6b below).

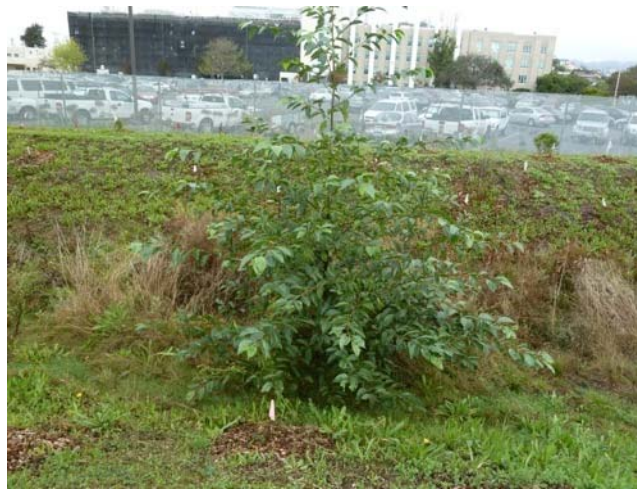
Photo 6b. Comparison Photos- alders in 2011.

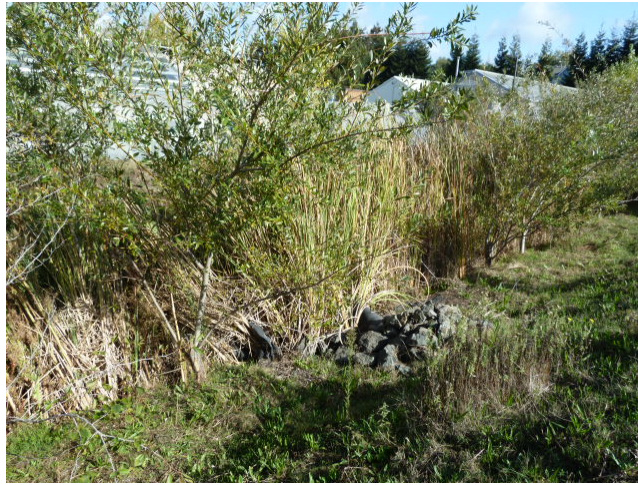
Photo 7a. 2014 . Creek channel after treatment (removal) of some cattails in 2012. Note regrowth of cattails may warrant future channel maintenance to improve flood flow capacity.
(Compare with Photo 7b below)

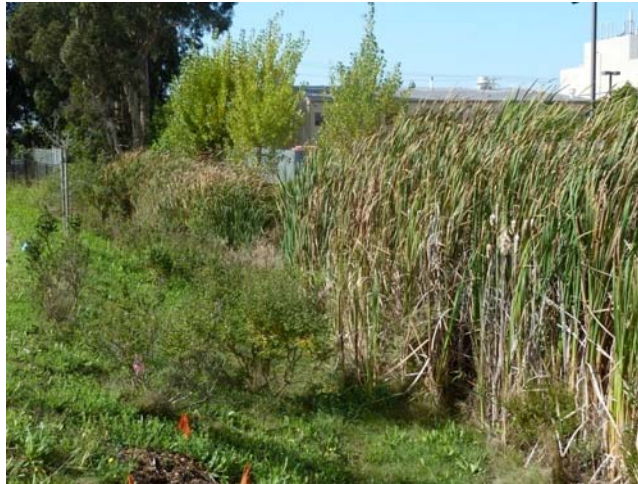
Photo 8. Typical channel conditions in 2011-excessive growth of cattails covering most of creek channel bottom
(requiring maintenance to allow for creek channel flow).

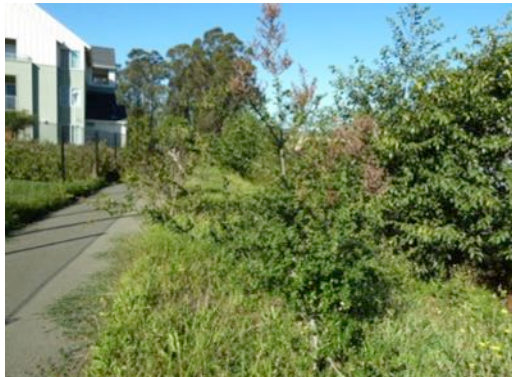
Photo Point 6A - Supplemental
Planting Site 2013 (Note additional
alder trees)

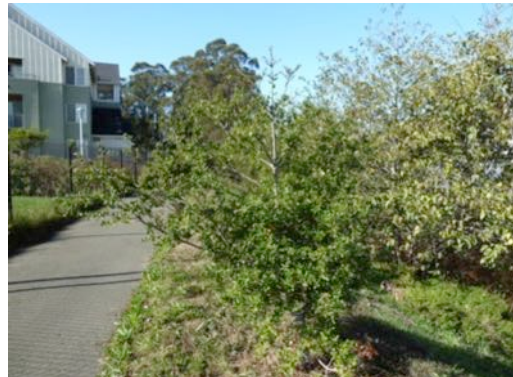
Photo Point 6A - Supplemental
Planting Site 2014 (Note additional
alder trees)
