Year 2 Annual Monitoring Report

North Fork Mitigation Project (2016)

University of California, Berkeley

Submitted January 25, 2017

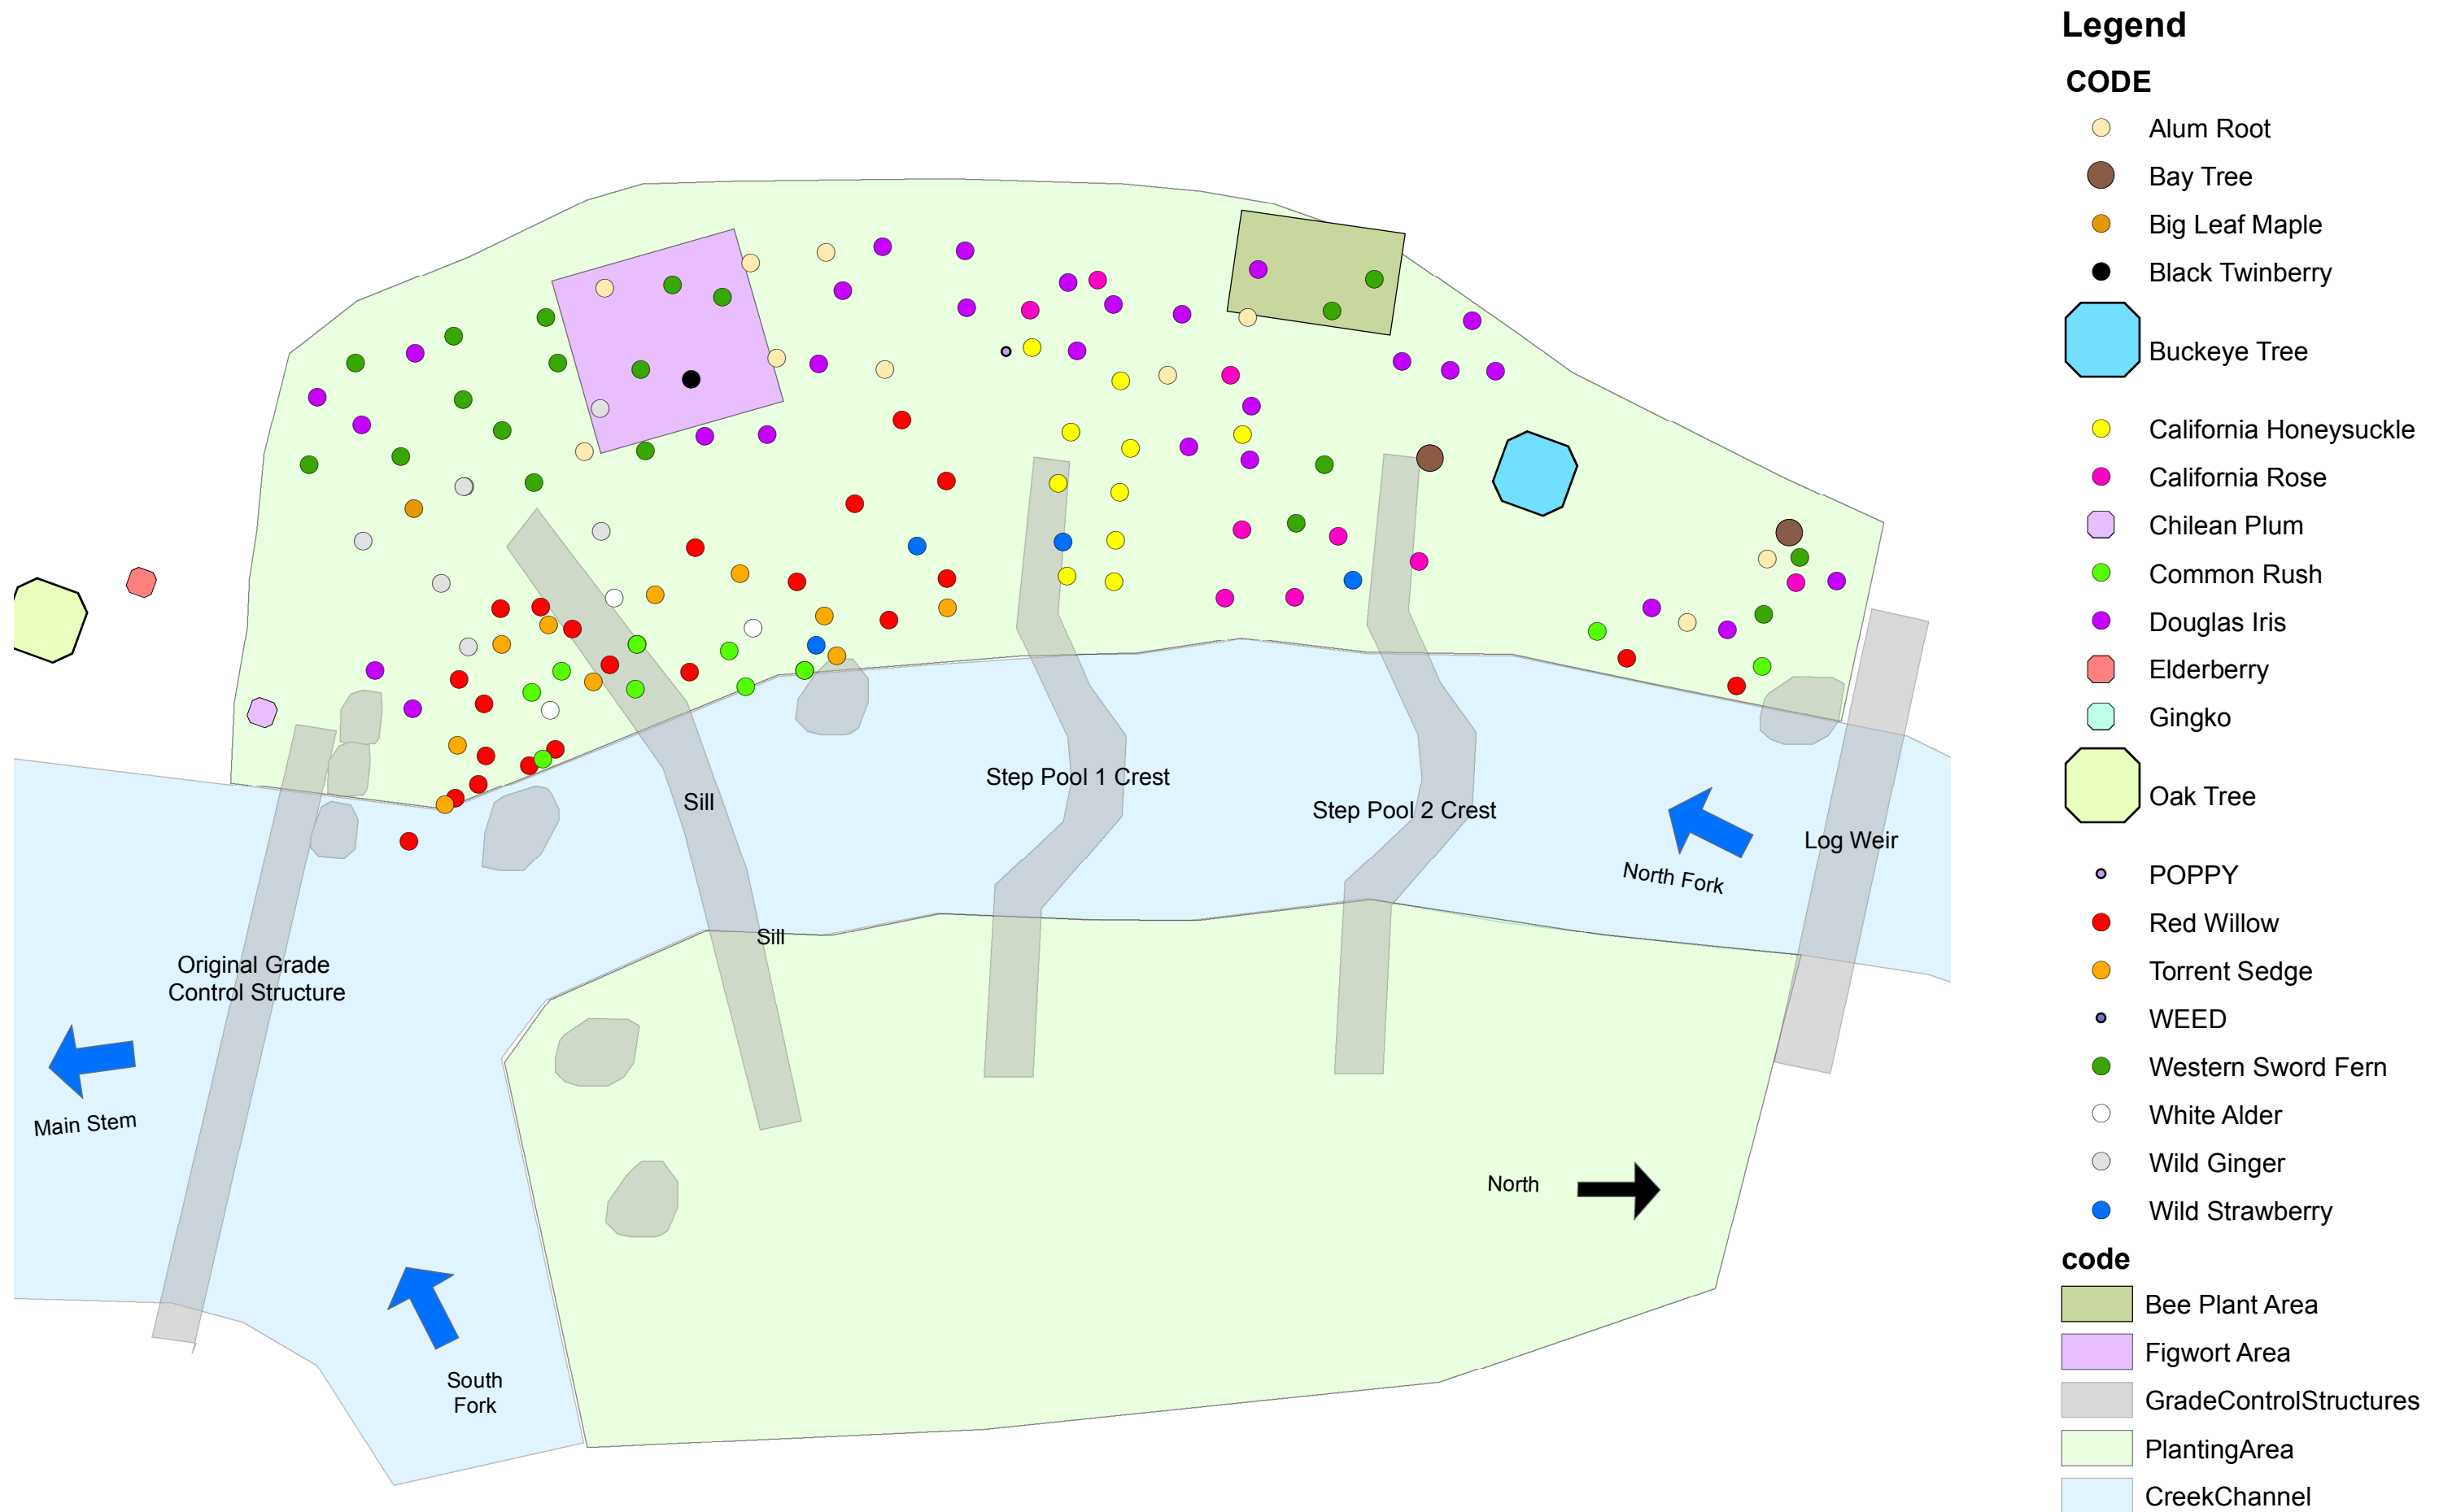
Figure 5: Vegetation Map

The plants on the right bank are mapped in **Figure 5**. All of the mapped plants were doing well, with little to no evidence of inadequate water, disease, wildlife browsing, or invasive species cover. Some mortality was evident, as explained in Section D below.

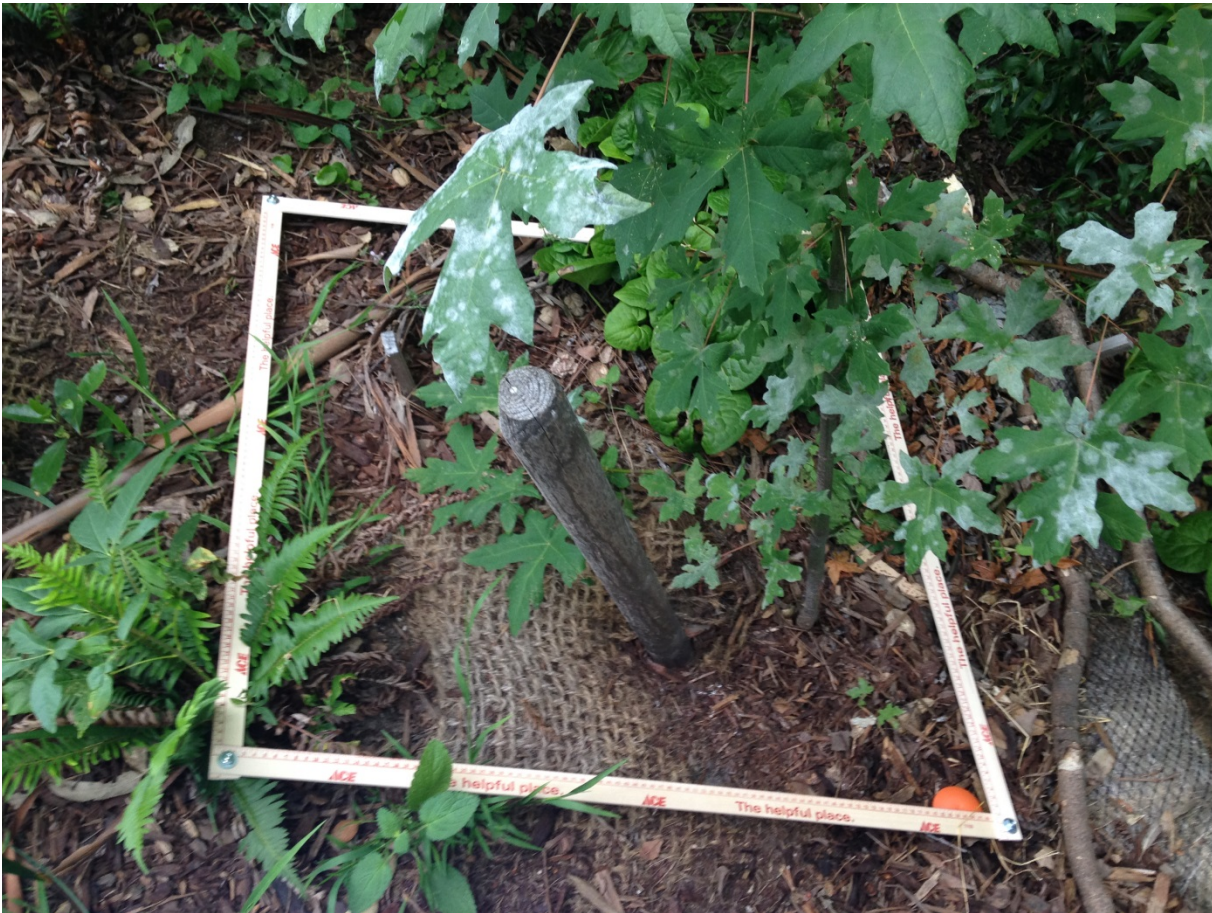
Plot 1

Year 2: 50% Cover Total – 45% native planted, 5% invasive (grass)

Year 1: 30% Cover – no invasive species

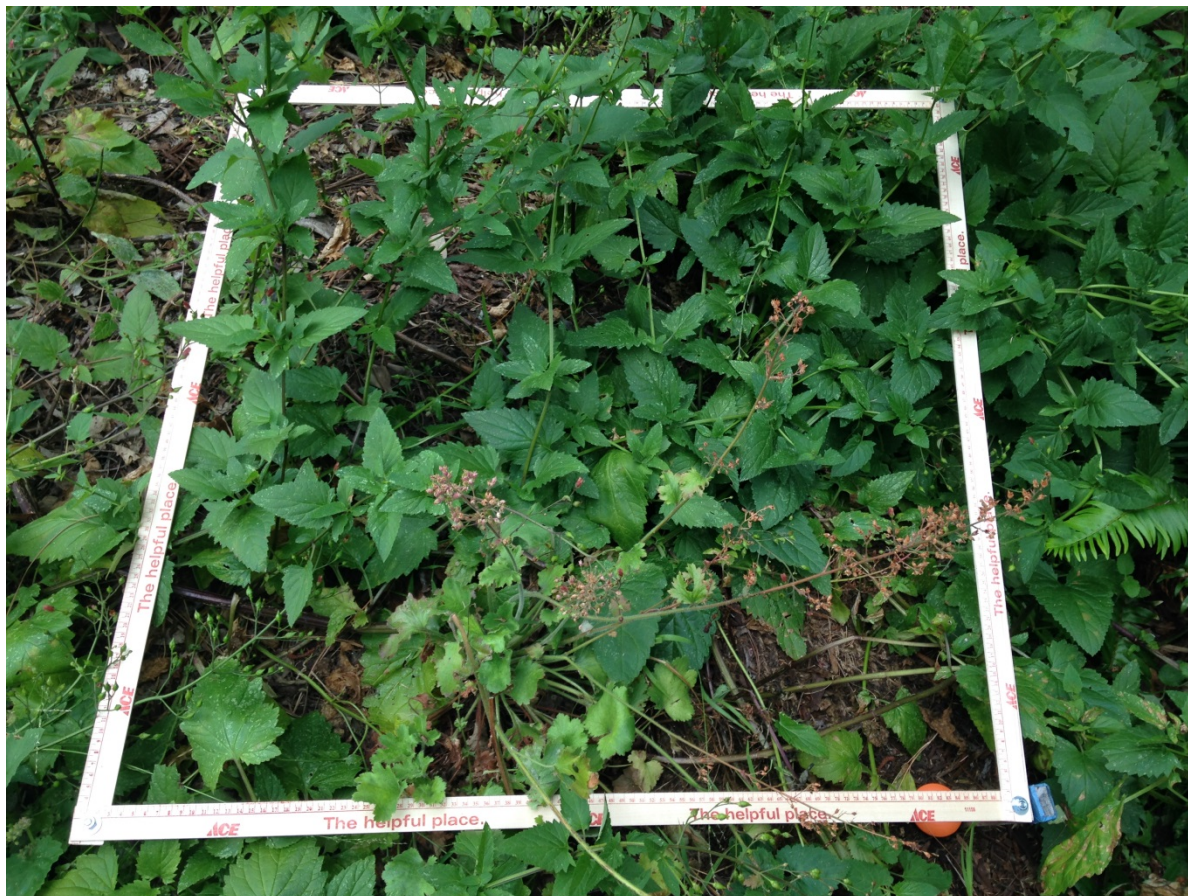
Plot 2

Year 2: 90% Cover Total – 10% native planted, 80% native volunteer (figwort)

Year 1: 60% Cover Total - 10% invasive (plum), 30% native volunteer (figwort), 20% native planted

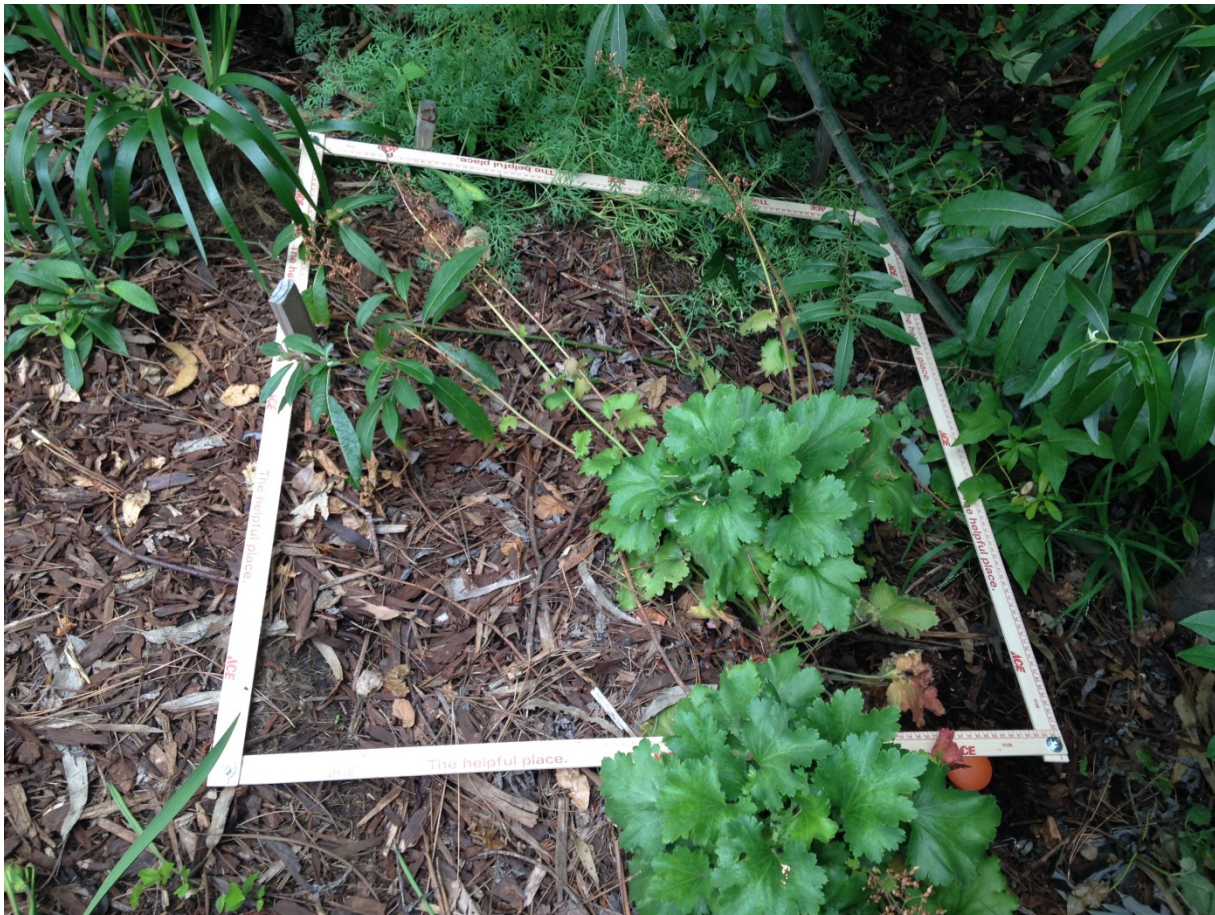
Plot 3

Year 2: 30% Cover Total – 25% native planted, 5% native volunteer (CA poppy)

Year 1: 20% cover

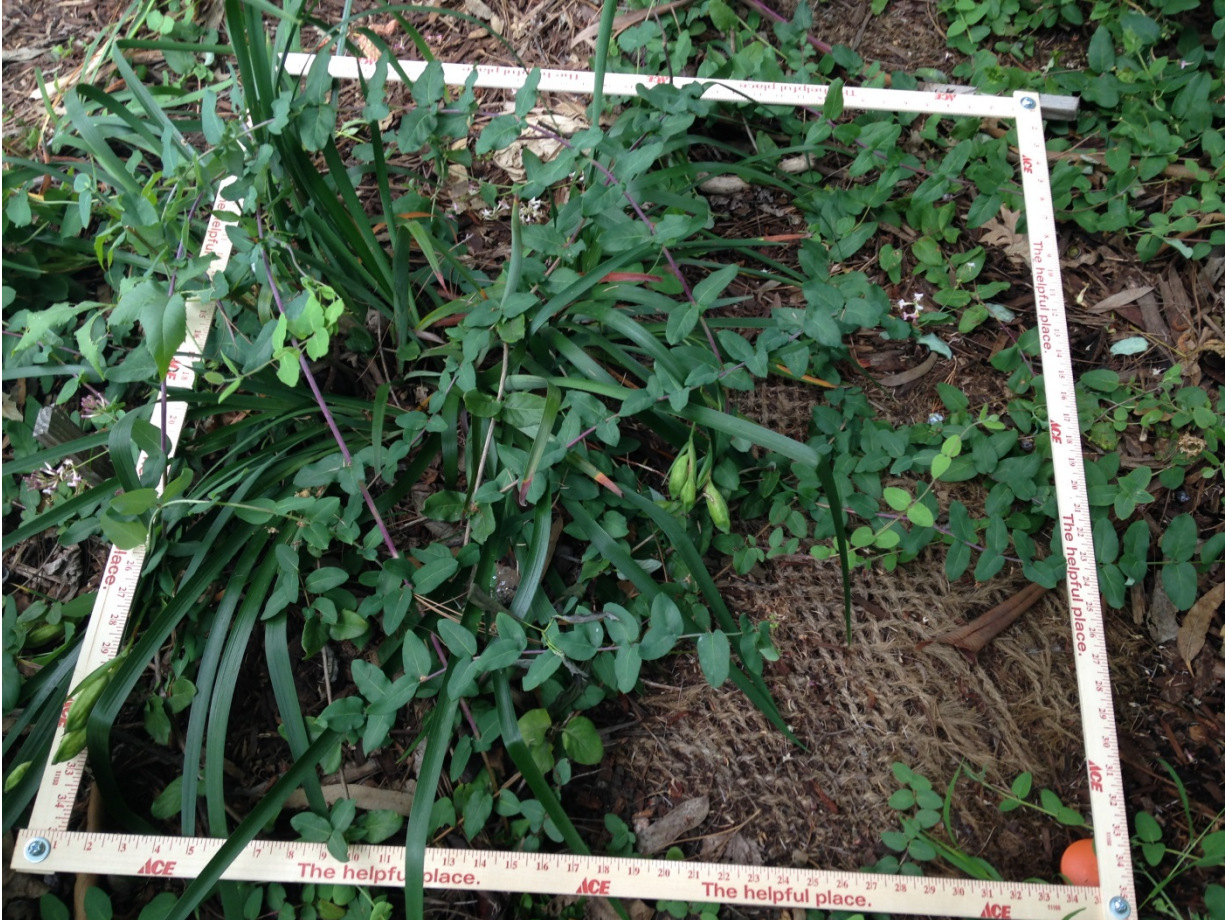
Plot 4

Year 2: 80% Cover Total – 80% native planted

Year 1: 50% Cover – no invasive species

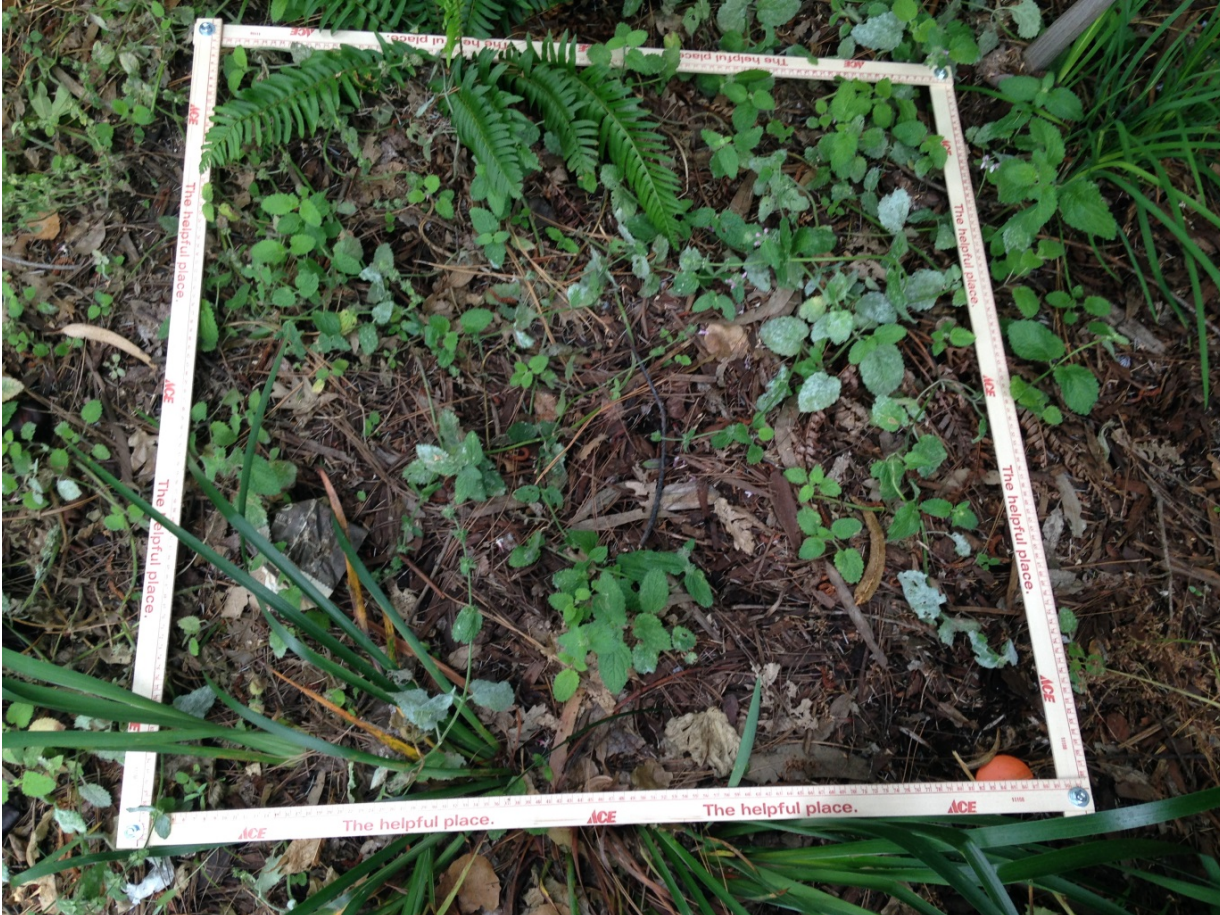
Plot 5

Year 2: 60% Cover Total– 20% native planted, 40% native volunteer (CA hedge nettle)

Year 1: 30% Cover – no invasive species

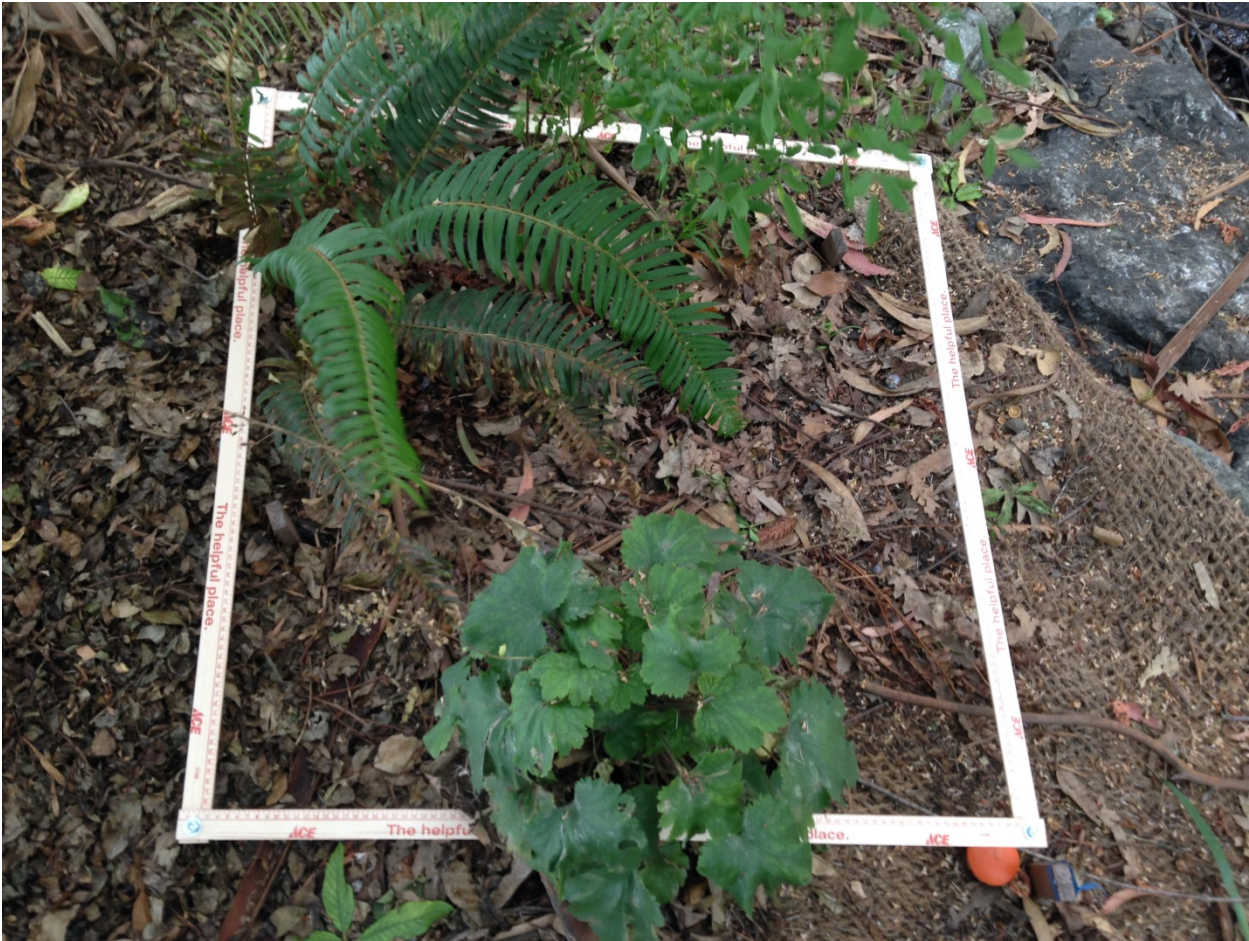
Plot 6

Year 2: 60% Cover Total – no invasive species

80% Cover – no invasive species

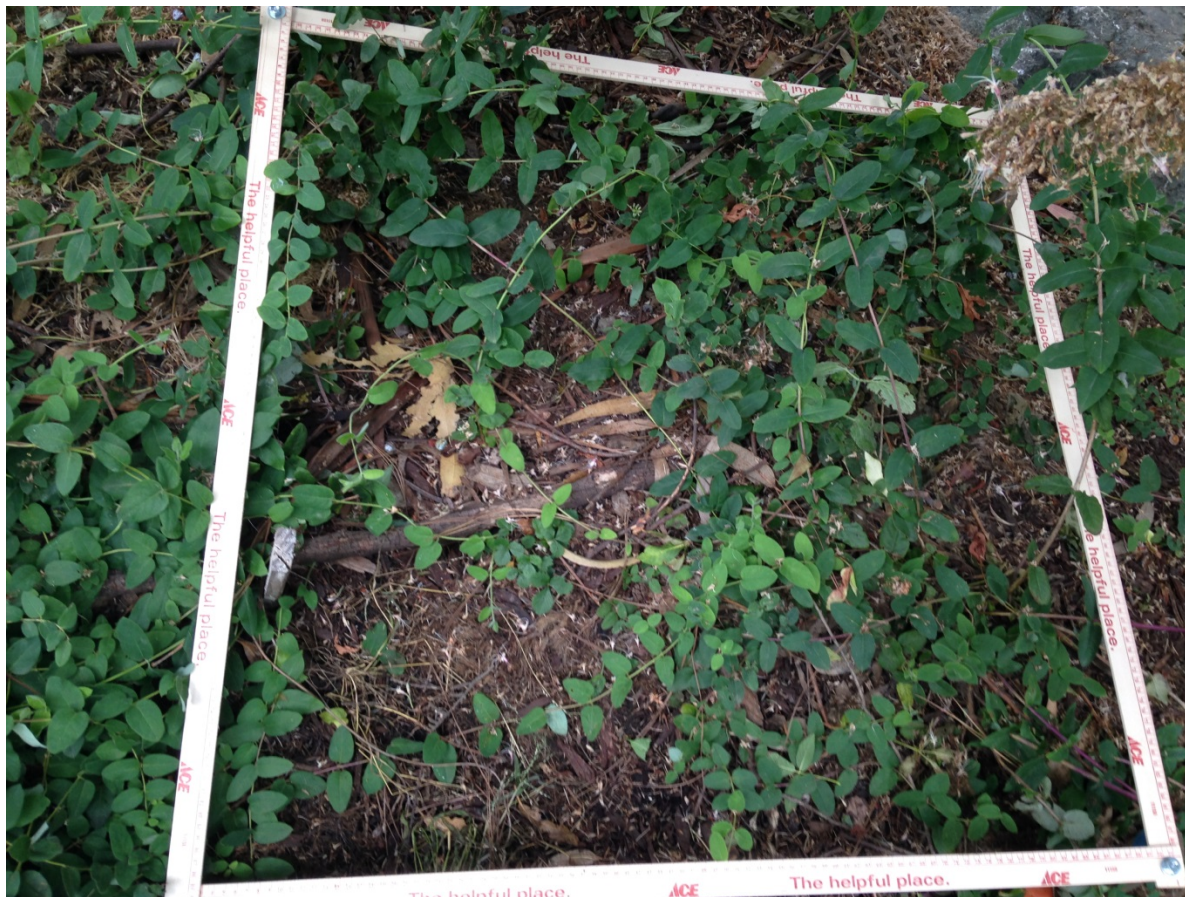
Plot 7

Year 2: 80% Cover – no invasive species

Year 1: 60% Cover – no invasive species

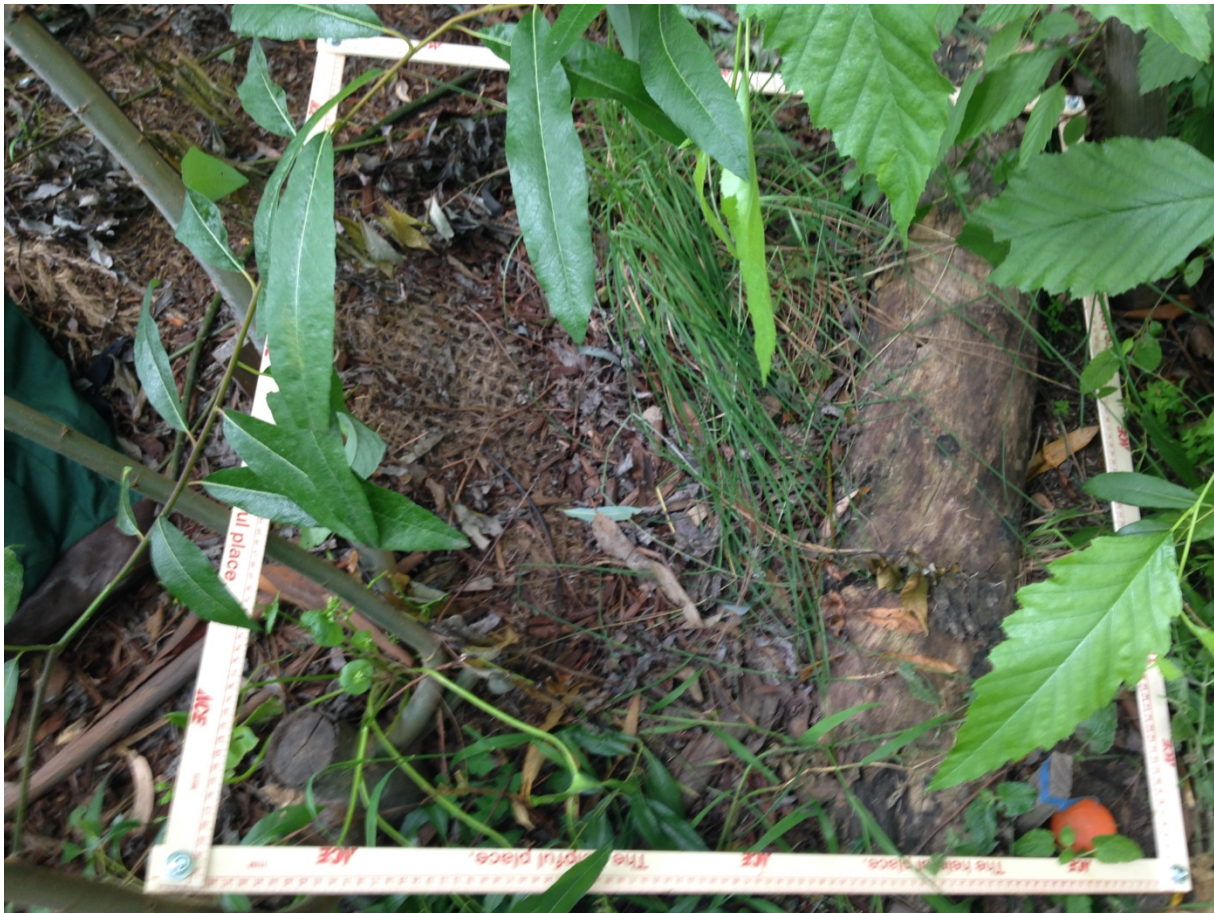
Plot 9

Year 2: Overstory – 90% shaded by willows, Understory – 10% native planted, 5% invasive grass

Year 1: 90% Cover total - 85% Natives, 5% invasive weeds

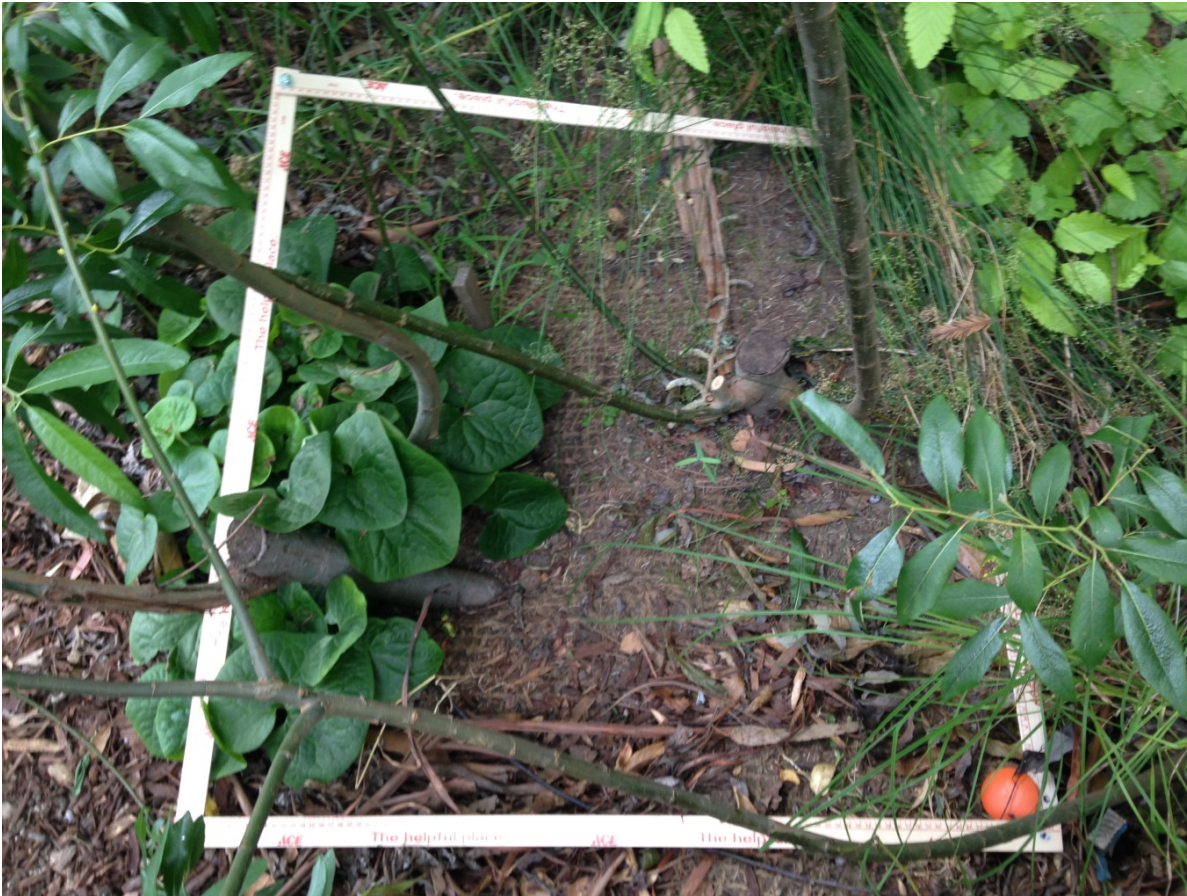
Plot 10

Year 2: Overstory – 80% shaded by willows, Understory – 40% native planted, 5% invasive grass

Year 1: 80% Cover - no invasive species
