Year 3 Annual Monitoring Report

Strawberry Creek

North Fork Mitigation Project

University of California, Berkeley

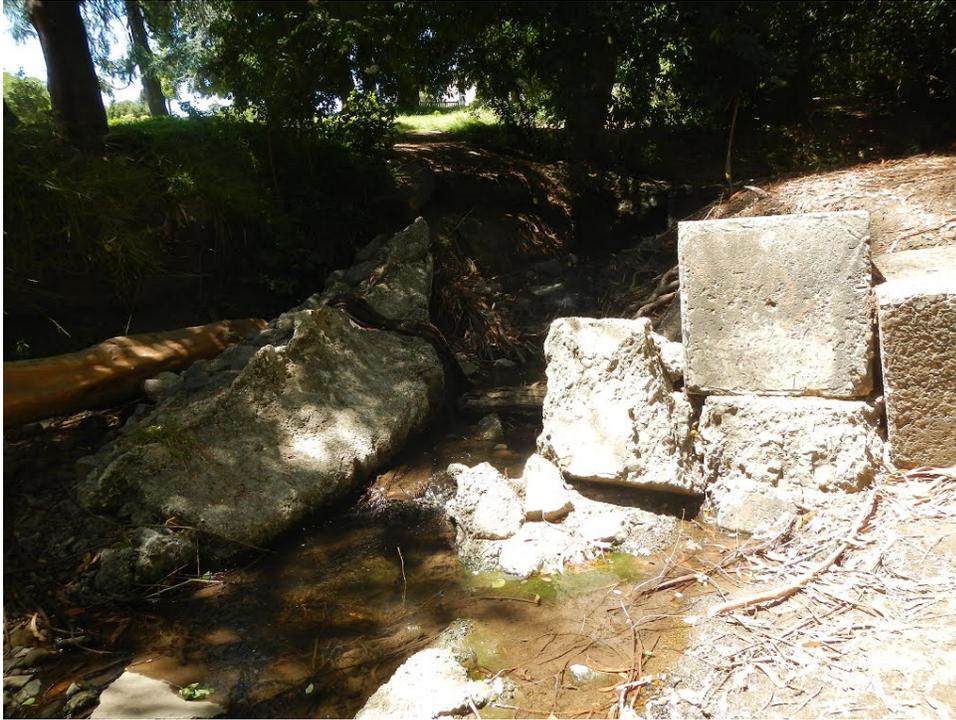
Photo 1: Failed check dam 1 (CD1) looking from the confluence upstream to the North Fork.

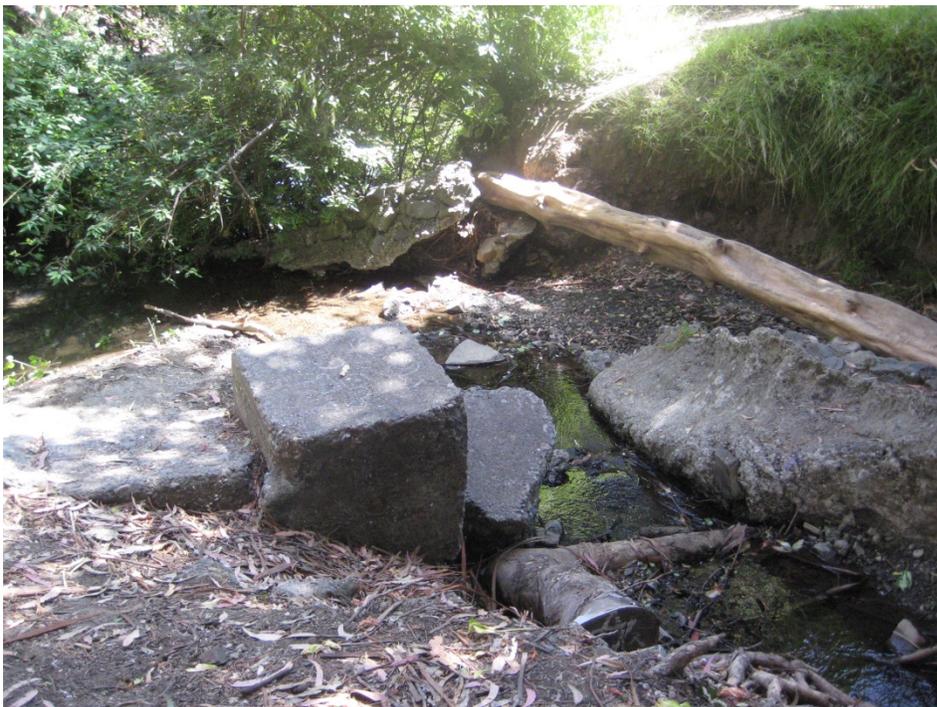
Photo 2: Failed check dam 1 (CD1) looking downstream to the confluence (South Fork comes in from the left side of the picture).

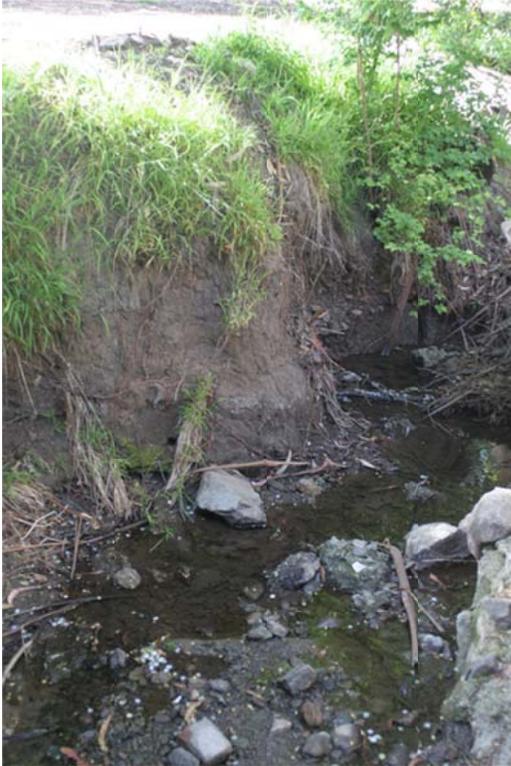
Photo 3: Right bank at the confluence continues to be eroded, leading to a 6-foot scarp.

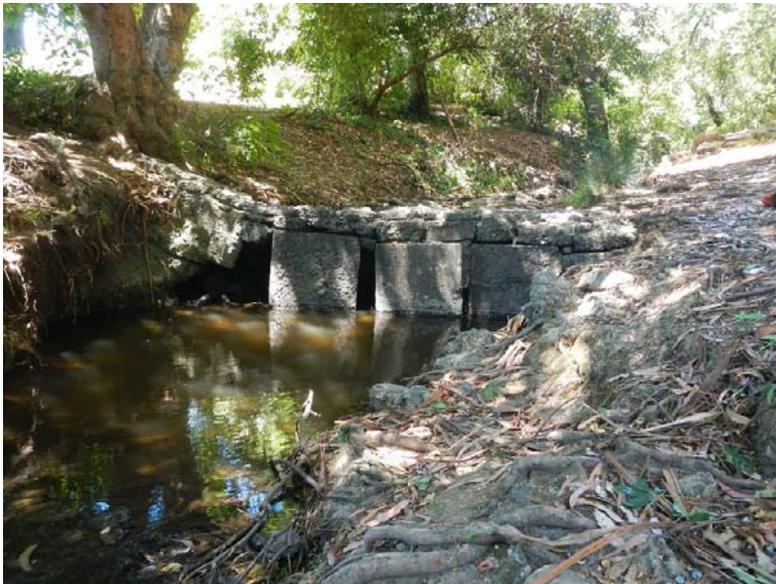
The Project site is located in an area that included one failed check dam (CD1) at Station 0+65 and another failing check dam (CD2) at Station 1+00 (**Figures 1-3**). CD1 was a decades-old check dam constructed on the north fork of Strawberry Creek located immediately upstream of the confluence of the north and south forks. The failure of this check dam in 2002 caused the main concrete body of the dam to orient stream-wise in the center of the channel (**Photos 1 & 2 of Attachment A**). Additionally, remnants of CD1 deflected flow into the right bank at the confluence, causing a near vertical 6-foot scarp (**Photo 3 of Attachment A**). The failure of CD1 caused the channel bed to incise upstream, undermining CD2 which was located 35 feet upstream of CD1. CD2 was at risk of failure due to undercutting of the support structure on the right bank (left side of **Photo 4 of Attachment A**) and water piping through the dam.

Photo 4: Check dam 2 (CD2) is about 35 feet upstream of CD1 on the North Fork. Notice instability on the right bank (left side of picture).

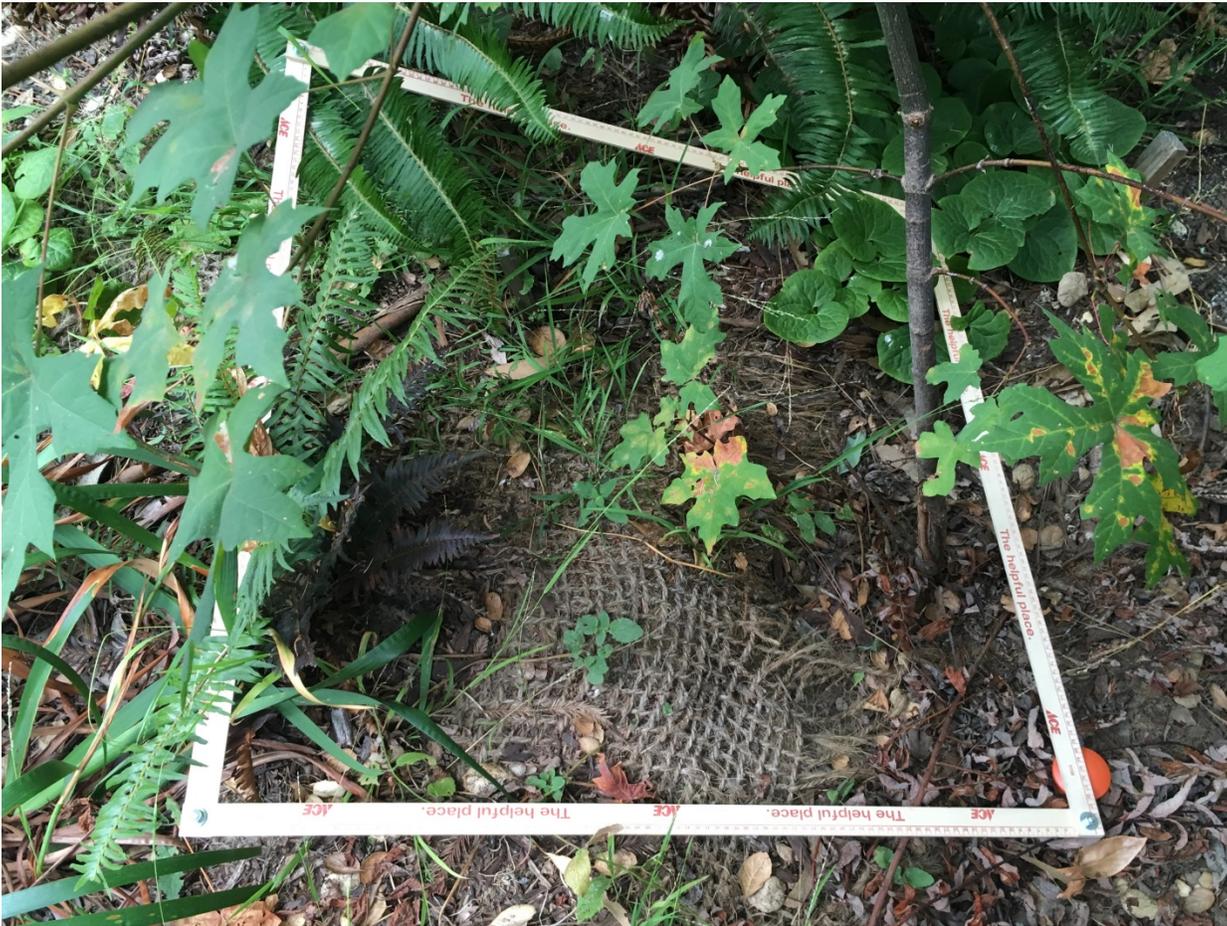
Plot 1

Year 3: 60% Cover Total – 55% native planted, 5% invasive (grass)

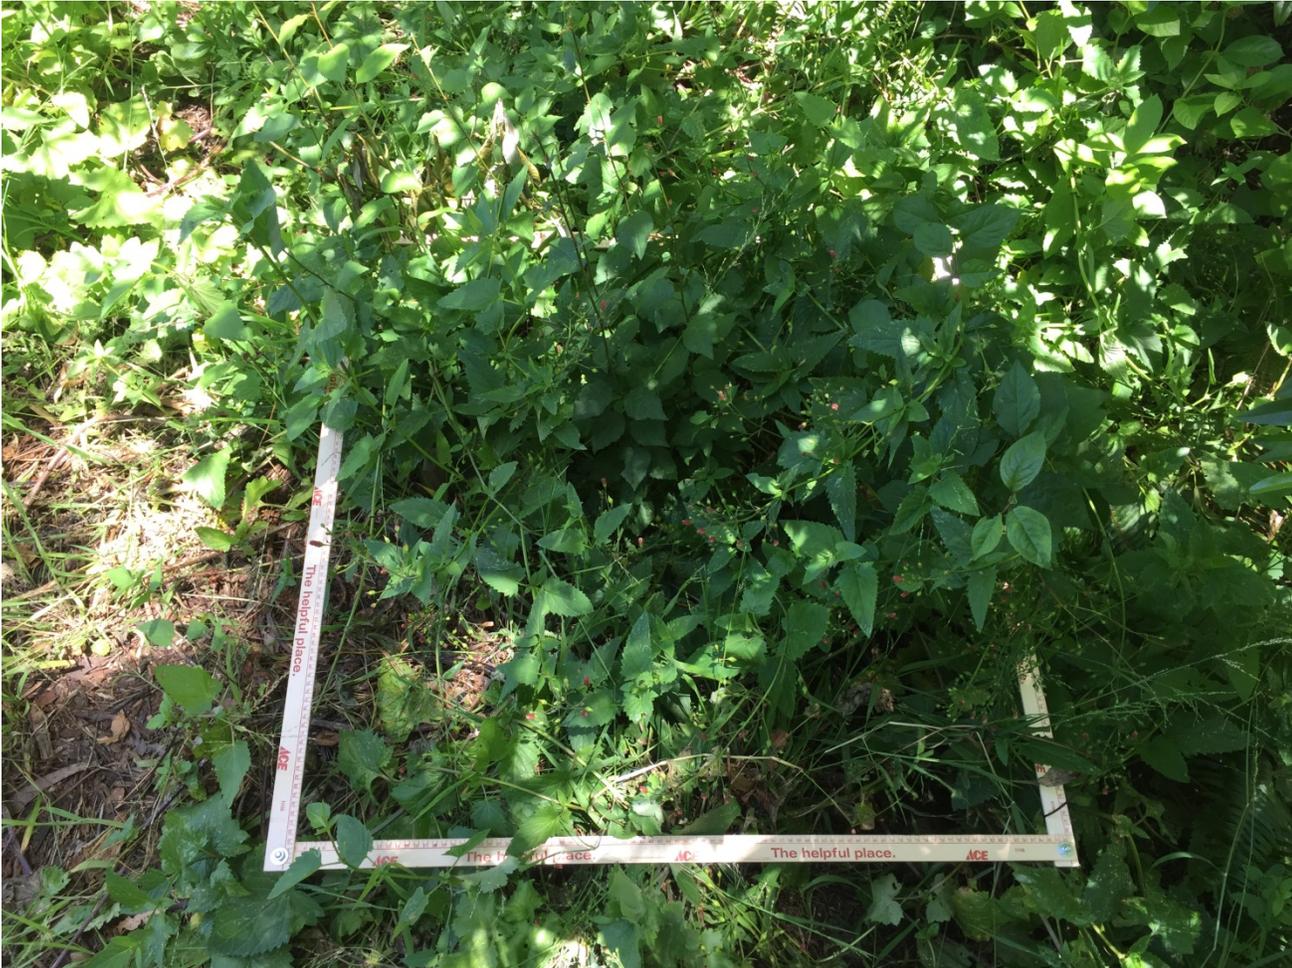
Plot 2

Year 3: 95% Cover Total – 10% native planted, 85% native volunteer (figwort)

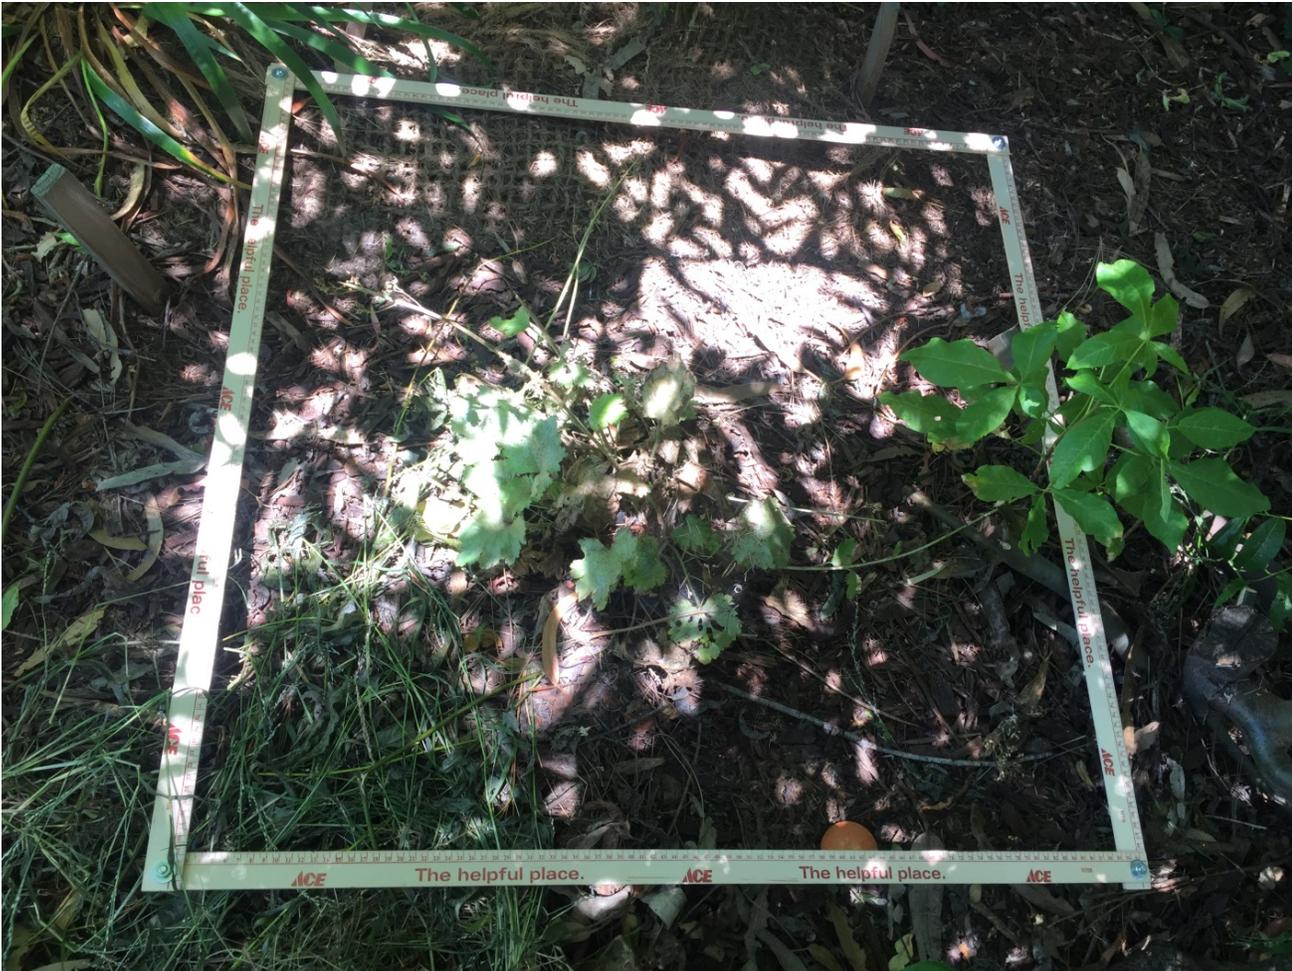
Plot 3

Year 3: 70% overstory (willow), 20% native understory (alum root and buckeye volunteer)

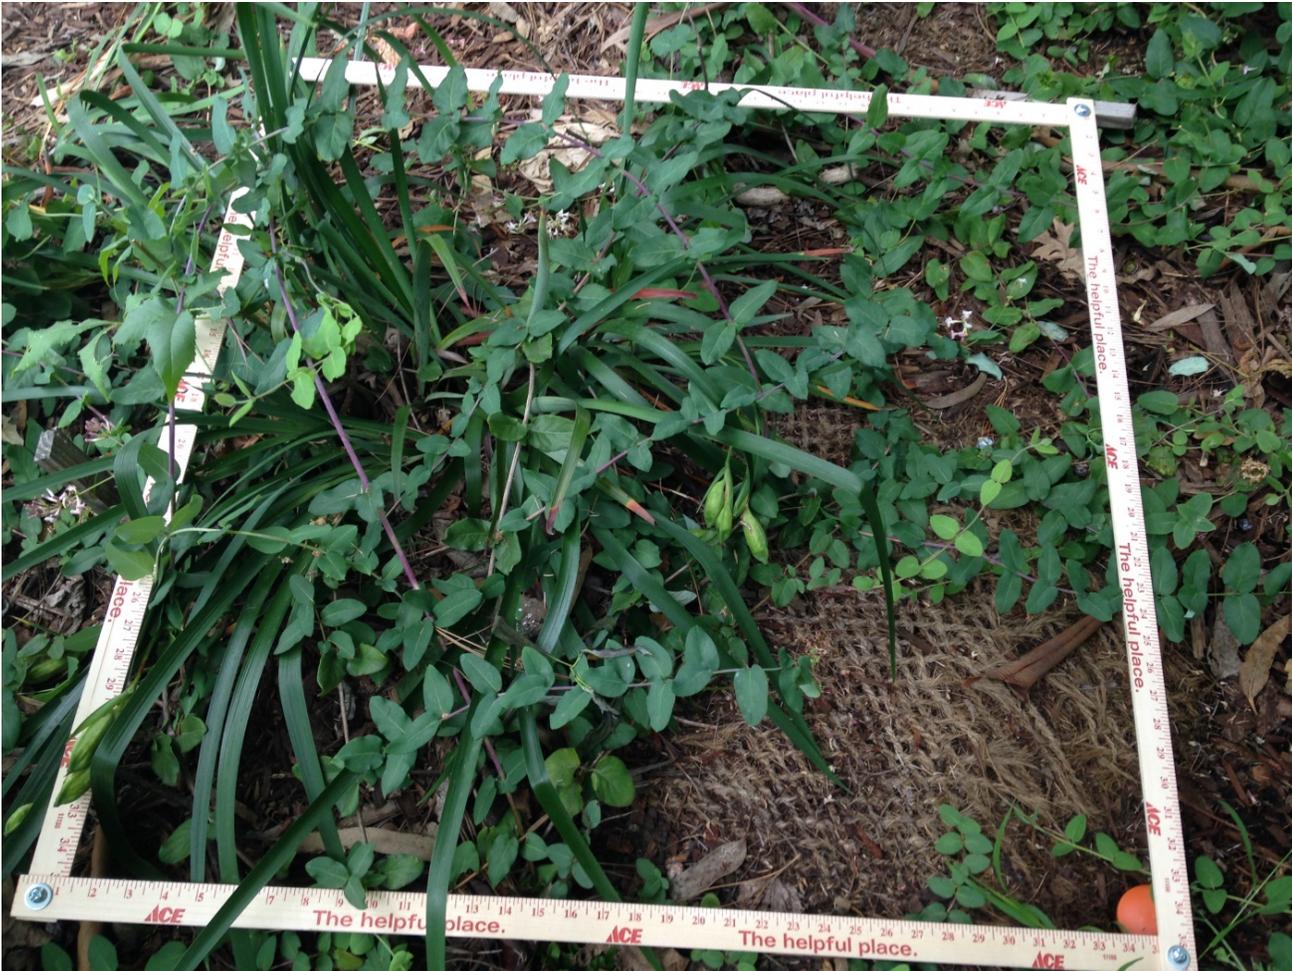
Plot 4 – Unable to find during Year 3

Year 2: 90% Cover Total – 80% native planted

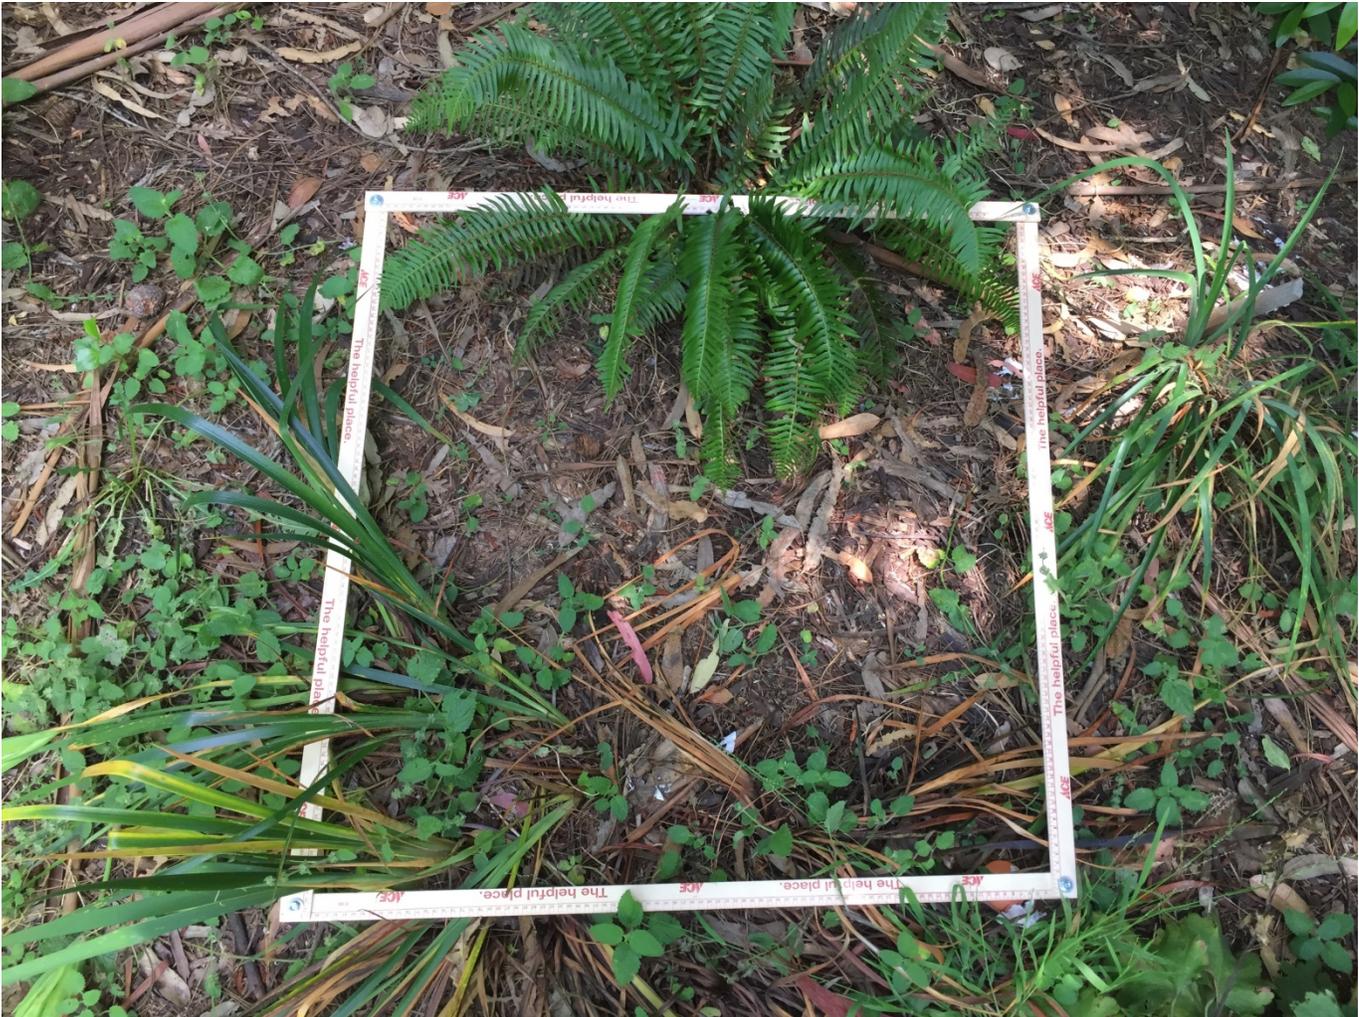
Plot 5

Year 3: 50% Cover Total— 30% native planted, 20% native volunteer (CA hedge nettle)

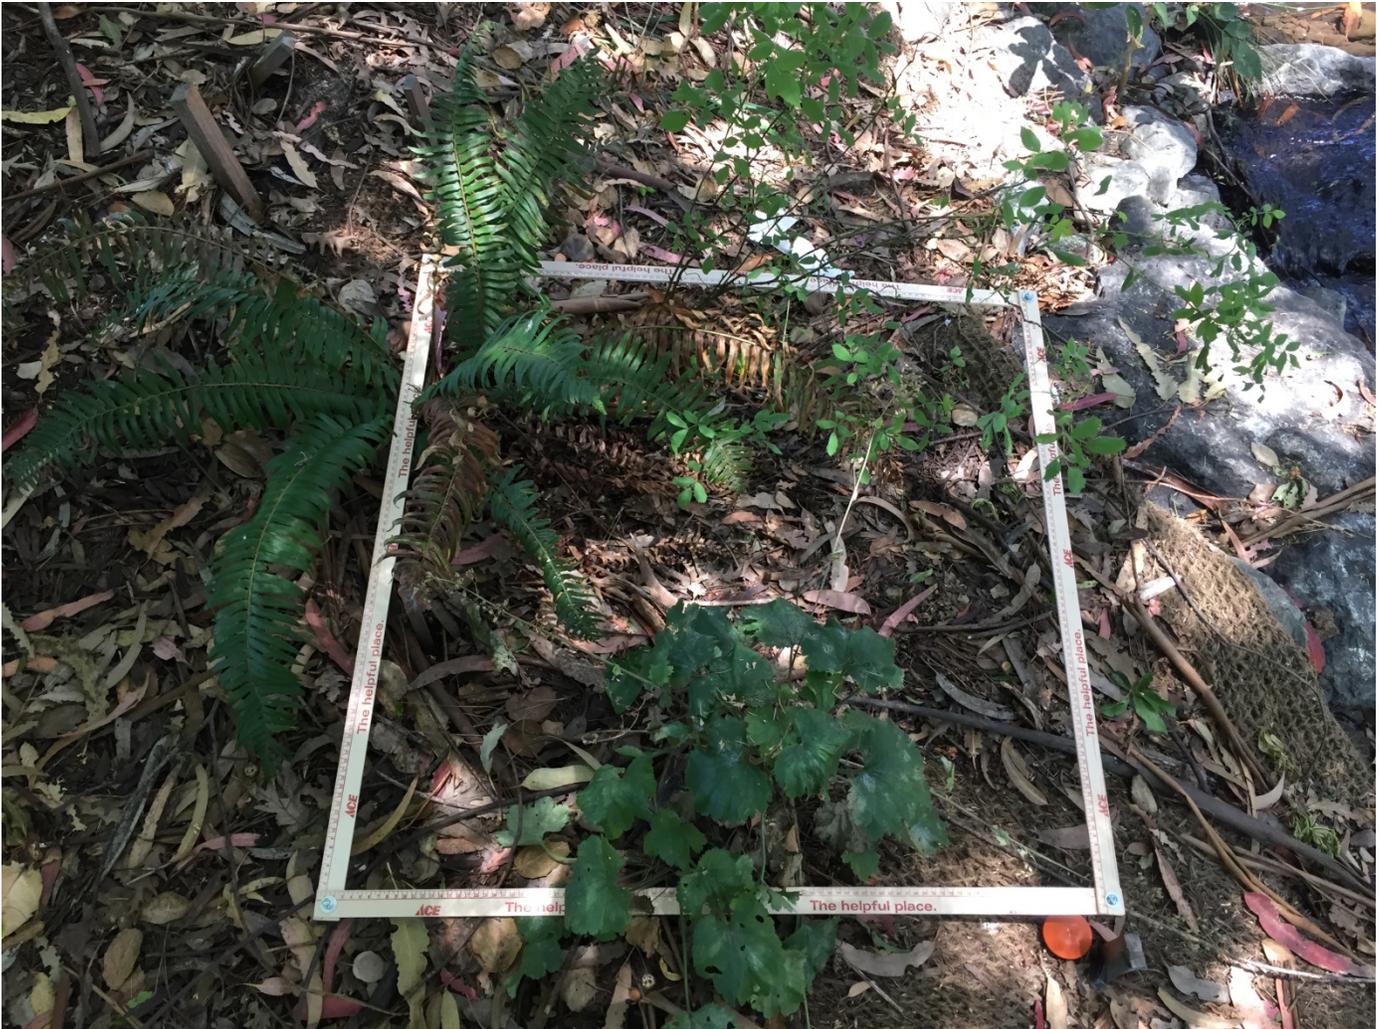
Plot 6

Year 3: 60% Cover Total – no invasive species

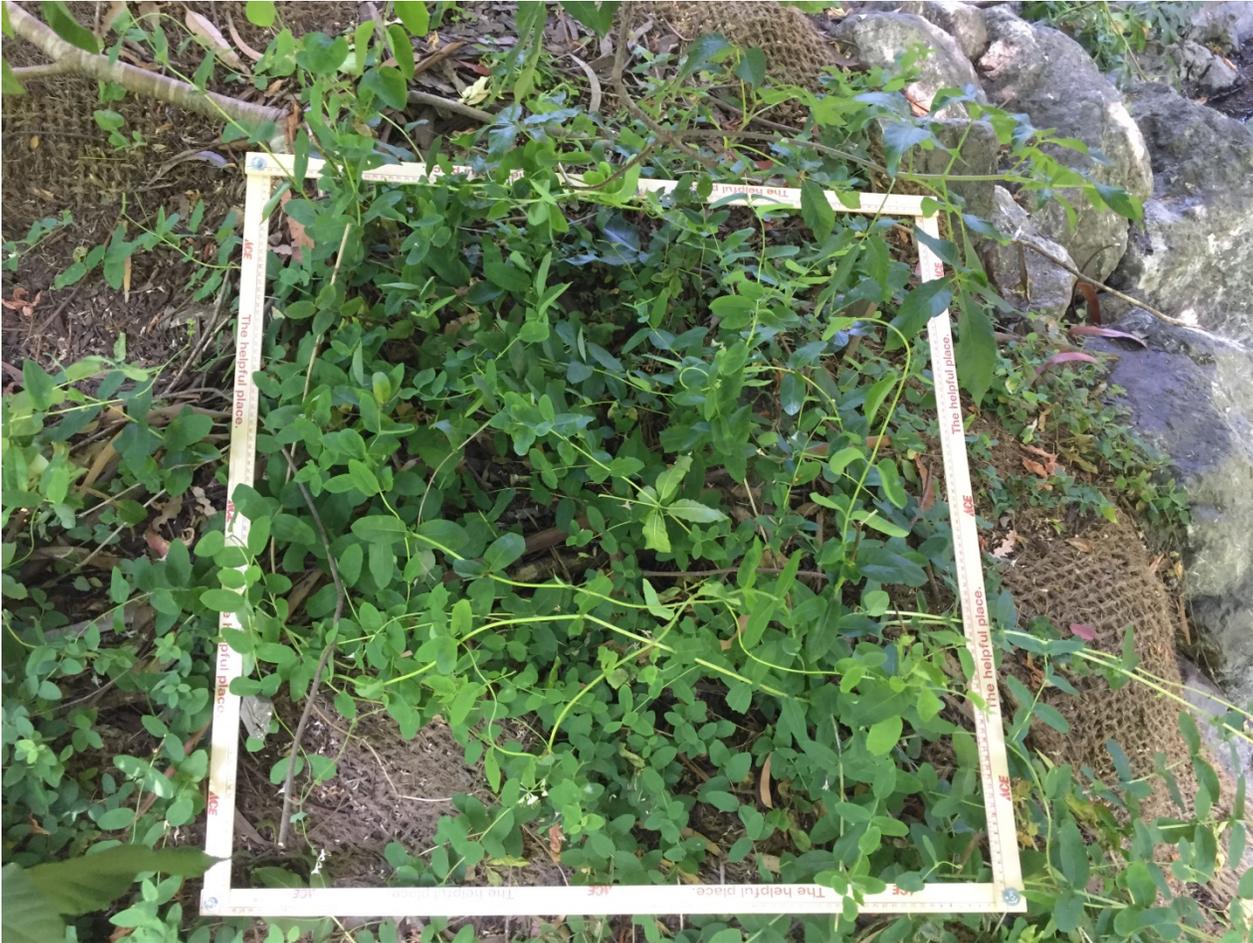
Plot 7

Year 3: 90% Cover – no invasive species

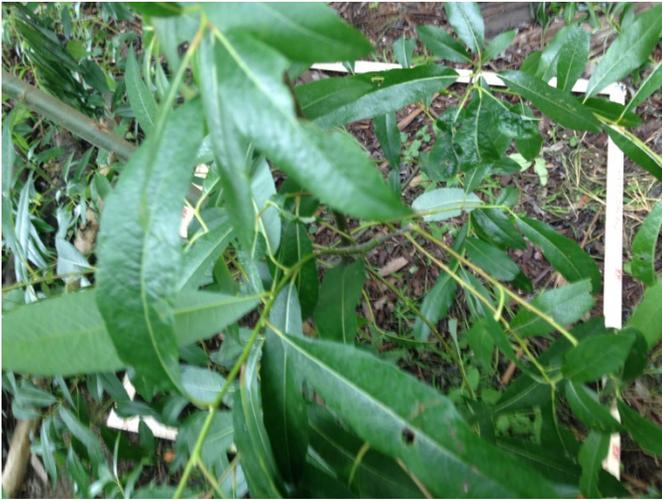
Plot 8 – Unable to find during Year 3

Year 2: Overstory - 95% shaded by willows

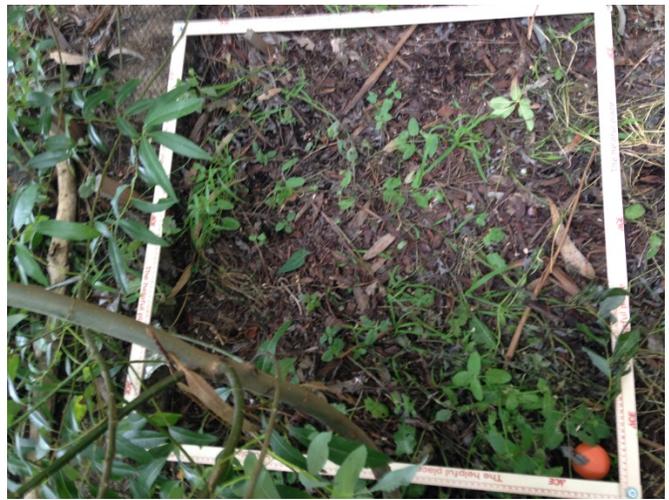
Understory – 10% invasive grass, 5% native volunteers

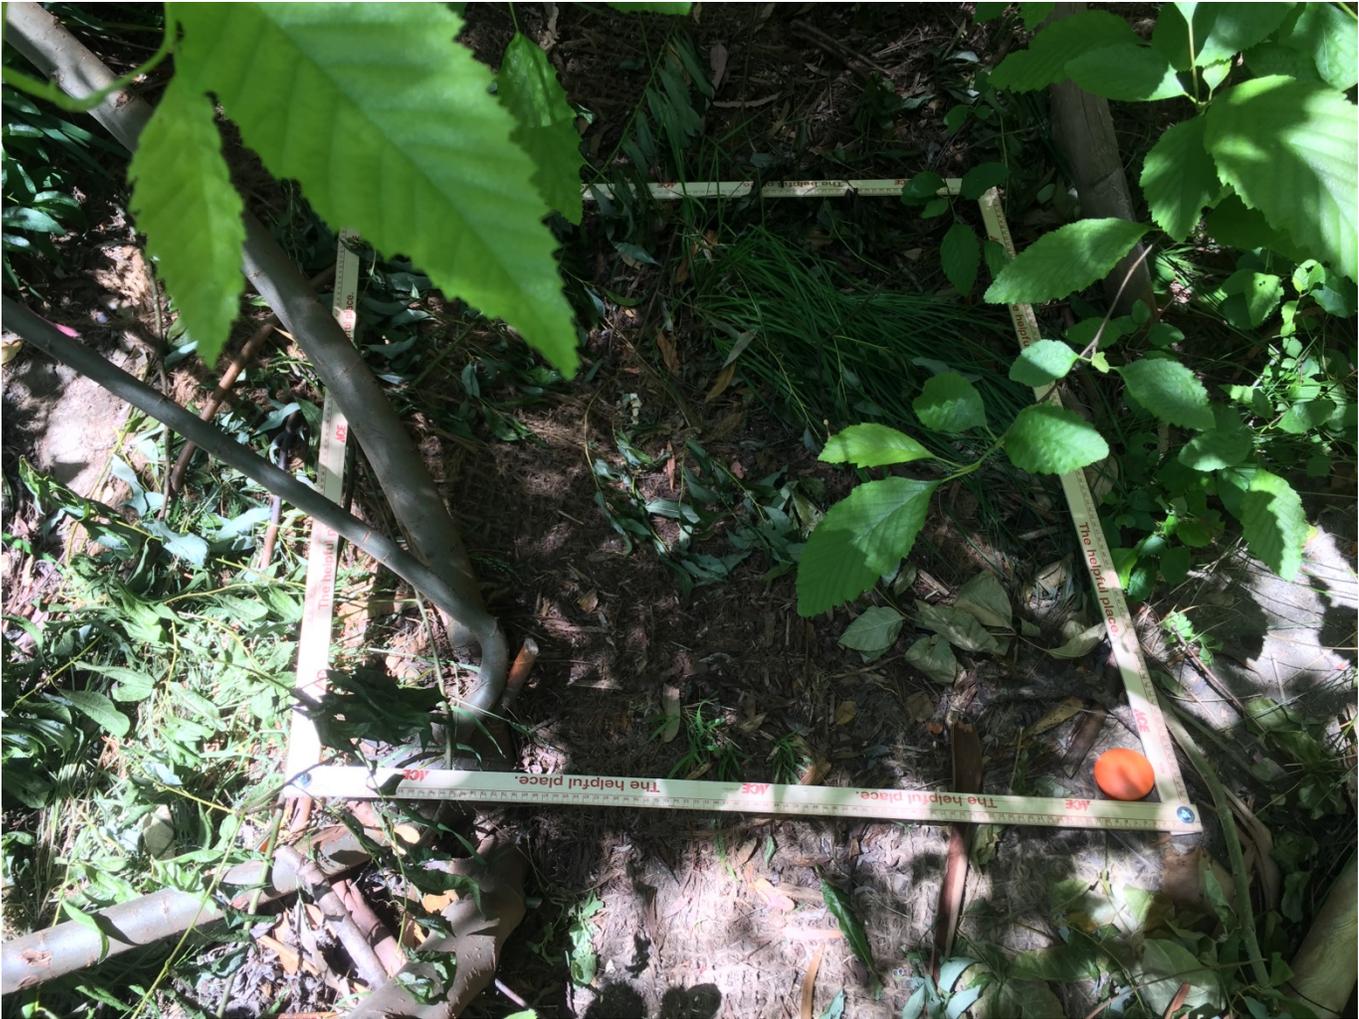
Plot 9

Year 3: Overstory – 90% shaded by willows, Understory – 10% native planted, 5% invasive grass

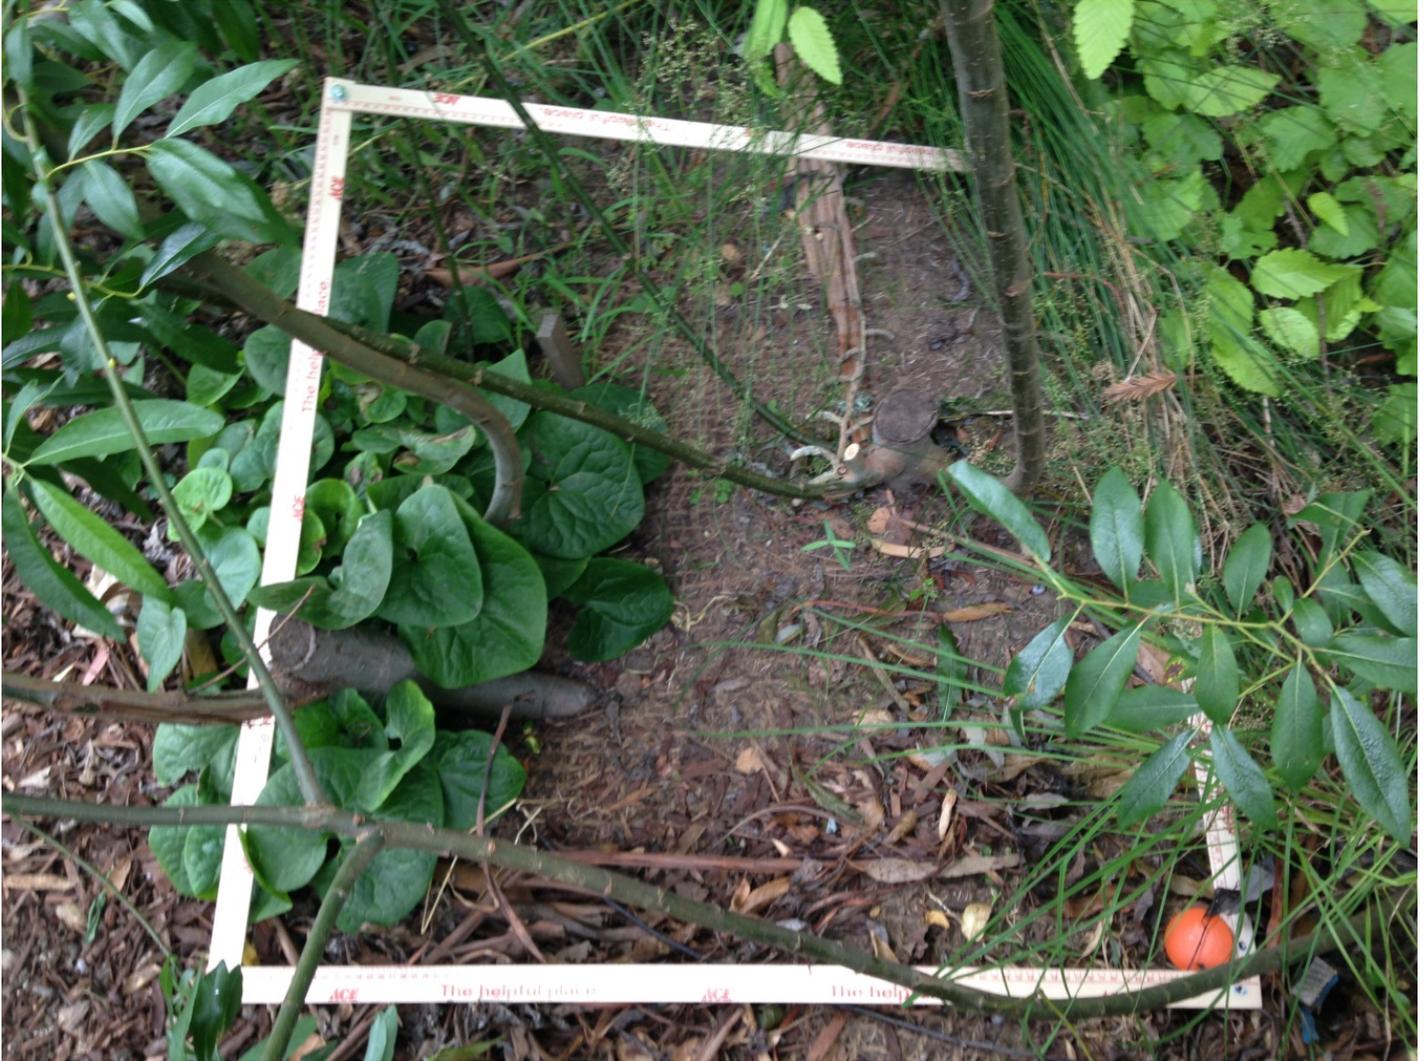
Plot 10 – Unable to find during Year 3

Year 2: Overstory – 80% shaded by willows, Understory – 40% native planted, 5% invasive grass
