**Summary of As-Built Conditions
for the
Strawberry Creek Confluence Ecological Stabilization Project
(2015)**

Prepared for the University of California at Berkeley

by Aysha Massell, Environmental Protection Specialist
Office of Environment, Health and Safety
University of California at Berkeley

Submitted February 6, 2015

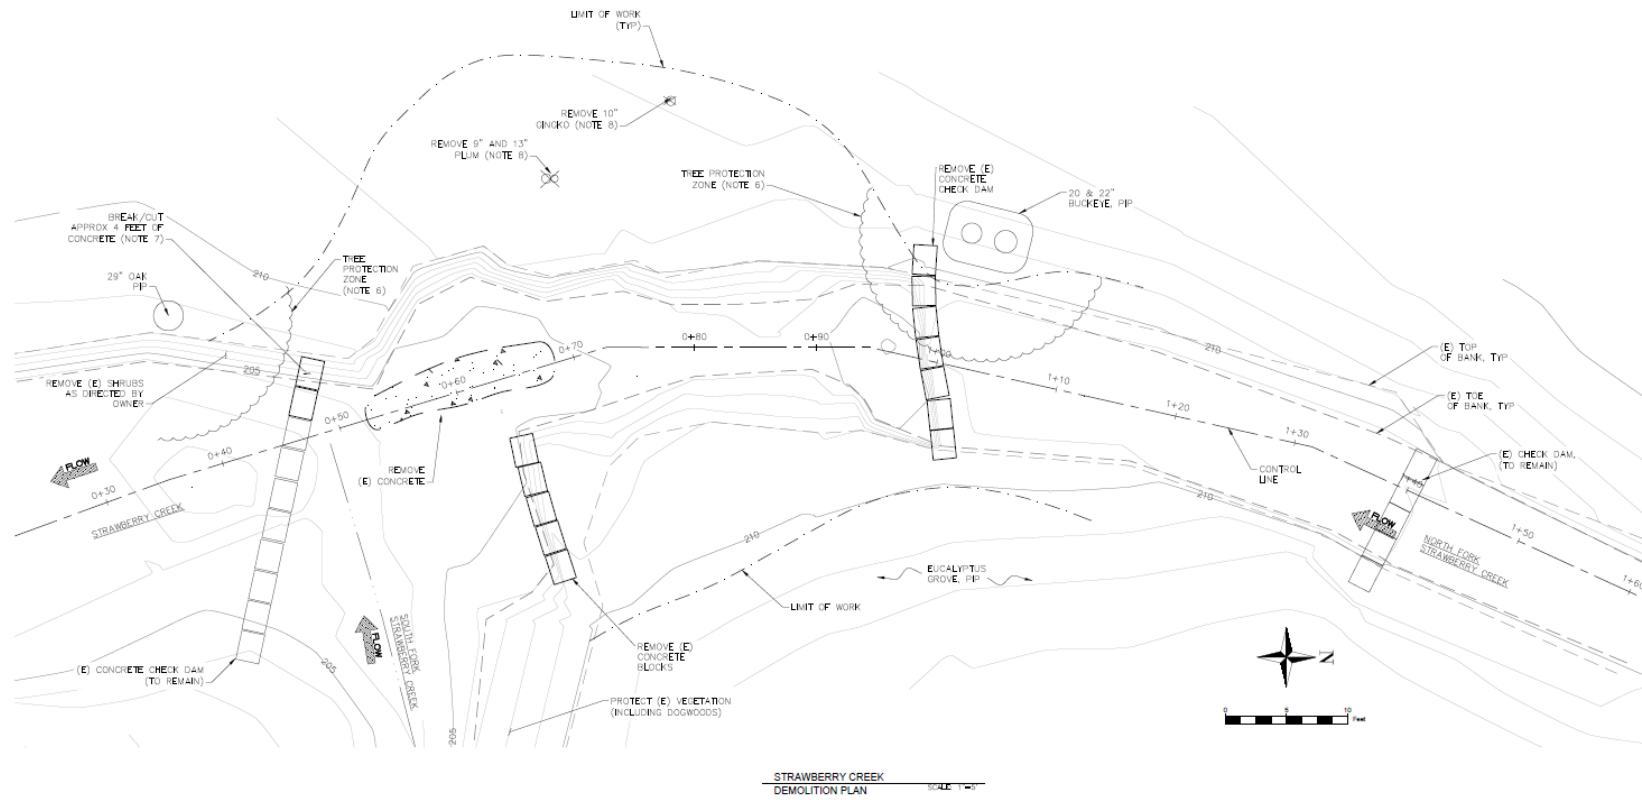
Figure 3: Existing Conditions Site Map

The project site is located in an area that included one failed check dam (CD1) at Station 0+65 and another failing check dam (CD2) at Station 1+00 (**Figure 3**). CD1 was a decades-old check dam constructed on the north fork of Strawberry Creek located immediately upstream of the confluence of the north and south forks. The failure of this check dam in 2002 caused the main concrete body of the dam to orient stream-wise in the center of the channel (**Photos 1 & 2** of

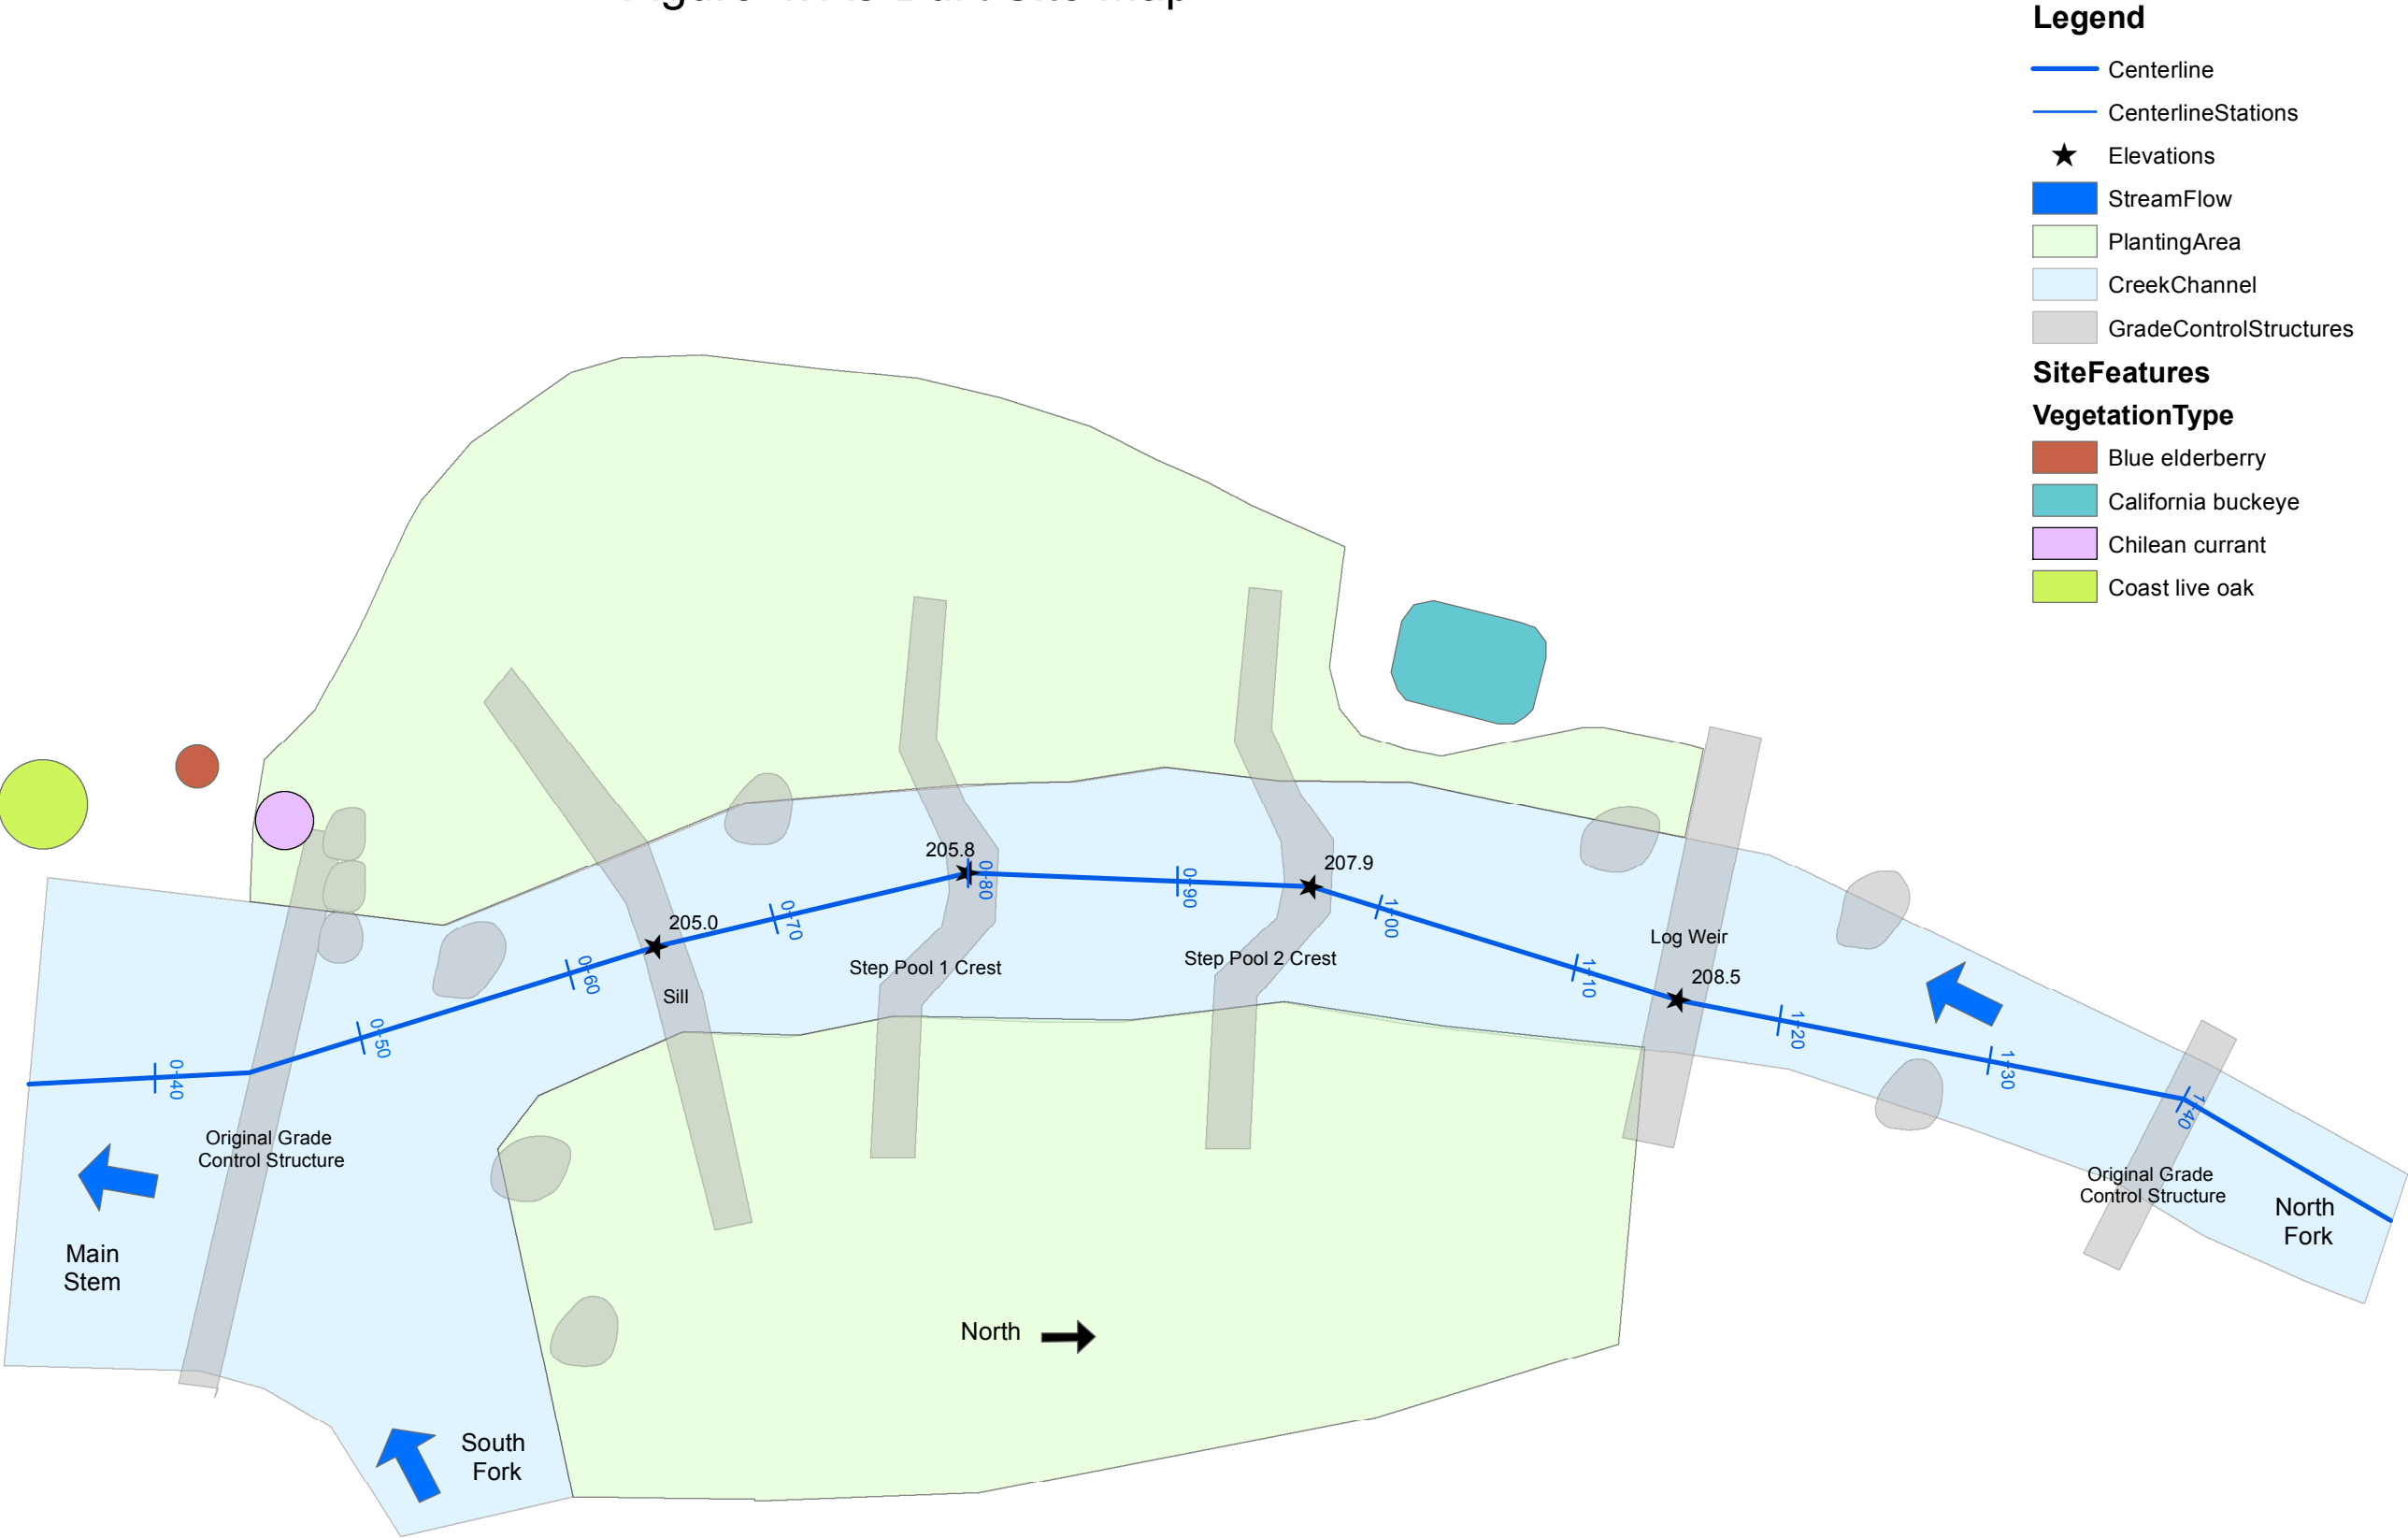
Figure 4: As-Built Site Map

A plan view of the as-built site conditions is presented in **Figure 4**. Comparisons with the design plan (**Figure 5**) show close adherence to the orientation and station locations of the grade control structures.

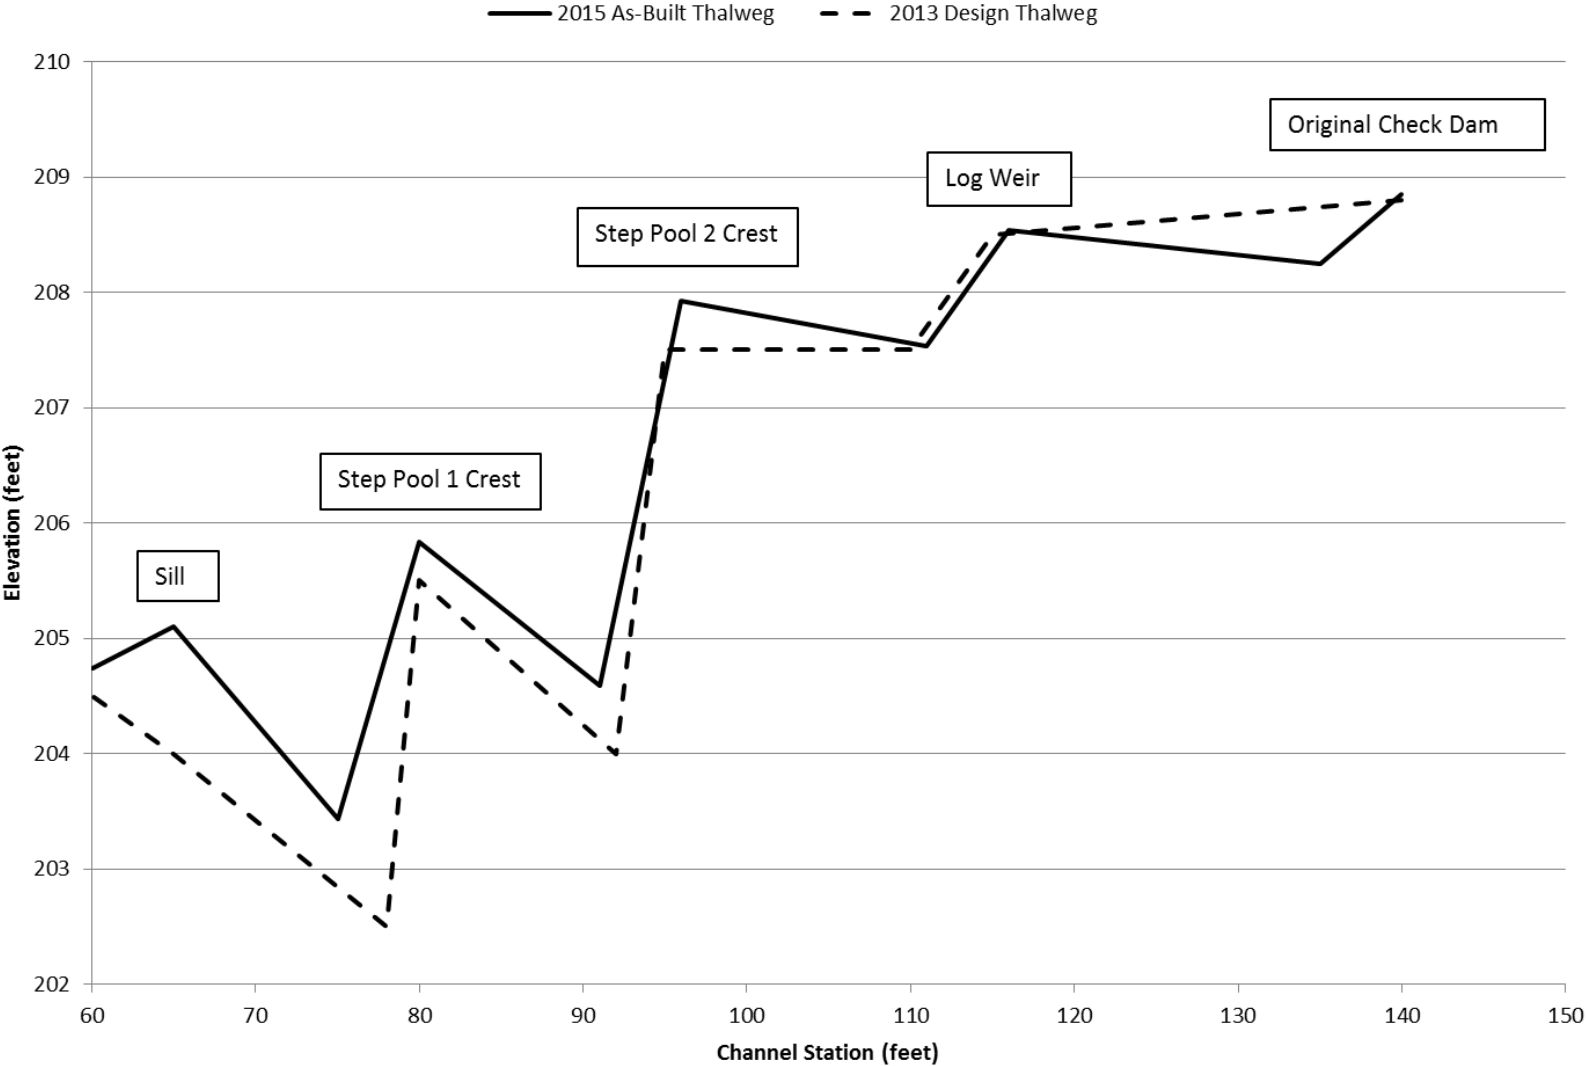
Chart 2: Thalweg Elevations Comparisons

As-built elevations reflect close adherence to the design elevations of the creek channel thalweg. Comparisons of the channel thalweg between design and as built conditions are shown in **Chart 2**. The greatest variance in elevations occurs at the sill - the as-built elevation is one foot higher than the design elevation. Inspection of the site indicates this elevation increase may be due to deposits of cobbles and sediment that were most likely transported during the major storm event on December 11, 2014. In addition, the pools formed below the two rock step structures are about half a foot shallower and about 2.5 feet farther downstream from the crest than the design. This represents the flexible nature of the rock step pools as they adjust to storm events. The small pool just downstream of the original check dam at Station 1+40 is an extra data point that was not taken during the baseline 2013 survey, and therefore cannot be accurately compared with the pre-project conditions. It was included in the graph for purposes of future study of this area.

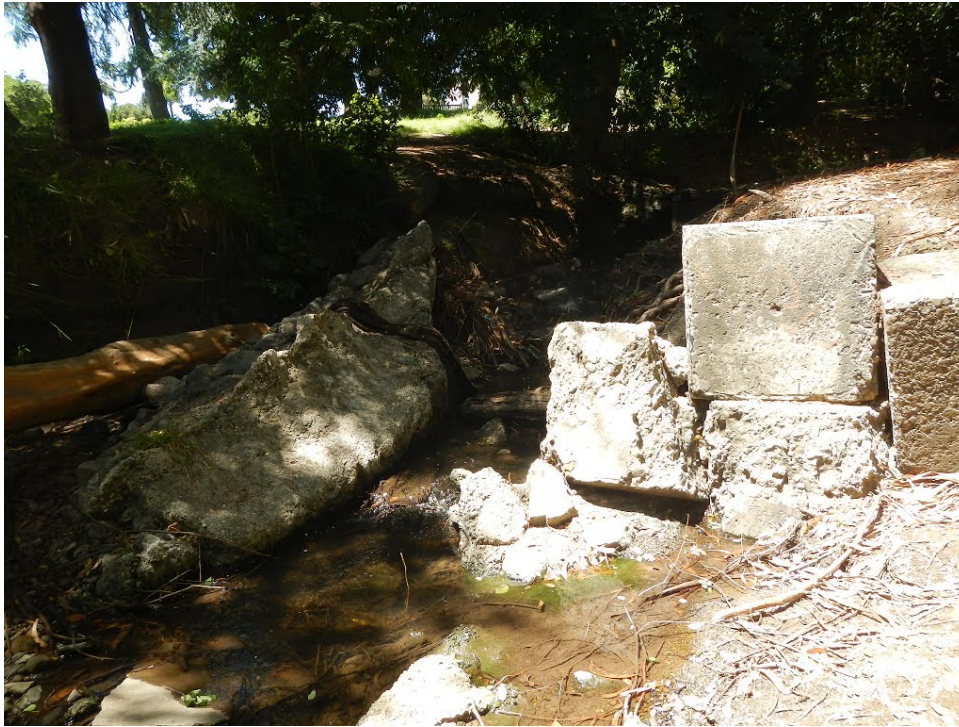
Photo 1: Failed check dam 1 (CD1) looking from the confluence upstream to the North Fork.

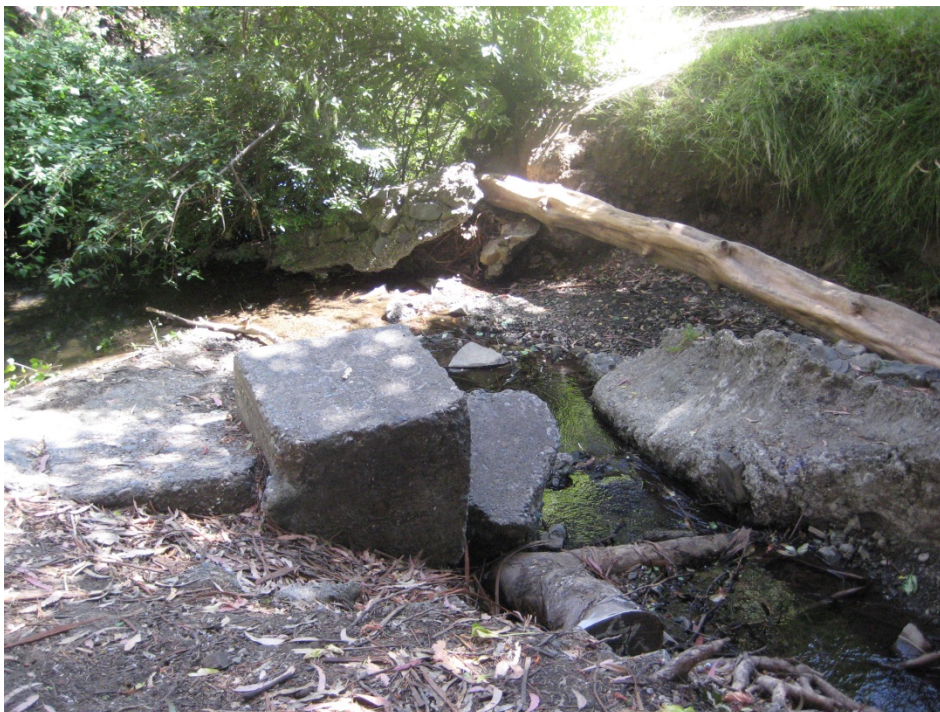
Photo 2: Failed check dam 1 (CD1) looking downstream to the confluence (South Fork comes in from the left side of the picture).

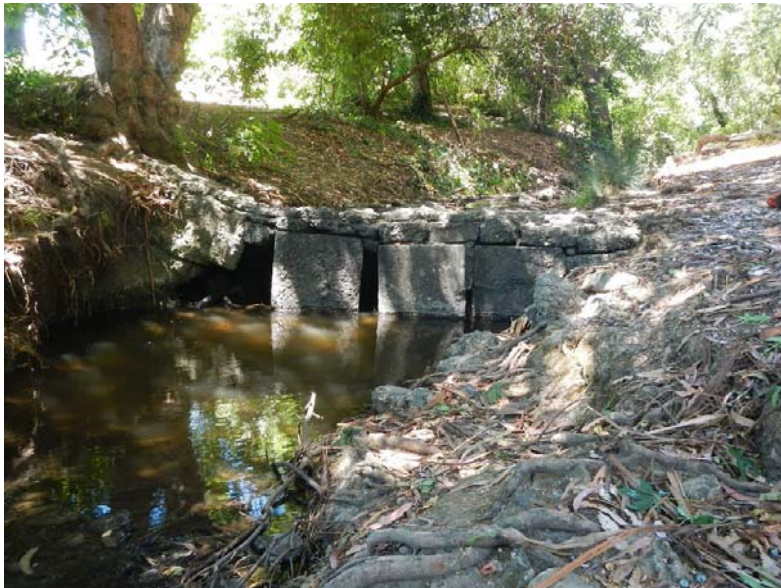
Attachment A). Additionally, remnants of CD1 deflected flow into the right bank at the confluence, causing a near vertical 6-foot scarp (**Photo 3 of Attachment A**). The failure of CD1 caused the channel bed to incise upstream, undermining CD2 which was located 35 feet upstream of CD1. CD2 was at risk of failure due to undercutting of the support structure on the right bank (left side of **Photo 4 of Attachment A**) and water piping through the dam.

Photo 4: Check dam 2 (CD2) is about 35 feet upstream of CD1 on the North Fork. Notice instability on the right bank (left side of picture).

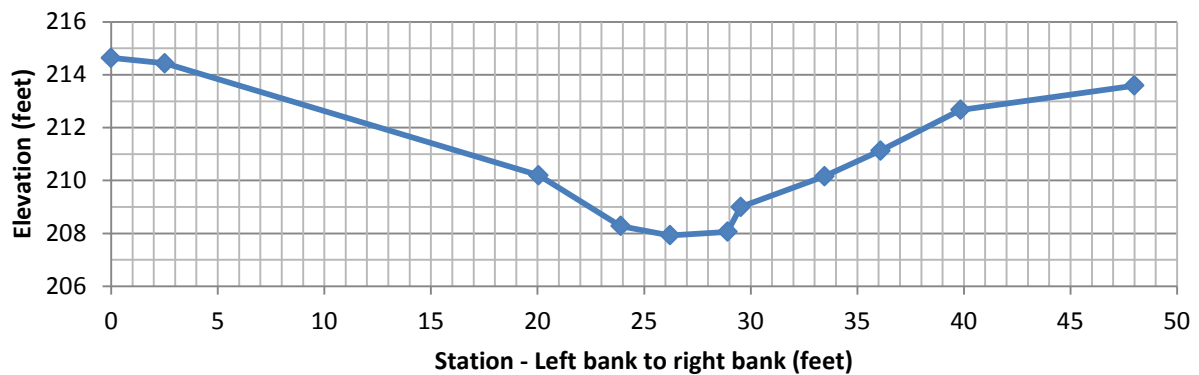
Station 0+96: Step Pool 2 Crest

- Station 0+95 – Step Pool 2 Crest: Possible piping of water through creek substrate may lead to subsurface water flow during dry periods.
 - Recommendation: if this problem persists during the summer dry season, call the contractor to implement a solution.
- Station 1+25 – Erosion on the right bank just downstream of the specimen boulder is most likely due to scour from constriction of the channel pathway.
 - Recommendation: move the boulder further into the right bank, thereby opening up the channel. Armor right bank with smaller boulders just downstream of specimen boulder and plant with riparian vegetation in order to protect against further erosion.
