# Codornices Creek Watershed Restoration Action Plan

Urban Creeks Council

Kier Associates

November, 2003

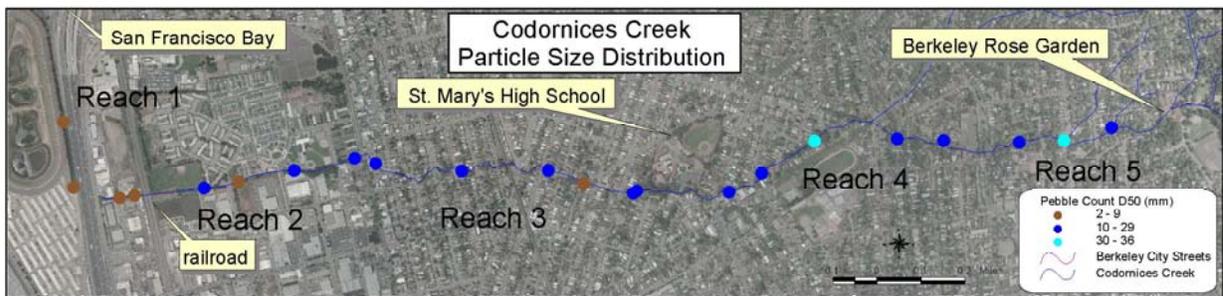
As for the ability of Codornices Creek’s gravels to support steelhead reproduction, Kondolf reported that the streambed particle sizes that are most suitable for supporting successful steelhead spawning, egg incubation, and fry emergence range in size from 10-45 mm (Kondolf, 1993). See figure 10 below. The median streambed particle size distribution indicates that while a number of Codornices Creek sites tested *below* Albina Avenue are unsuited to these critical steelhead life history stages, the sites tested *above* Albina are all uniformly suitable.

Figure 10. Codornices Creek pebble count sites showing suitable (blue) and unsuitable (brown) gravel areas.

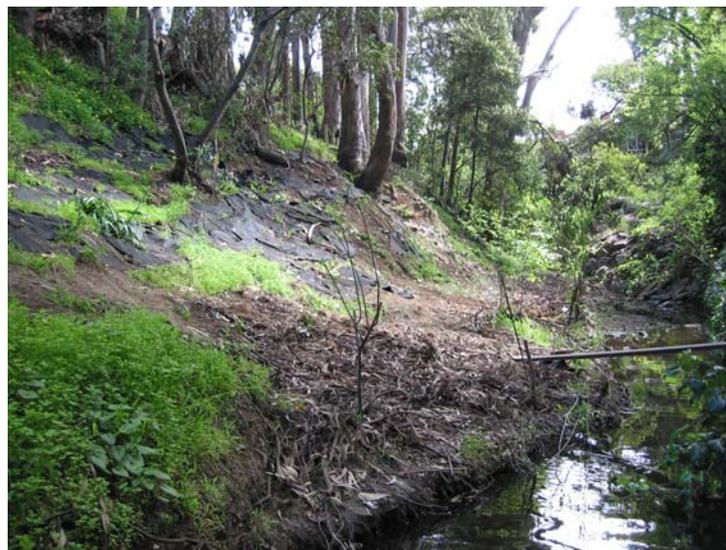
As we noted above, the survey team recorded and geo-referenced streambank erosion sites. The failing hillside shown in figure 11, near St. Mary’s High School, is contributing significant amounts of fine sediment into the stream and it may be reducing steelhead productivity below this point.

Figure 11. Sediment from the hillside is entering Codornices Creek near Albina Avenue

For each of the problematic sites, including the major erosion site on the right streambank of Codornices Creek near Albina Avenue, FarWest Restoration Engineering has fashioned preliminary restoration recommendations ([Appendix A](#)).

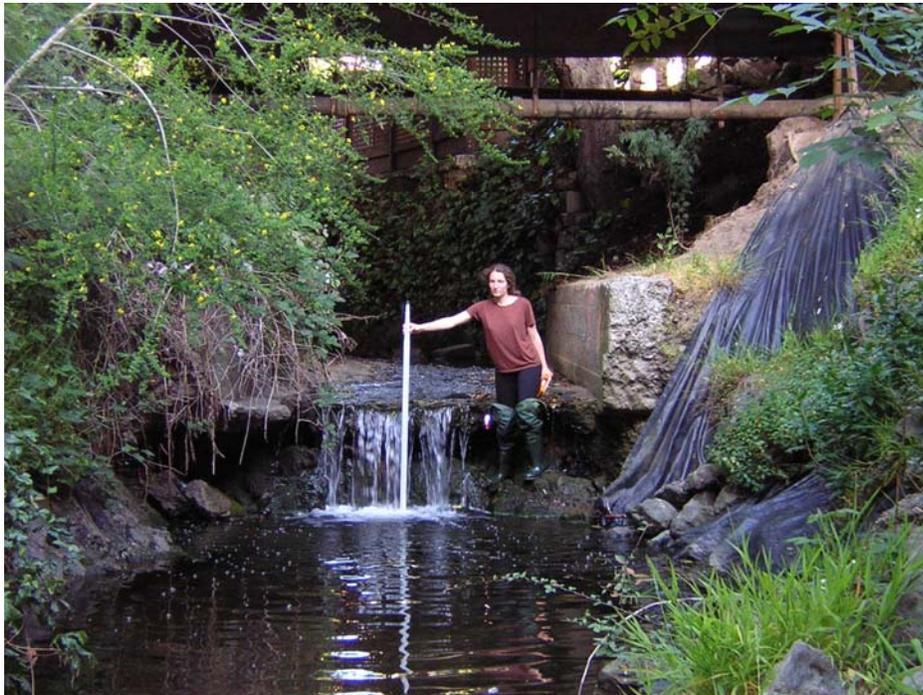
Figure 12 illustrates a typical Codornices Creek steelhead migration barrier. Here, California Department of Fish and Game-trained CCWRAP habitat survey field leader Michelle Wallar measures the distance from the Albina Avenue culvert to the water surface elevation below, and the depth of the scour pool immediately below the culvert.

Adult steelhead could negotiate the jump shown here easily if the depth of the scour pool were equal to more like one-and-a-half times, rather than only one-half, the vertical distance from the stream's surface to the culvert's invert. Another fish passage issue at this site is the spreading of the flow across the relatively wide culvert invert, making the stream too shallow to support effective adult steelhead upstream swimming.

Figure 12. Down-cutting of streambeds below culverts has created most of Codornices Creek's fish barriers
