Baseline (Year 1) Habitat Monitoring Report Village Creek Restoration Project (University Village Albany Step 2, #12810A) University of California, Berkeley

January 2008

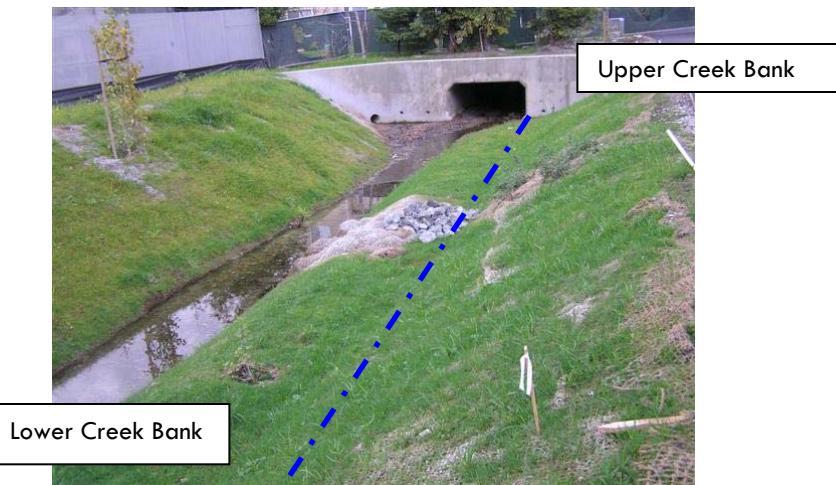
Baseline vegetation cover was visually estimated for upper creek banks and for lower creek banks that were hydroseeded in October 2007. By January 2008, both upper and lower creek bank areas were establishing well, with observed vegetation cover at 85% for Upper Creek banks, and 90% for lower creek banks (Photo 1). The baseline Year 1 observed vegetation cover exceeds Year 3 and 5 performance standards for the project. No remedial actions are necessary at this time for this monitoring parameter.

Photo 1. Typical vegetation cover, upper and lower creek banks

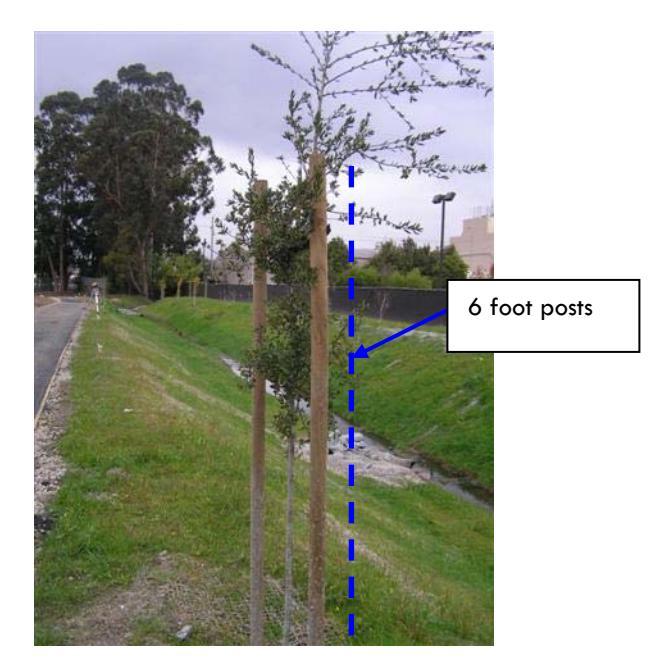
Plant height for the newly installed shrubs averaged 8 inches. Plant height for the trees varied from 4 to 5.5 feet for smaller trees such as bigleaf maple and California buckeye, to from 7 to 9.5 feet for larger trees such as coast live oak (Photo 2) and Fremont's cottonwood. Baseline Year 1 results will be visually compared against each year's result to determine if there is an overall increase in plant height over time.

Photo 2. Typical coast live oak planting showing baseline for average tree height (est. at 7 to 9.5 feet).

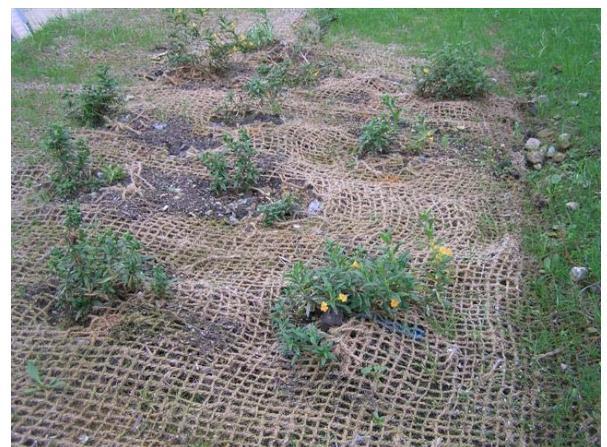
Photo 3. Typical Sticky monkey shrubs showing baseline for average shrub height (est. at 8 inches)

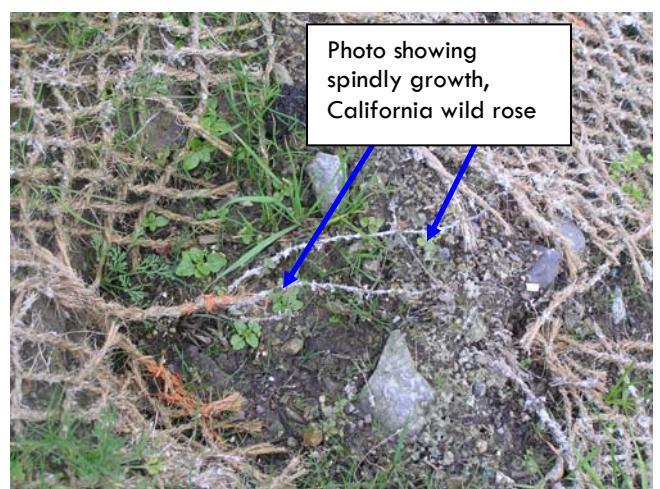
Shrub and tree plantings in general appear to conform to the approved planting plan (Sheet L7.01, prepared by J.R. Roberts Corporation). Trees appear to be doing well, with most trees installed in October 2007 present and surviving by the January 2008 monitoring site visit. There was a greater-than-anticipated die off of some shrub species and of blue elderberry trees. There are several possible reasons for the lower than anticipated survivorship rate. One possibility is that the plants were diseased, root bound, or improperly installed. An example of this would be some of the observed California wild rose plants, which were spindly, and/or had chlorotic leaves at the time of the January survey (Photo 4). In general, California wild rose does not do well on newly-exposed creek banks, and replacement planting efforts may wish to substitute a different species such as marsh baccharis.

Photo 4. California wild rose showing spindly habitat and chlorotic leaves.

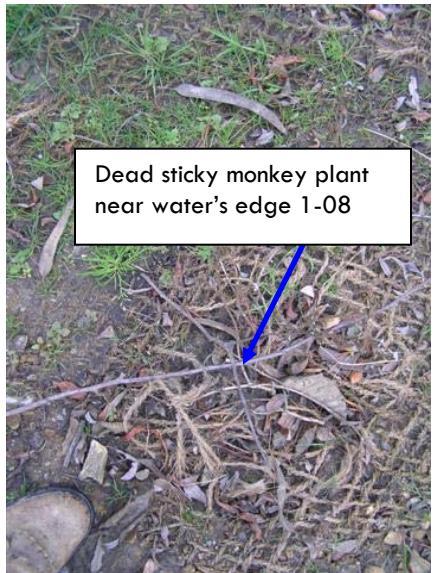
A final possibility is that plant species were installed in areas where the individual species are not thriving due to microclimatic conditions. An example if this is the observed mortality of an entire cluster of sticky monkey flower that was installed immediately adjacent to flowing water of the constructed channel. This species tends to favor drier conditions, and would be more likely to persist if placed higher on the creek bank in the future.

Photo 5. Close-up of dead sticky monkey flower plant adjacent to water in creek.

Regardless of the reason for plant mortality, some remedial plantings are recommended to make sure the project stays on track to meet year 5 performance criteria, as described below in Section 5.0. Refer to Figure 3 for recommended planting locations.
