**2013 Supplemental Monitoring Report**  
**Village Creek Restoration Project**  
(University Village Albany Step 2, #12810A)  
**University of California, Berkeley**

**December 2013**

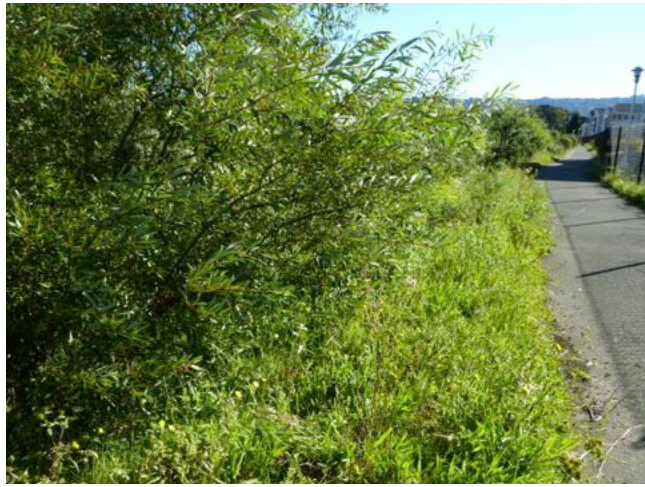
Photo 1a. (2013) Typical vegetation cover, upper and lower creek bank. Note willow growth in creek channel

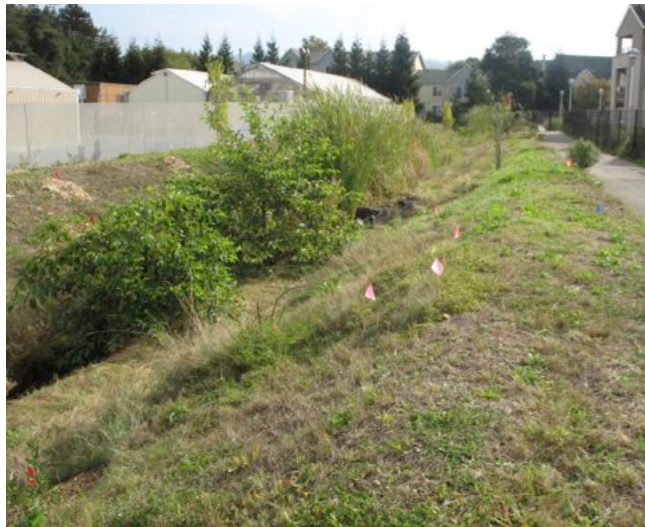
Photo 1b. Comparison, Typical vegetation (2011) upper and lower creek banks immediately after supplemental plantings

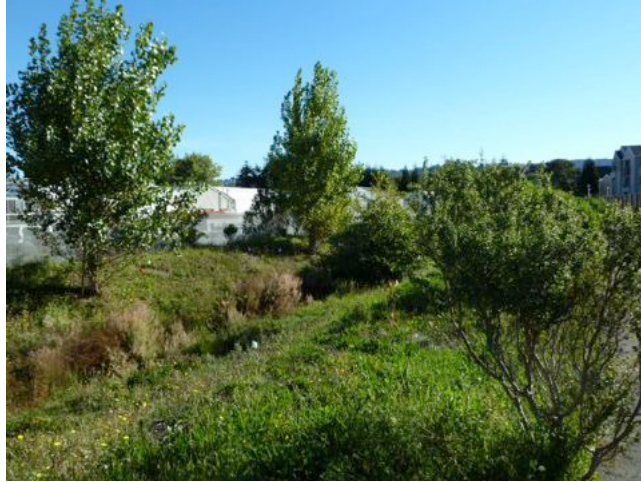
Photo 2a. Typical Tree height – Fremont’s cottonwood (October 2013) site conditions.  
Note height increase, robust growth and excellent condition of cottonwood trees.

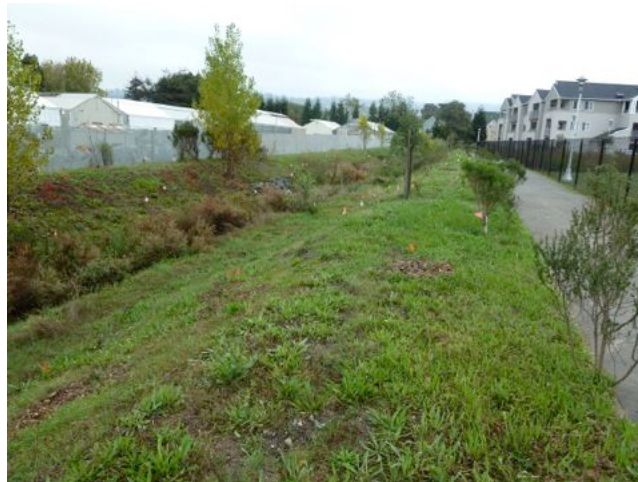
Photo 2b. Comparison photo-Typical tree height- Fremont’s cottonwood (2011)

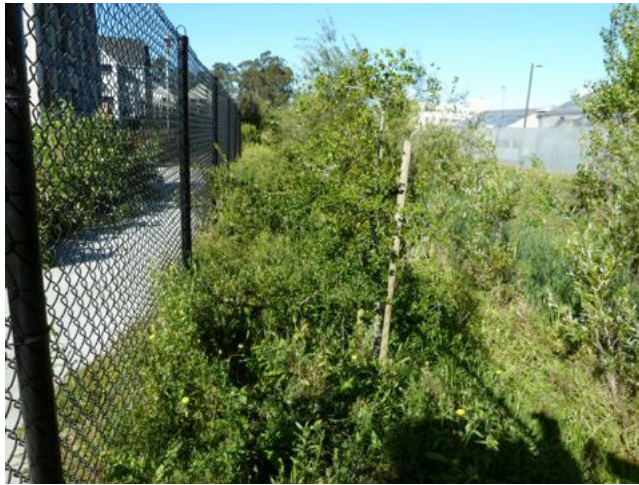
Photo 3a. Typical coast live oak planting (October 2013)

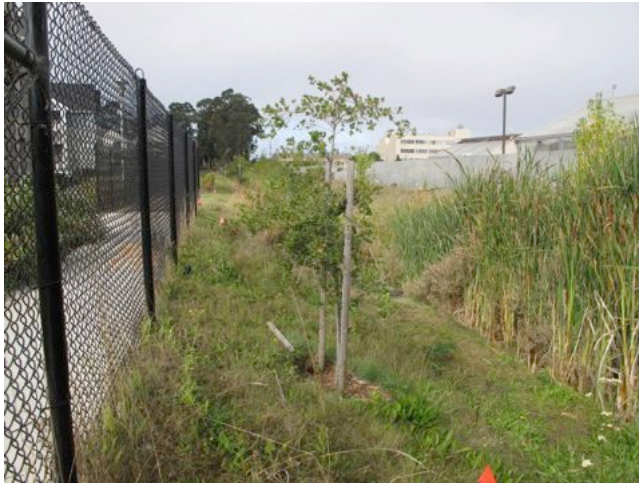
Photo 3b. Comparison Photo, typical coast live oak (2011) site conditions.

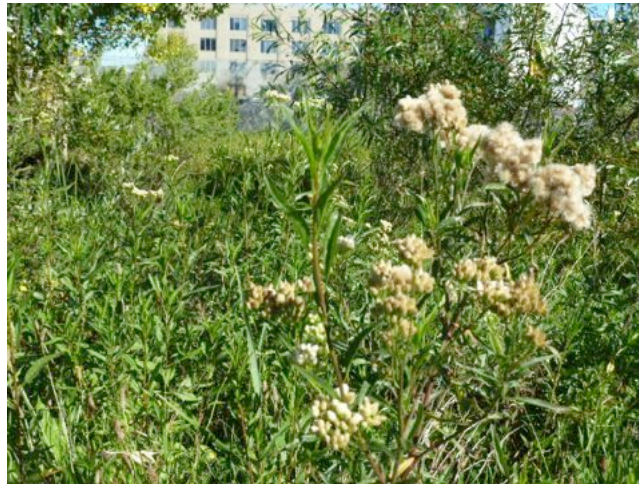
Photo 4. Replacement planting (marsh baccharis) showing natural regeneration (outward spread) from original planting site (2013)

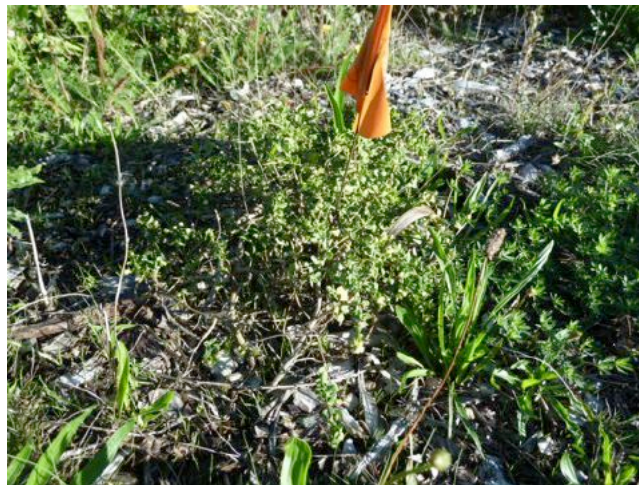
Photo 5.  
Photo depicting increase in height of shrubs (coyote bush) (2013)

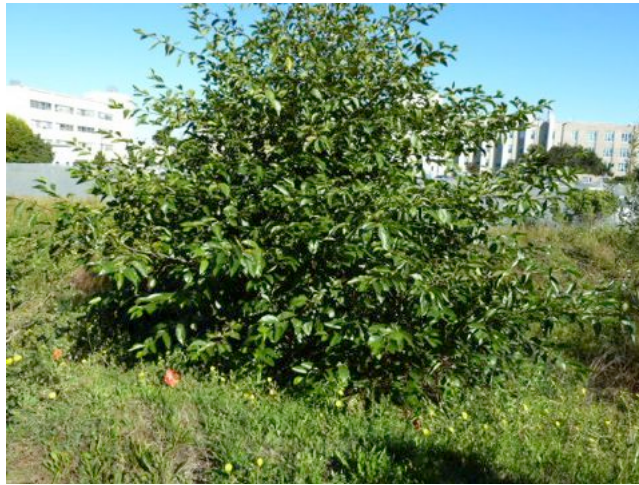
Photo 6a. Substantial increase in number and size of alders in 2013 (compare with Photo 6b below).

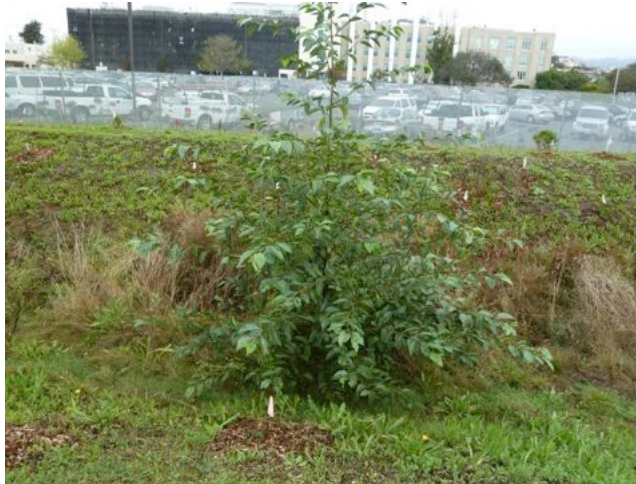
Photo 6b. Comparison Photos- alders in 2011.

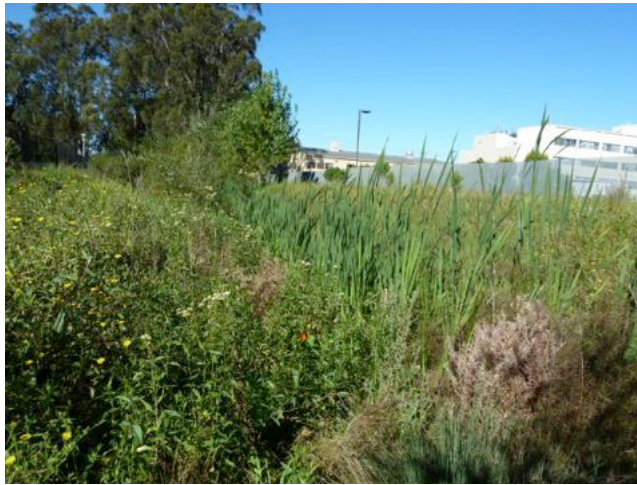
Photo 7a. 2013 Creek channel after treatment (removal) of some cattails in 2012  
(Compare with Photo 7b below)

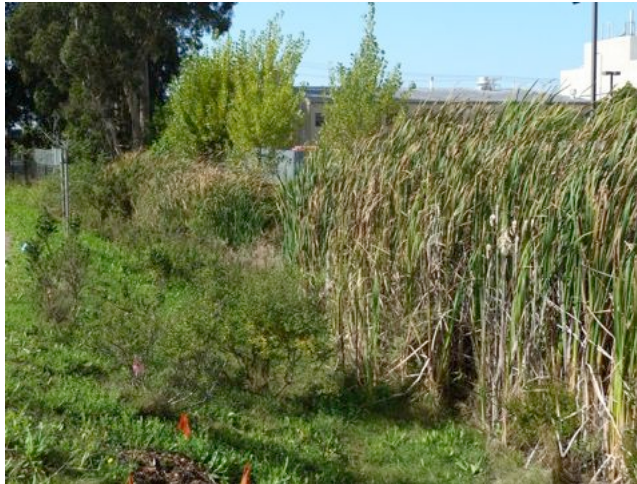
Photo 8. Typical channel conditions in 2011-excessive growth of cattails covering most of creek channel bottom  
(requiring maintenance to allow for creek channel flow.)

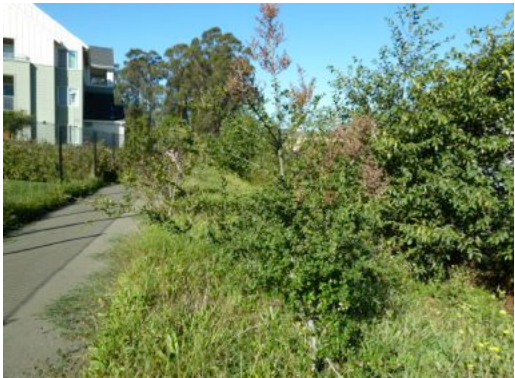
Photo Point 6A - Supplemental  
Planting Site 2013 (Note additional  
alder trees)
