## ***Strawberry Creek on the University of California, Berkeley Campus: A case history of urban stream restoration***

ROBERT CHARBONNEAU

VINCENT H. RESH

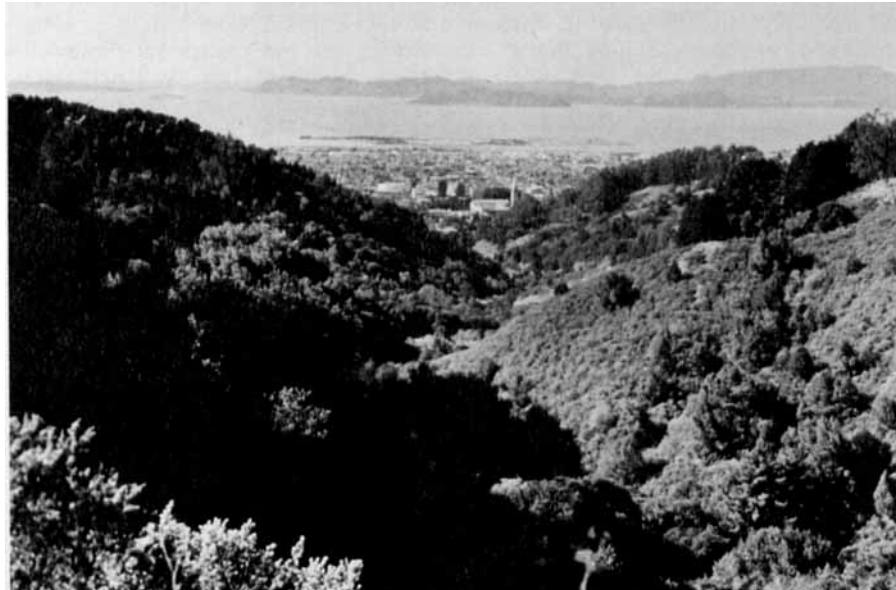
Figure 1. Strawberry Canyon, the University of California, Berkeley campus, and San Francisco Bay. The South Fork of Strawberry Creek originates in this canyon and flows through the campus to central San Francisco Bay.

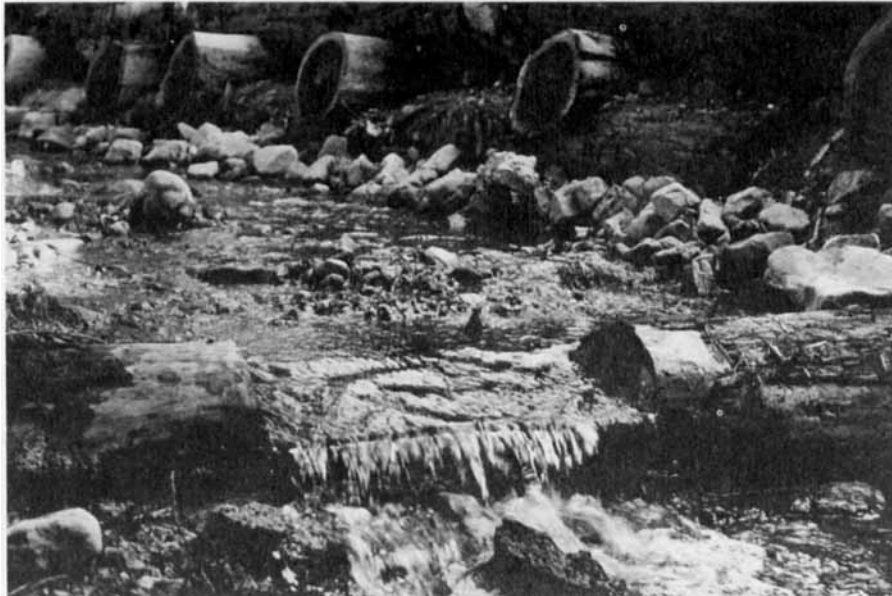
Figure 4. Notched redwood-log check dam in the creek.

In addition to the cribwall, a number of grouted rock or wood check dams were designed and placed in the creek to prevent further downcutting of the stream bed and subsequent bank undercutting and erosion (Figure 4). The dams were designed to be as low as possible (maximum 45 cm from spillway to plunge pool) so that if migratory salmonids were ever reintroduced into the creek, they could overcome these obstacles. Low check dams were also found to be much more stable over time. The dams were usually installed in a series, stairstep-fashion, in areas of steep channel gradient in order to achieve desired channel aggradation and stability while still maintaining a low profile. In addition to stabilizing the channel and dissipating storm-flow energy, the check dams also provide varied habitat for fish and aquatic insects in the downstream plunge pools. Most of the dams were built by California Conservation Corps (CCC) crews under the supervision of campus staff. Old check dams were also repaired and stabilized with riprap.

concentrated energy loss). Most likely these check dams will fail within a few years. A successful check dam must be protected from toe scour, endcutting and seepage-induced washout, and be strong enough to withstand the impact of large, floating debris; unfortunately, universally applicable engineering designs for these structures have not been developed (Sklar and Haltiner, 1991). Finnigan *et al.* (1980), Wesche (1985) and Swales (1989) provide information on stream channel enhancement techniques; upon request, we will provide information on features of stable check dams and other modifications that have been successfully used on Strawberry Creek.
