memorandum

date May 8, 2014
to Tim Pine, UC Berkeley EH&S
from Scott Stoller, PE
subject Strawberry Creek Confluence Ecological Stabilization Project Basis of Design

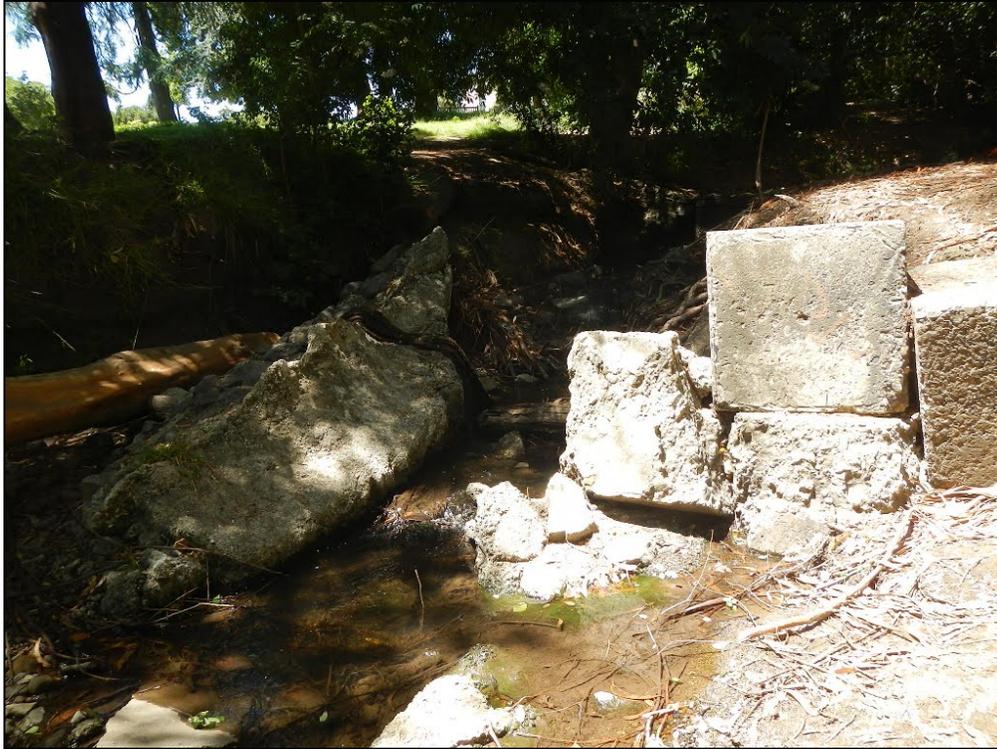
PHOTO 1. Failed Check Dam #1

The project site extends from the confluence of the North and South Forks of Strawberry Creek to 80 feet up the North Fork, which encompasses an area that includes one failed check dam (CD1) and another failing check dam (CD2). CD1 is a decades-old check dam constructed on the north fork of Strawberry Creek located immediately upstream of the confluence of the North and South Forks. The failure of this check dam in 2006 caused the main concrete body of the dam to orient stream-wise in the center of the channel (Photo 1) and the channel bed to incise upstream, undermining CD2 (Photo 2). Additionally, remnants of CD1 deflect flow into the right bank causing a near vertical 6-foot scarp (Photo 3). CD2 is the same vintage and is located 35 feet upstream of CD1; it is at risk of failure due to undercutting of the support structure on the right bank and the water piping through the dam.

The Project proposes to remove the remnants of CD1 and the failing check dam CD2, and install three in-stream grade control structures. Two step-pool structures and one log drop structure will be constructed within the project area. The step pools will be constructed of ungrouted rock and will be flexible to adjust to modest changes in channel conditions. The structures and grading of adjacent banks will impact a total of 80 linear feet of channel bed and approximately 1000 square feet of channel and bank area. The grade control structures consist of a crest, a cascading drop, and a pool feature which transitions into the channel design grade. The typical step-pool structure is 15 feet long, measured along the channel. The crests (measured at the low flow channel) will range from 5-8 feet wide. The crest is keyed 4-5 feet into the adjacent channel banks to capture and direct flows to the channel as well as to provide protection against flanking in larger storm events. Each rock structure has a drop of 1.5 feet and the log drop structure has a drop of 1.0 feet. Grading and revegetation elements will integrate the step-pools with the channel banks. In addition to the installation of the grade control structures, steep adjacent banks will be graded to a stable slope and planted with native vegetation.

1. Station 0+45 (approx) – just downstream of confluence, this grade control is near at grade with no signs of deterioration.
2. Station 0+65 (approx) – failed grade control structure (referenced as CD1) just upstream of confluence, and there is currently concrete debris in the creek causing erosion on the right bank.
3. Station 1+00 (approx) – failing grade control structure (referenced as CD2) to be removed and replaced by current project.
4. Station 1+45 (approx) – existing grade control with no signs of deterioration.

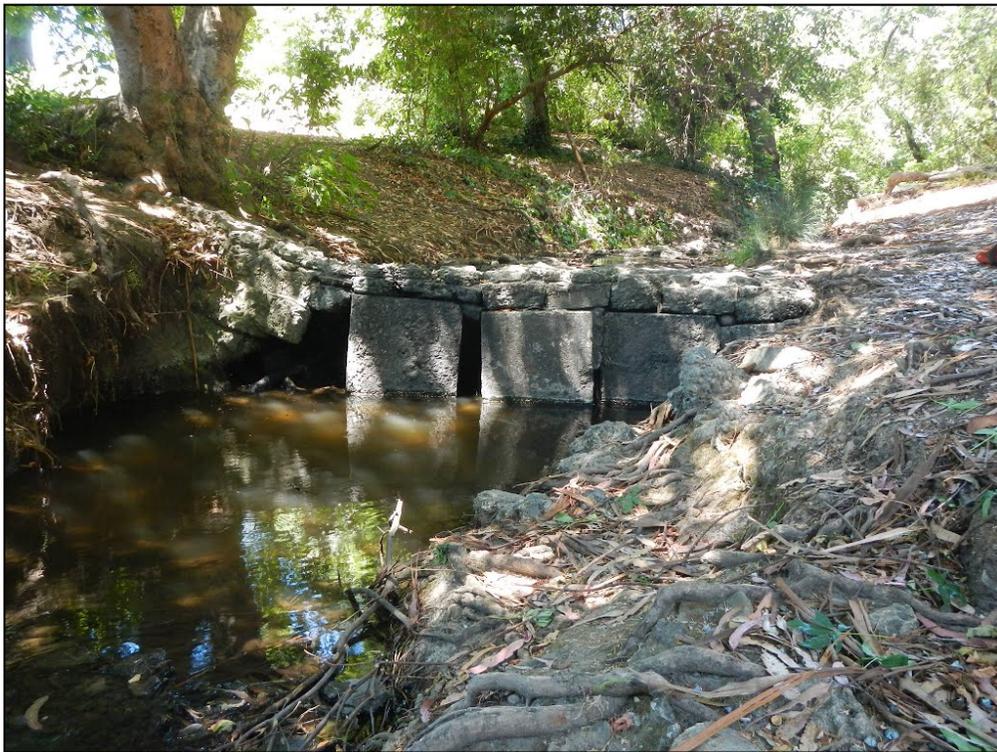
PHOTO 2. Failing Check Dam #2

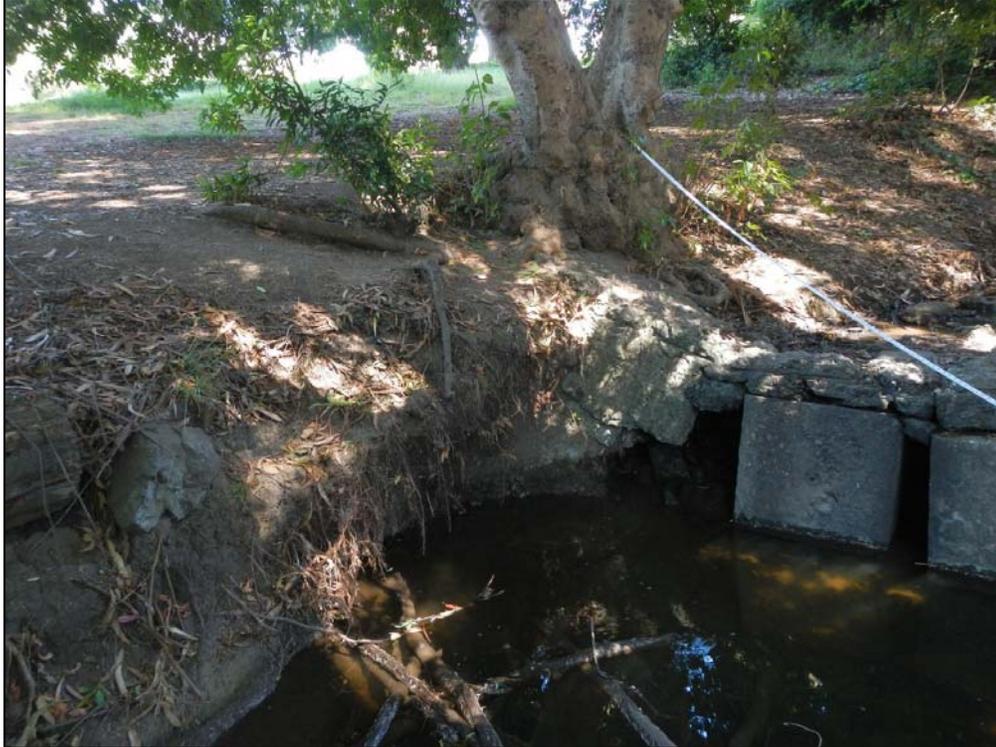
PHOTO 3. Erosion on Right Bank
