Technical Memorandum

Date: March 6, 2012

RE: **UC Berkeley Stanley Hall Diesel Spill - Natural Resource Damage Assessment December 2011 Water and Sediment Sampling Summary**

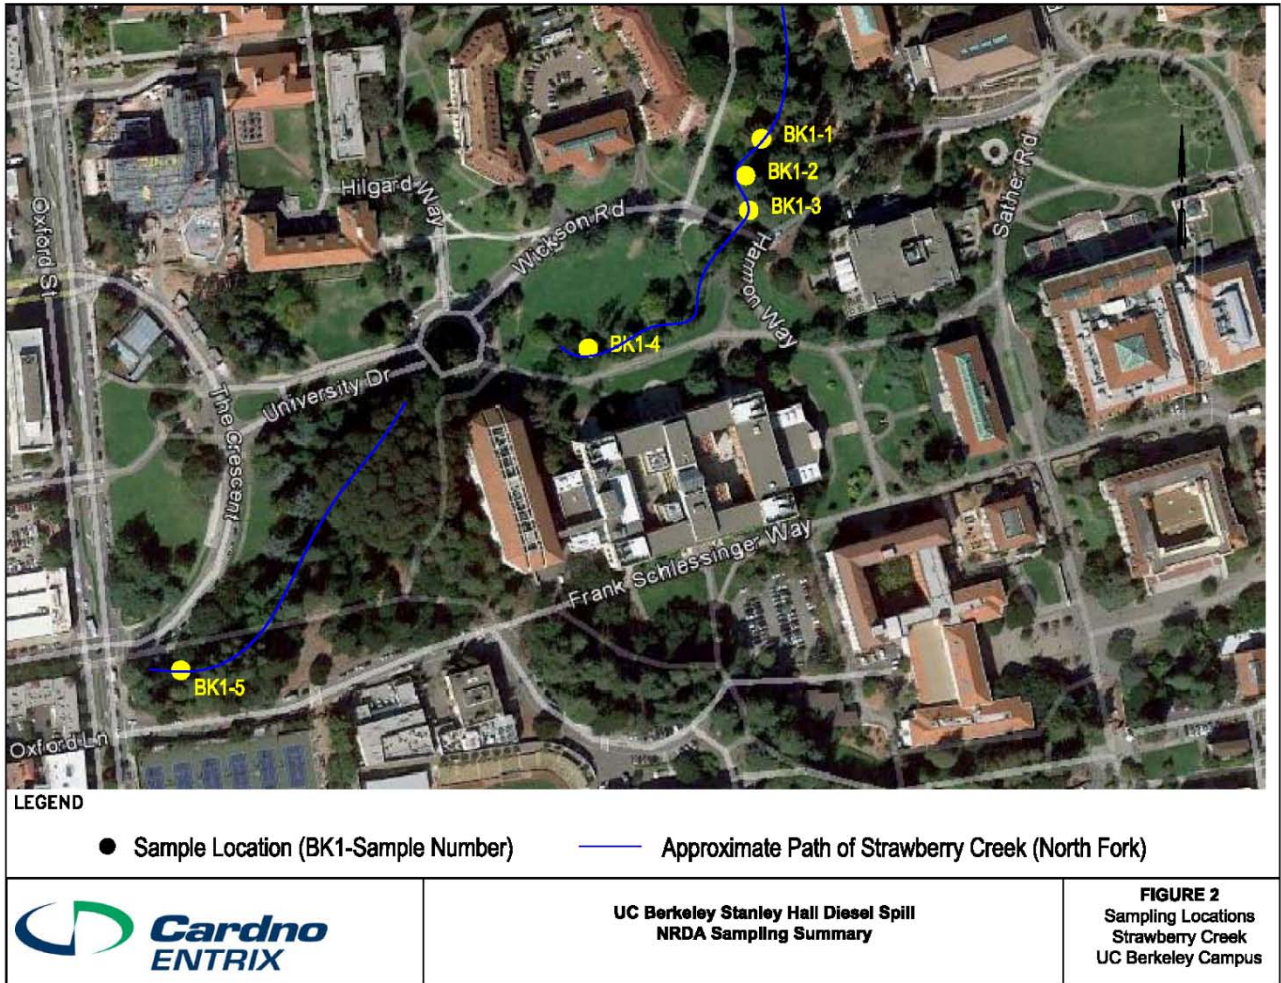
Figure 2 Sampling Locations along Strawberry Creek on the UC Berkeley Campus

(TPH-DRO); one at the location adjacent to the Valley Life Sciences Building (VLSB; Figure 2) and one on campus immediately upstream of the Oxford Culvert (Figure 2). Review of the FID chromatograms indicated that the sample at the VLSB was not related to diesel hydrocarbons, whereas the sample at the Oxford Culvert appeared to have a possible weathered diesel contribution.

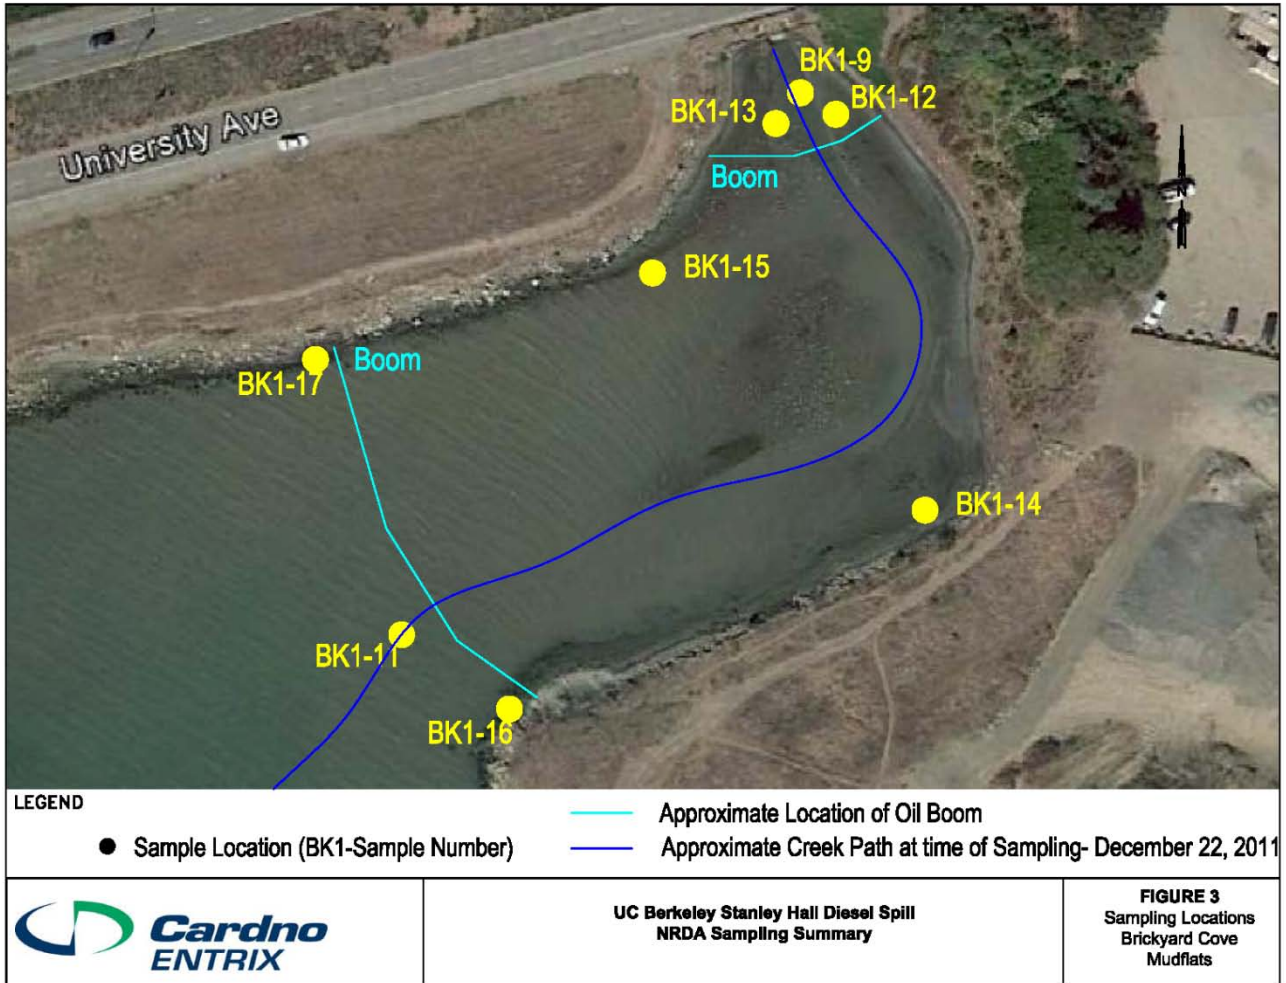
Figure 3 Sampling Locations in Brickyard Cove

Sediment samples were collected at the Brickyard Cove mudflat between the installed booms (Figure 3). As with all Brickyard Cove locations, the field team did not observe any sheen or diesel odor in this location. VOCs were not detected in the sediment samples (Table 4). TPH-DRO and TPH-LOR were detected in both samples from this location (BK1-14-SL1, BK1-15-SL1; Table 4; Figure 4 – top). The diagnostic ratio for the left bank sample (BK1-14-SL1) was approximately equal to the reference location, whereas the diagnostic ratio for the right bank sample (BK1-15-SL1) was twice the average value of the index ratio at the reference location. Upon inspection of the FID chromatogram for BK1-14-SL1, it was evident that, as seen with the reference locations, the TPH signature was high boiling, and not related to diesel range organics (Figure 20). Inspection of the FID chromatogram for BK1-15-SL1 showed that there may be a trace level of diesel range organics in the sample. However, the potential diesel components are so low in the sample that they may not result in detectable signals in Tier 2 analyses (Figure 21).

Three (3) sediment and water samples were collected at the Brickyard Cove outside of the second boom (Figure 3). No sheen or diesel odor was evident in this location. VOCs were not detected in either water or sediment samples (Tables 3 and 4). TPH-DRO was not detected in the water sample (Table 3).

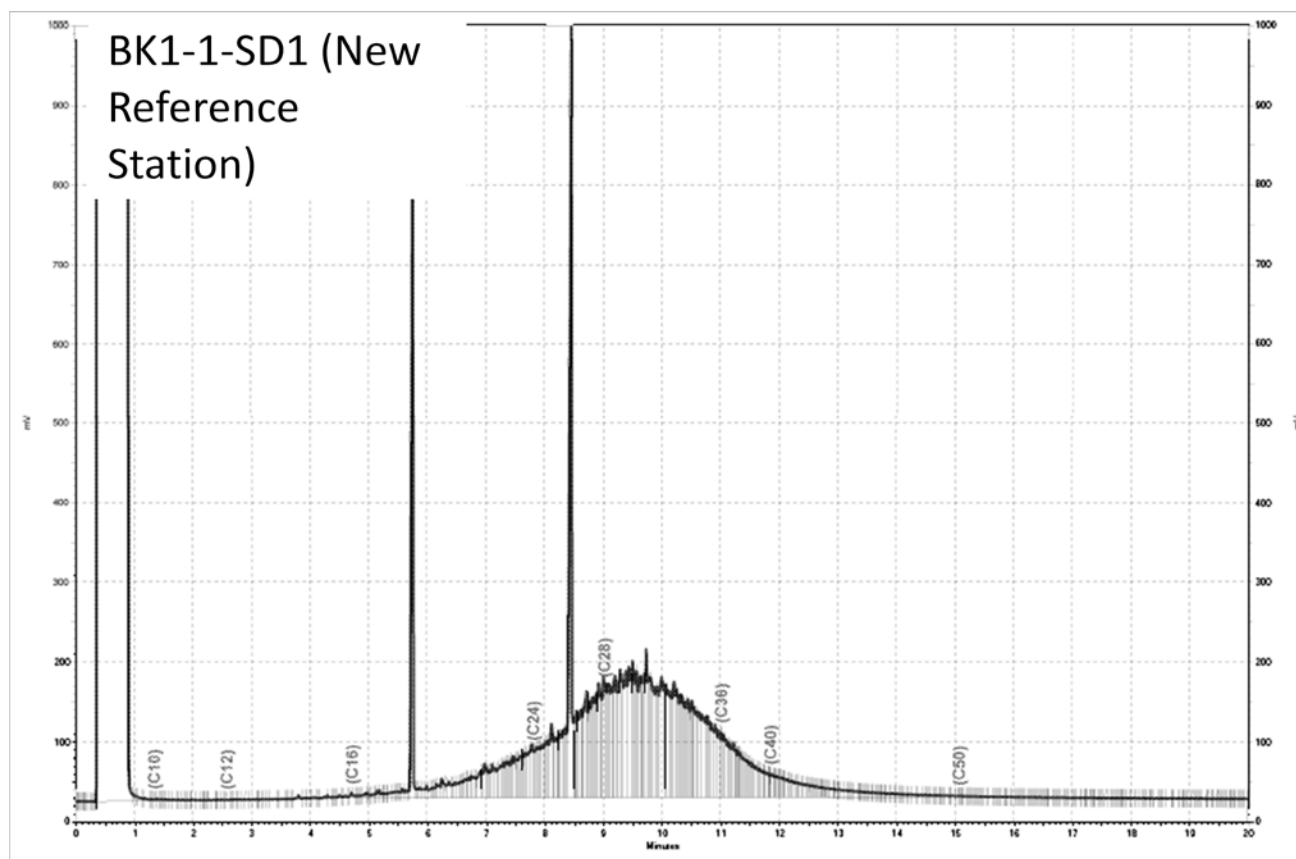
Figure 6 FID Chromatogram for Station BK1-1, "New Reference" Station, Sediment Sample

Sediment sample BK1-1-SD1 had a TPH-DRO concentration of 13 µg/Kg, and a TPH-LOR concentration of 100 µg/Kg. Soil sample BK1-1-SL1 had a TPH-DRO concentration of 22 µg/Kg, and a TPH-LOR concentration of 120 µg/Kg. The diagnostic ratio value was 0.13 for the sediment sample, and 0.18 for the soil sample. The TPH chromatograms were inspected, and indicated a hydrocarbon boiling range not related to diesel oil (Figures 5 and 6). The average diagnostic ratio value for these reference sediments served as the diagnostic ratio index to compare samples collected downstream of the Source in an effort to tease out urban background characteristics (Figure 4 - bottom). The urban background sources in these samples are characterized by a chromatographic TPH profile that peaks well beyond the boiling range of diesel range organics.

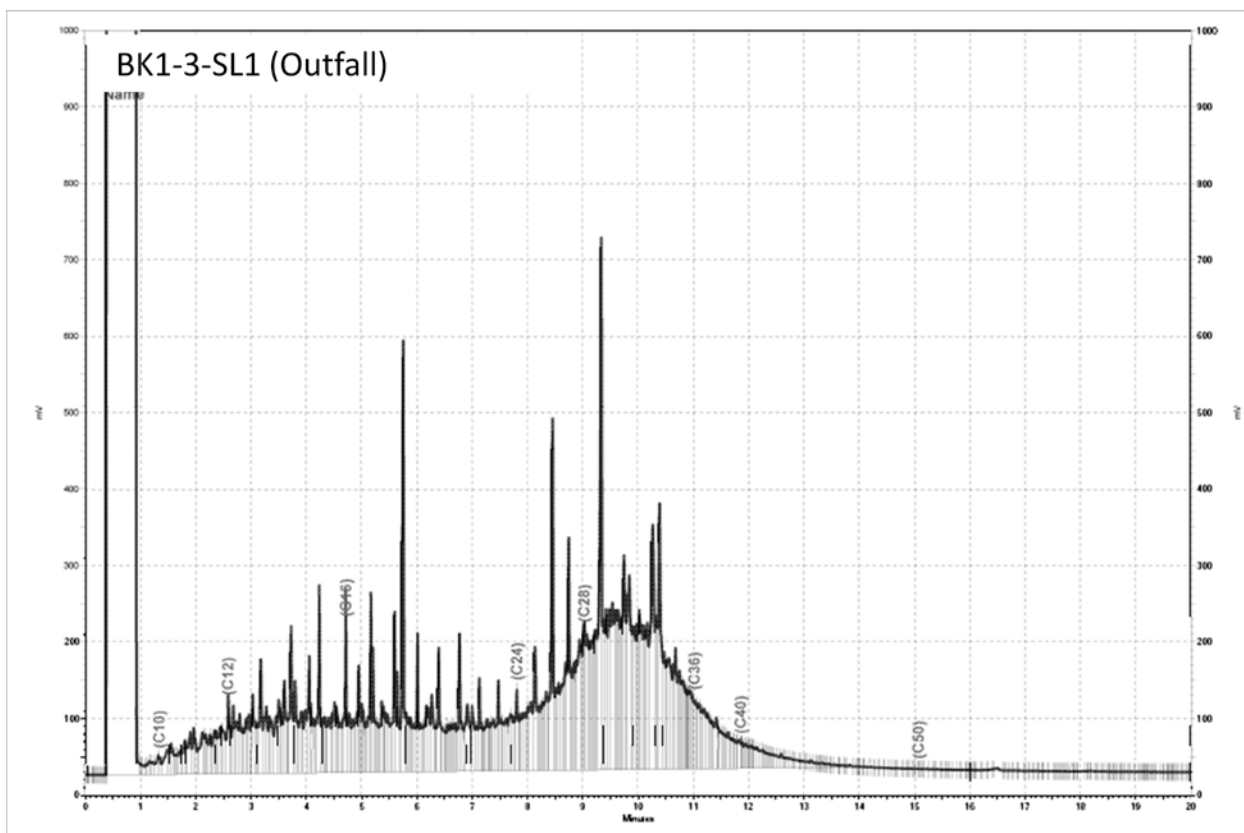
Figure 7 FID Chromatogram for Station BK1-3, Source/outfall Station, Left Bank Soil Sample

TPH-DRO and TPH-LOR were detected in all Source location/outfall sediment and soil samples (BK1-3-SD1, BK1-3-SL1, BK1-3-SL2; Figure 4 – top). The diagnostic ratio for the sediment sample was only slightly higher than the reference location (Table 4; Figure 4 - top). The diagnostic ratio for the soil samples collected in the left and right banks at the wetted perimeter were approximately three to four times higher than reference. Upon inspection of the diagnostic ratios (Figure 4 – bottom) and the FID chromatograms (Figures 7 and 8), it was evident that only the left bank sample BK1-3-SL1, and to a lesser extent the right bank sample BK1-3-SL2, displayed a diesel fingerprint. The FID chromatogram for the sediment sample was characteristic of the reference conditions (Figure 9).

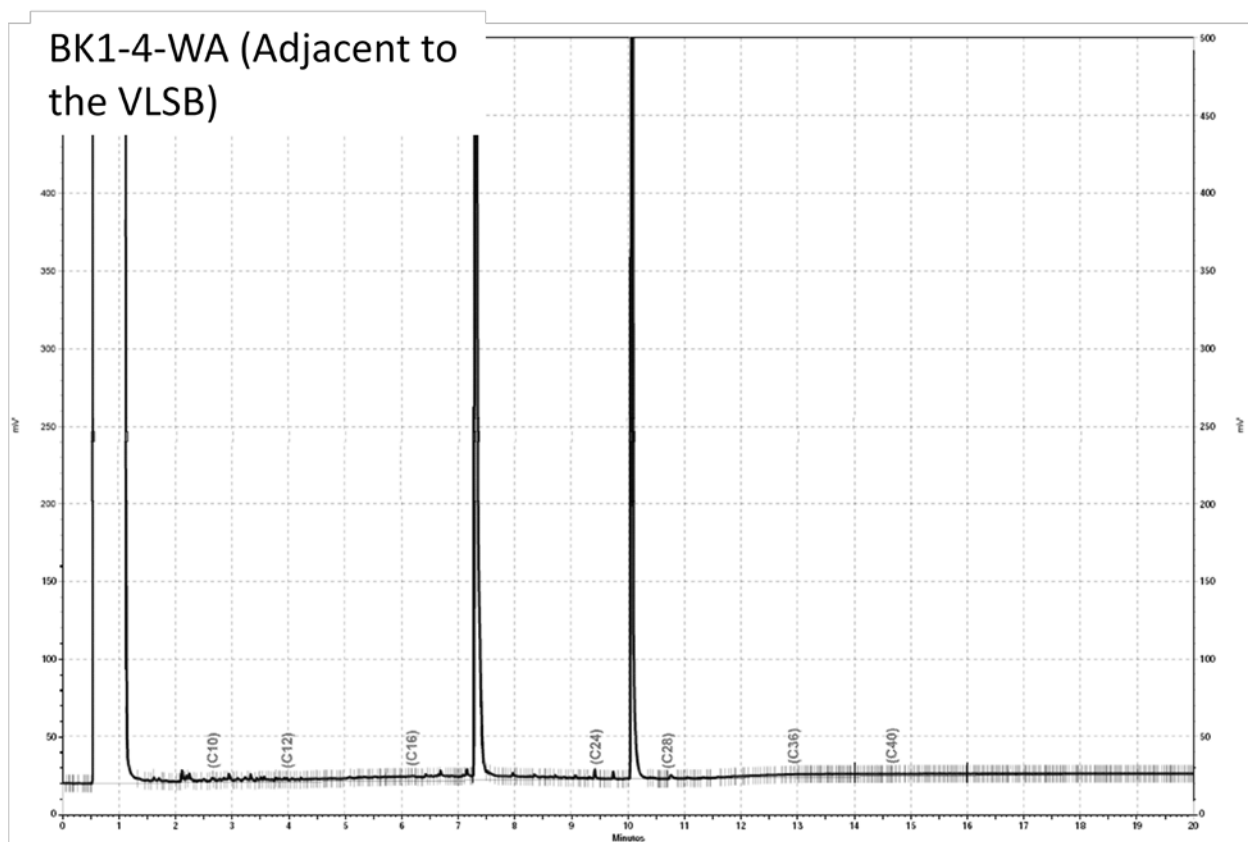
Figure 10 FID Chromatogram for Station BK1-4, VLSB, Water Column Sample

Sediment, soil and water samples were collected adjacent to the VLSB above the culvert (BK1-4). Although sheen was visible in the pooled water present at the location, along with a slight diesel odor, VOCs were not detected in water samples (Table 1). As noted above, this result suggests that diesel related hydrocarbons were at undetectable concentrations in the water column below the diesel sheen. In light of the visual confirmation of sheen at this location, sheen sample collection could have yielded chemical detections. TPH-DRO was measured in the water sample BK1-4-WA1 at a low level (68 µg/L) however upon more detailed inspection of the FID chromatogram there was no evidence of any hydrocarbons measured for this sample (Figure 10). As noted above, TPH-DRO measurements do not necessarily indicate the contribution of diesel to the sample. In this case, the chromatographic signature provided evidence that the measured TPH-DRO concentration was not due to a diesel source.

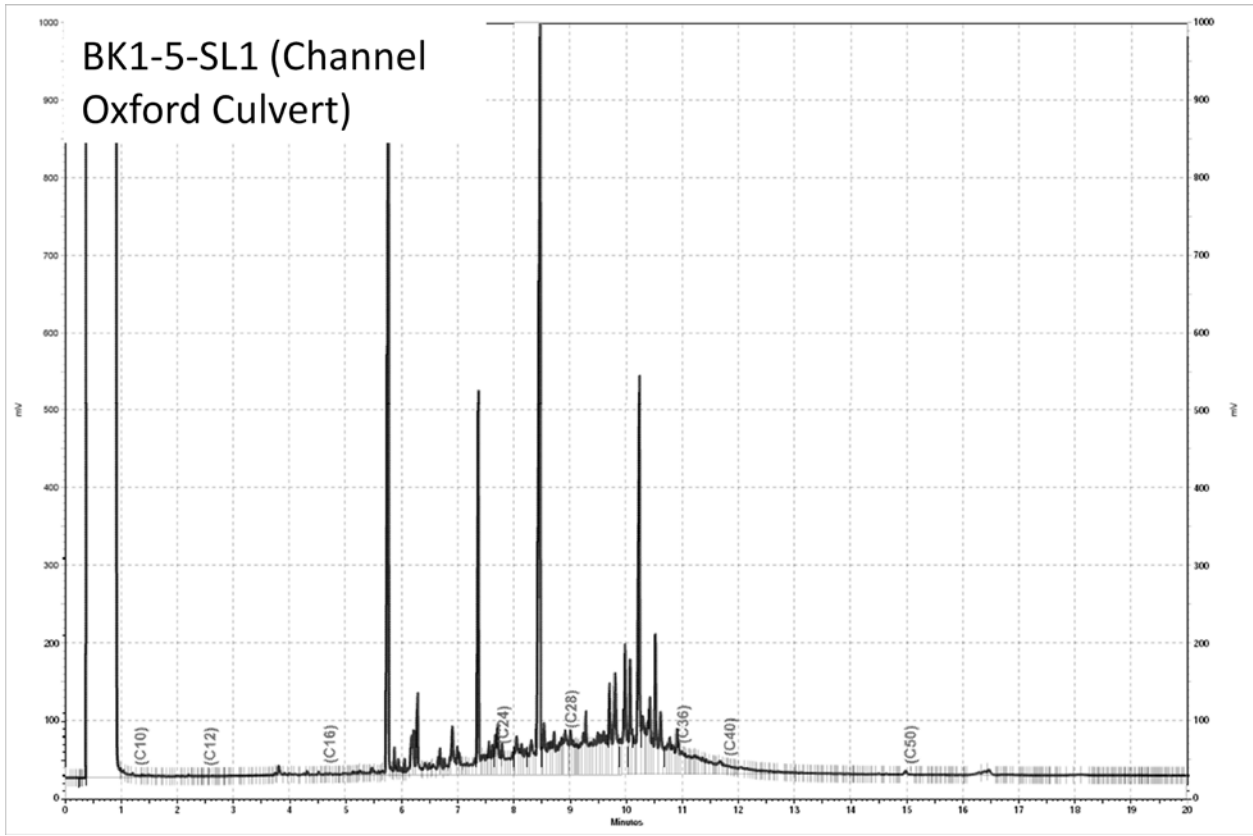
Figure 15 FID Chromatogram for Station BK1-5, Oxford Culvert, Left Bank Soil Sample

TPH-DRO and TPH-LOR were detected in all sediment and soil samples (BK1-5-SD1, BK1-5-SL1, BK1-5-SL2; Table 4; Figure 4 – top). The sediment concentration of TPH-DRO was approximately two times the average value of the reference locations. Soil concentrations of the TPH-DRO were six and seven times higher than the average of the reference concentrations, and approximately 30 times less than concentrations measured at the VLSB site (BK1-4-SL1 and BK1-4-SL2; Table 4; Figure 4). Upon inspection of the FID chromatograms for the soils (Figures 15 and 16) and diagnostic ratios (Figure 4 – bottom), it was evident that the elevated diagnostic ratio values were not likely diesel related due to the heavier than diesel boiling range of the TPH signature. As noted above, the TPH signature gives a general indication of hydrocarbon characteristics. In this case, the chromatographic signature provided evidence that the elevated diagnostic ratios for these samples were not due to a diesel source. No diesel contribution is evident in the sediment sample BK1-5-SD1 (Figure 17).

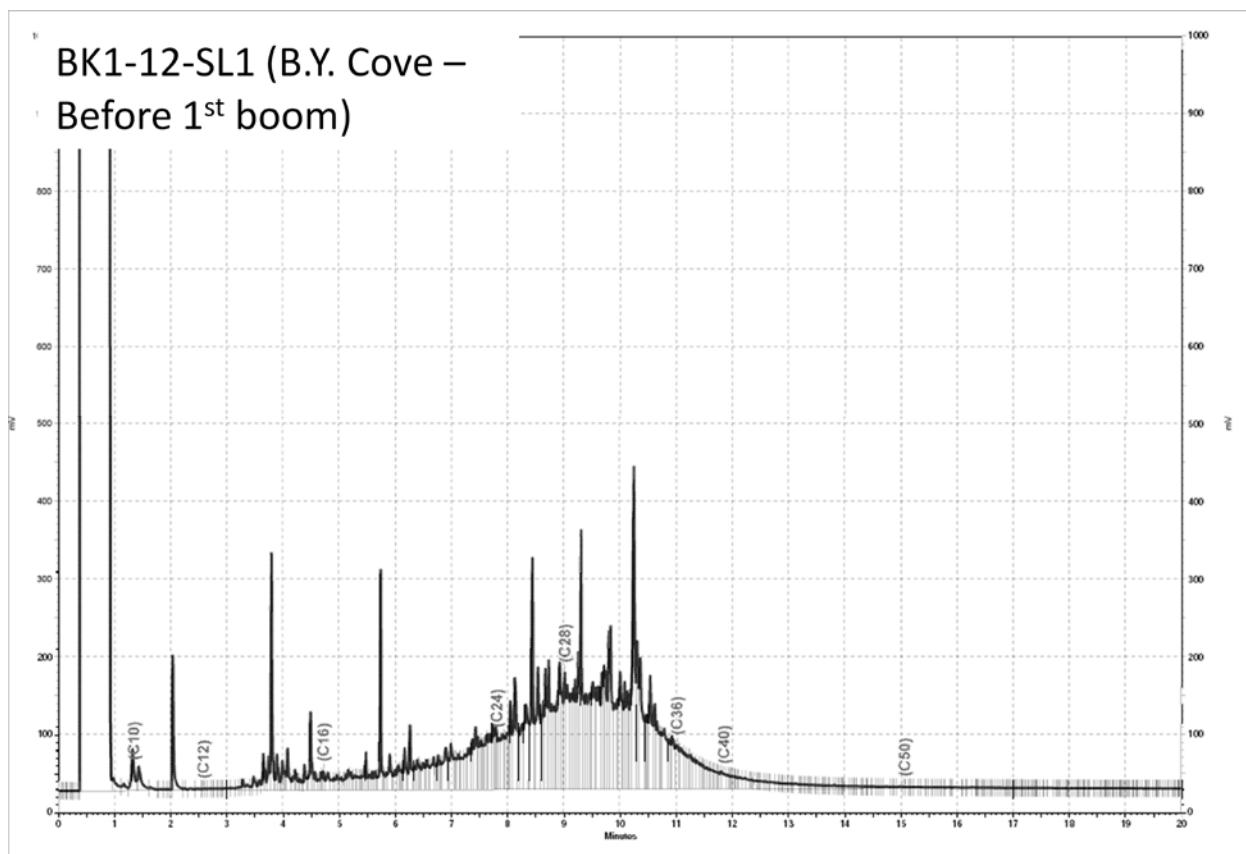
Figure 18 FID Chromatogram for Station BK1-12, Brickyard Cove inside First Boom, Left Bank Sediment/Soil Sample

TPH-DRO and TPH-LOR were detected in both sediment/ soil samples from this location (BK1-12-SL1, BK1-13-SL1; Table 4; Figure 4 – top). The diagnostic ratio for the left bank sample (BK1-12-SL1) was twice the level of the reference ratio. Upon inspection of the FID chromatogram for BK1-12-SL1, it was evident that there may be a trace level of diesel range organics in the sample. However, the potential diesel components are so low that they may not result in detectable signals in subsequent Tier 2 analyses (Figure 18). Upon inspection of the FID chromatogram for the right bank sample BK1-13-SL1, it was evident that the high TPH signature was not related to diesel range organics, but derived from the urban background (Figure 19). This is consistent with the diagnostic ratio for this sample which was nearly the same as the upstream reference location (Figure 4 – bottom).
