**Summary of As-Built Conditions
for the
Strawberry Creek Confluence Ecological Stabilization Project
(2015)**

Prepared for the University of California at Berkeley

by Aysha Massell, Environmental Protection Specialist
Office of Environment, Health and Safety
University of California at Berkeley

Submitted February 6, 2015

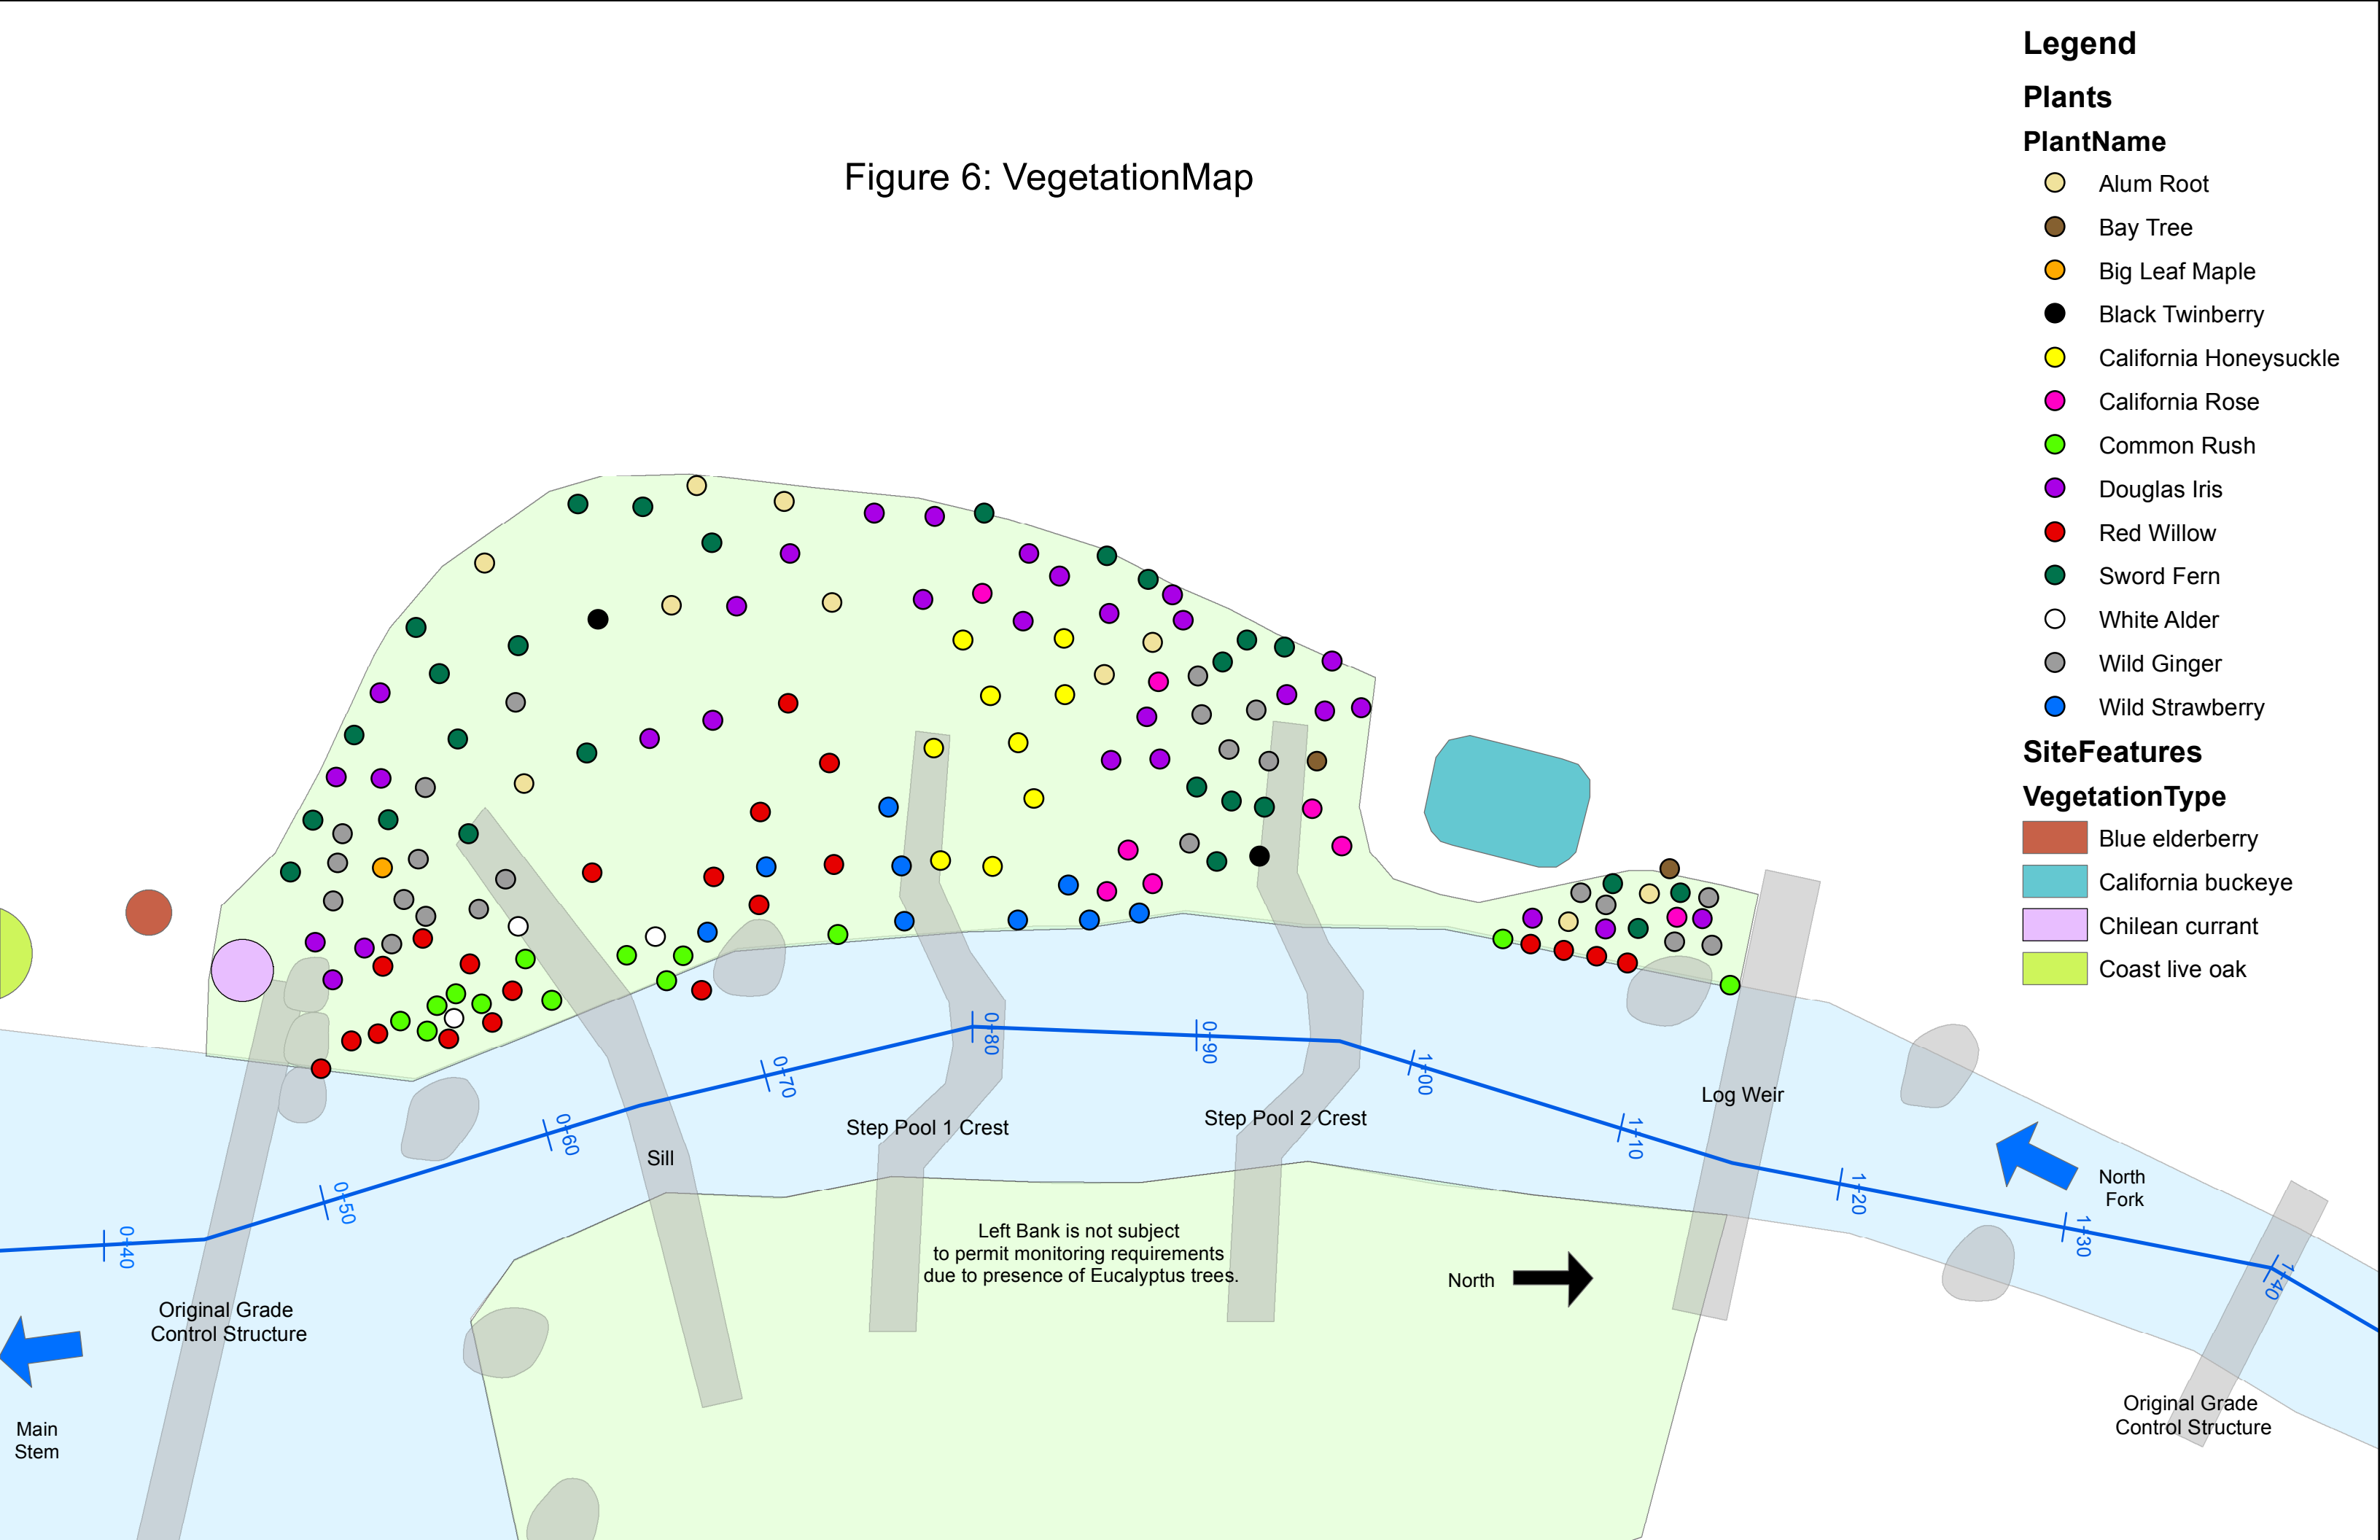
Figure 6: VegetationMap

The plants on the right bank are mapped in **Figure 6**. The following table lists the species and numbers of plants on the right and left banks.

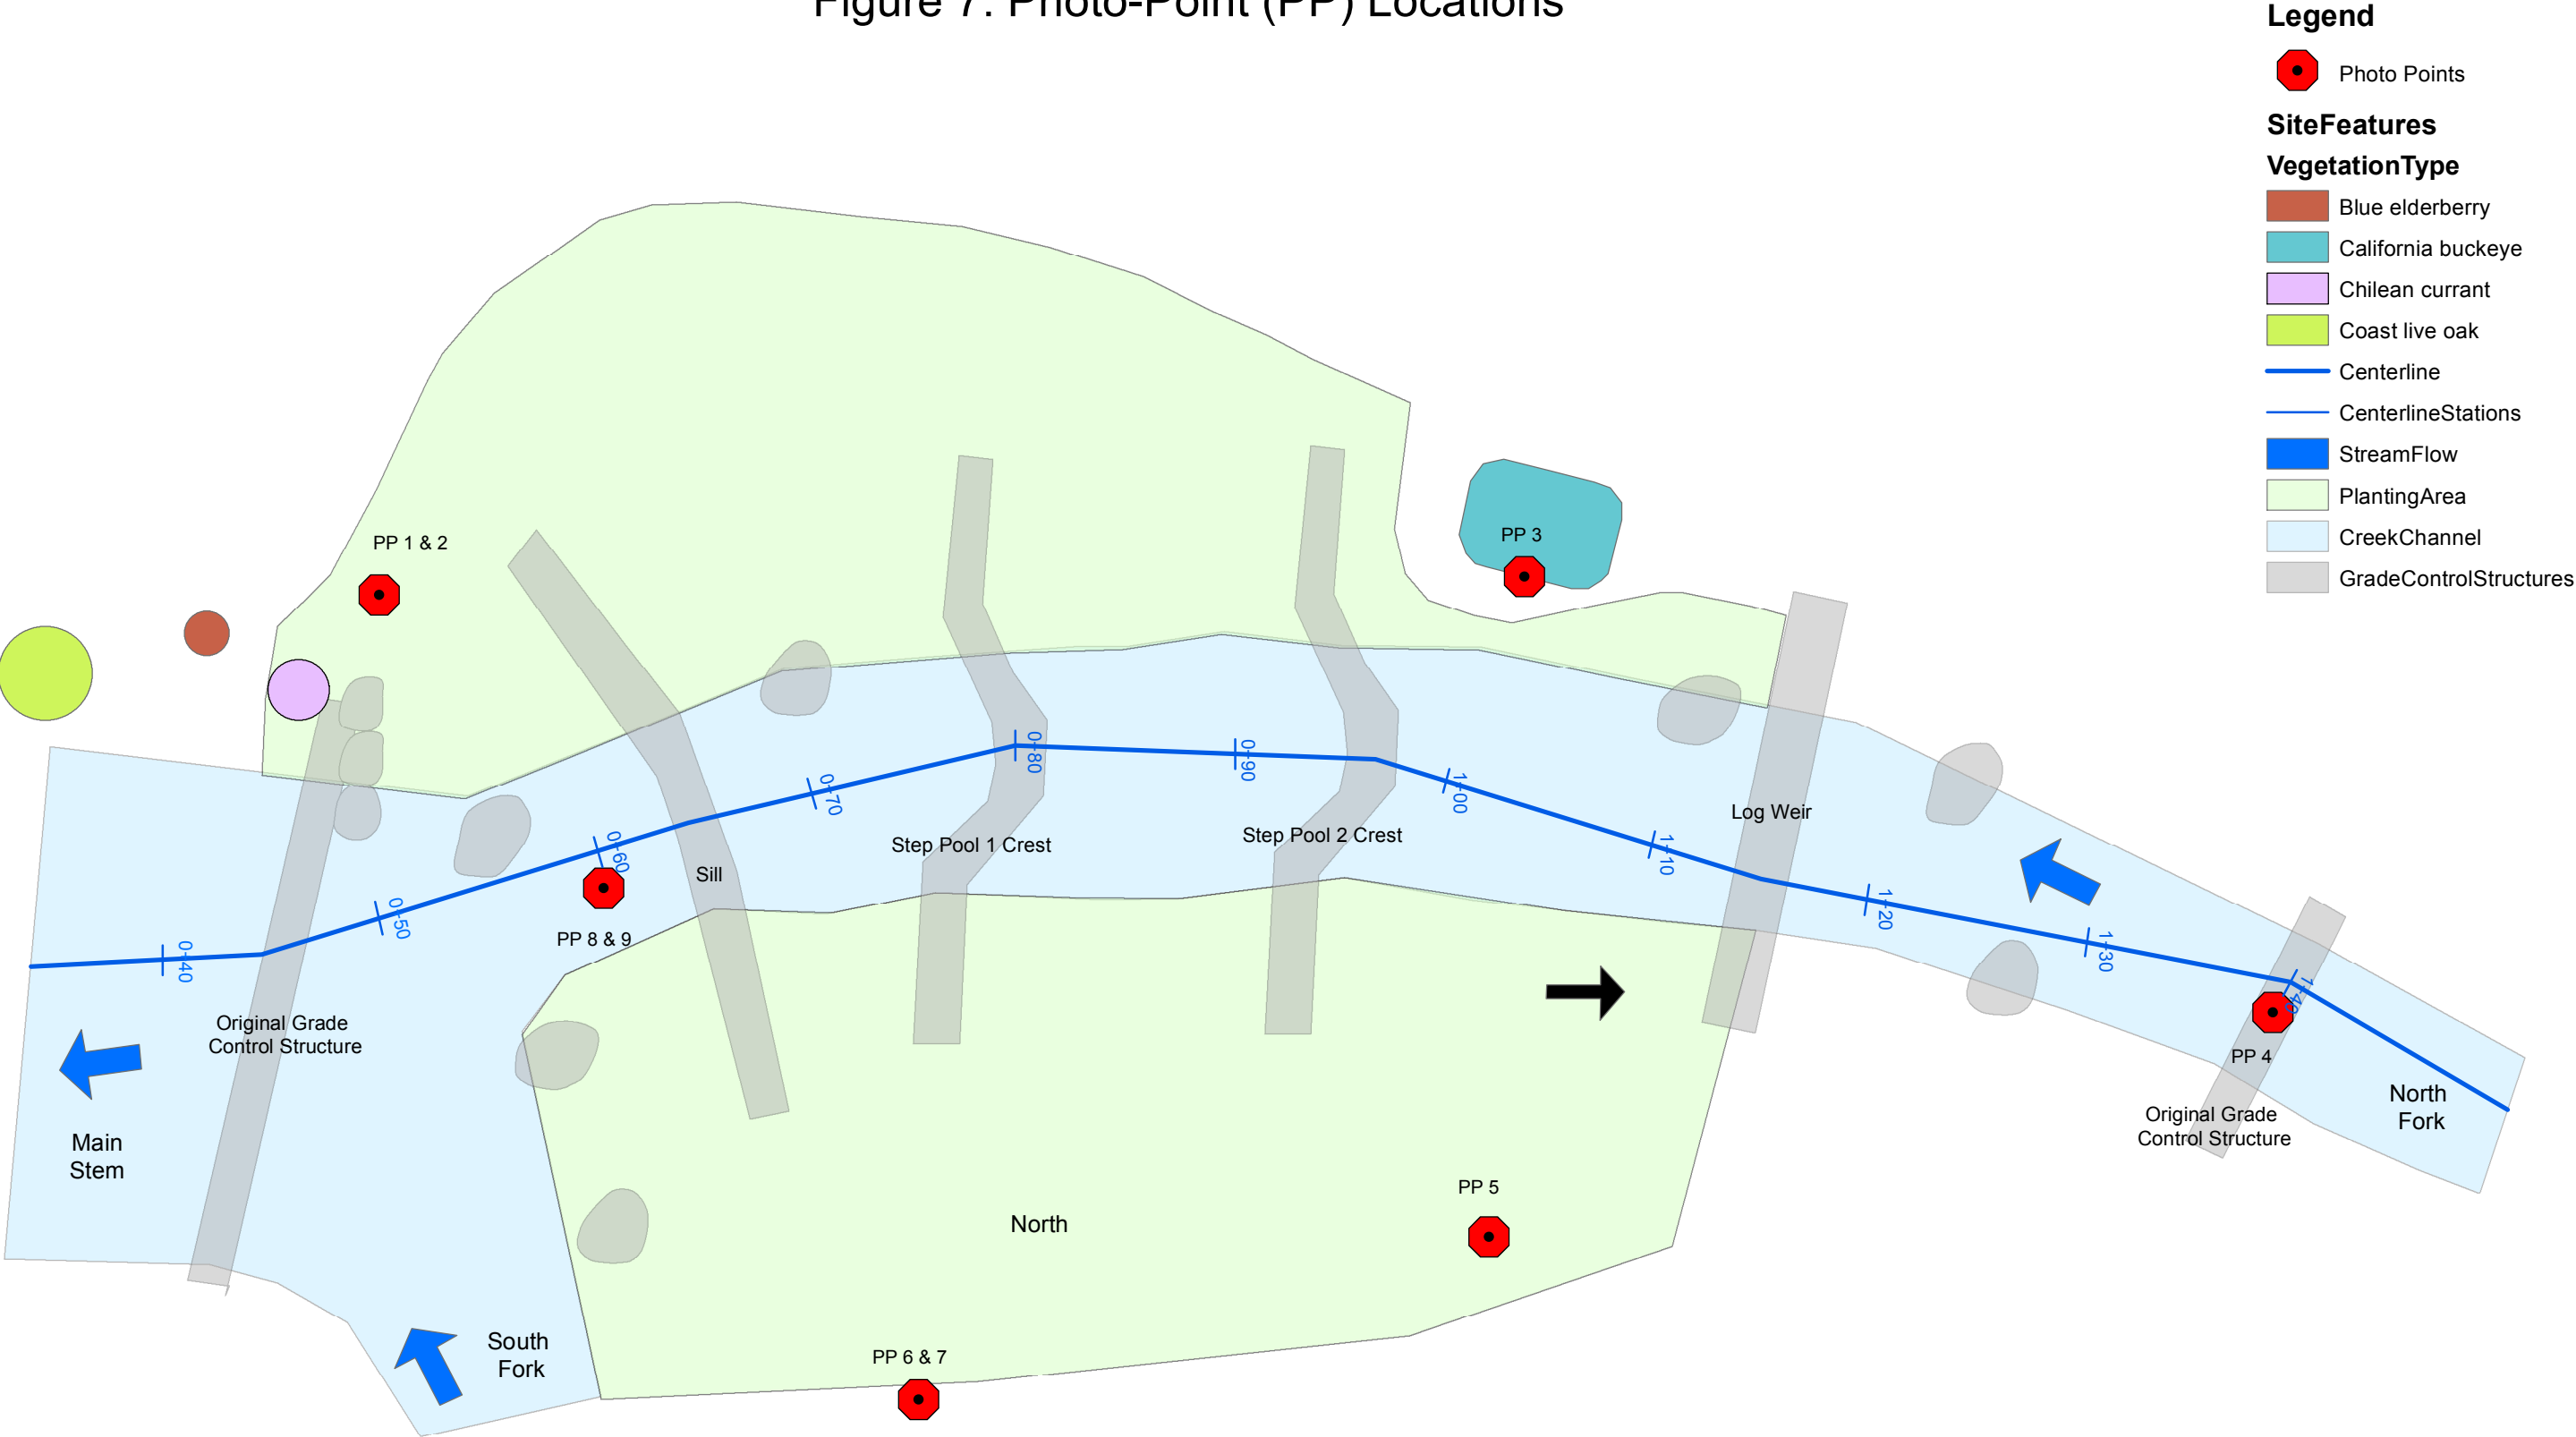
Figure 7: Photo-Point (PP) Locations

Photo-documentation points (PP) were established at the site prior to construction (**Figure 7**). Pre-construction photos were taken prior to construction activities and post-construction photos were taken just after the channel work, irrigation and planting were completed (**Attachment F**).

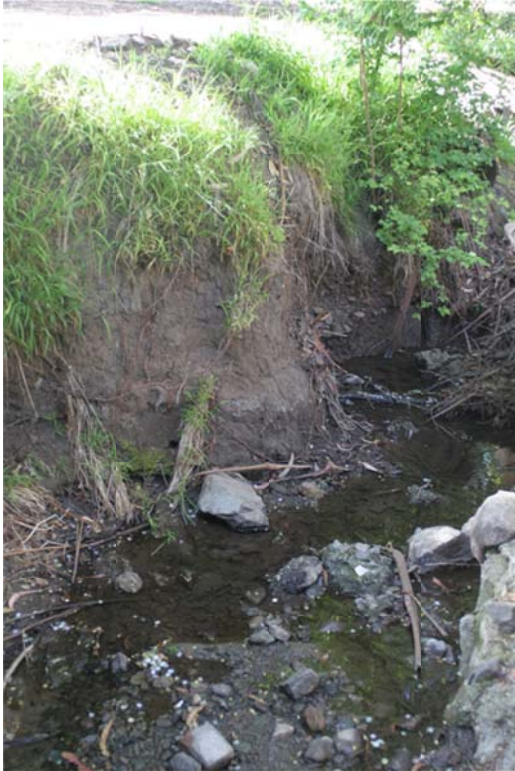
Photo 3: Right bank at the confluence continues to be eroded, leading to a 6-foot scarp.
