Katie McKnight
LA 222 – Hydrology
Lab #5 – Channel Cross-Section Survey and Flow Measurement
02-23-15

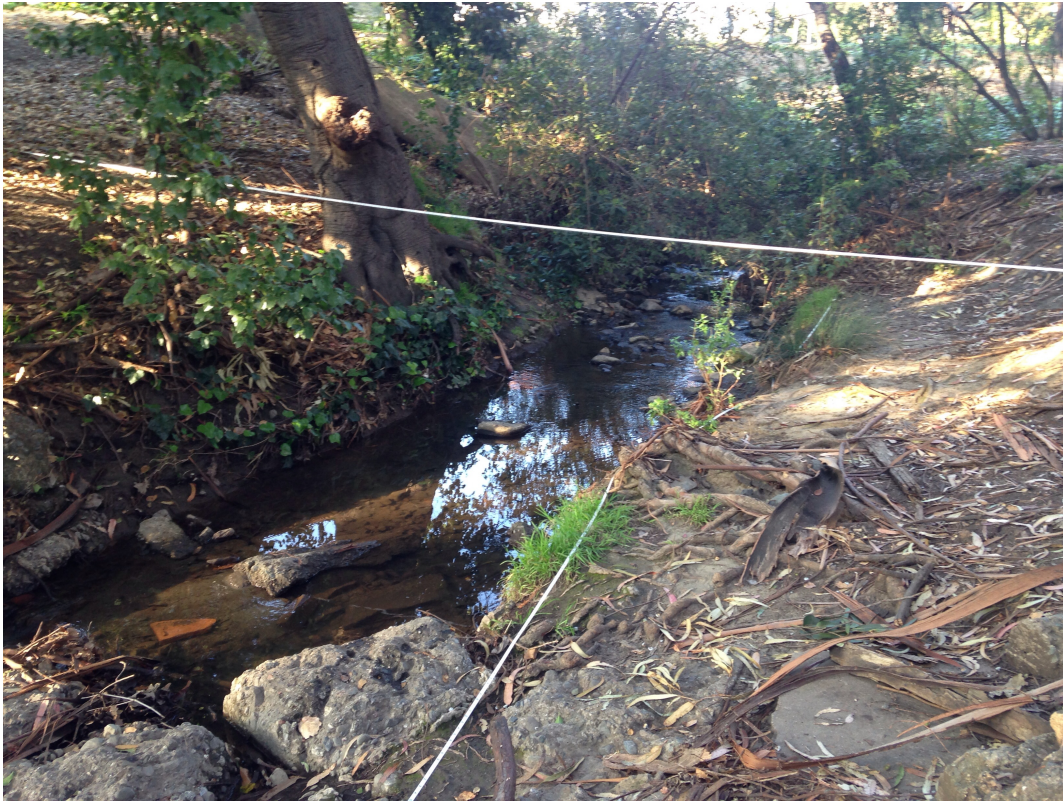
Figure 6. The measuring tape across the stream marks the non-restored cross-section that was surveyed (upstream-facing). The sandy area on the left bank reveals a potential high water mark from a recent flooding event.

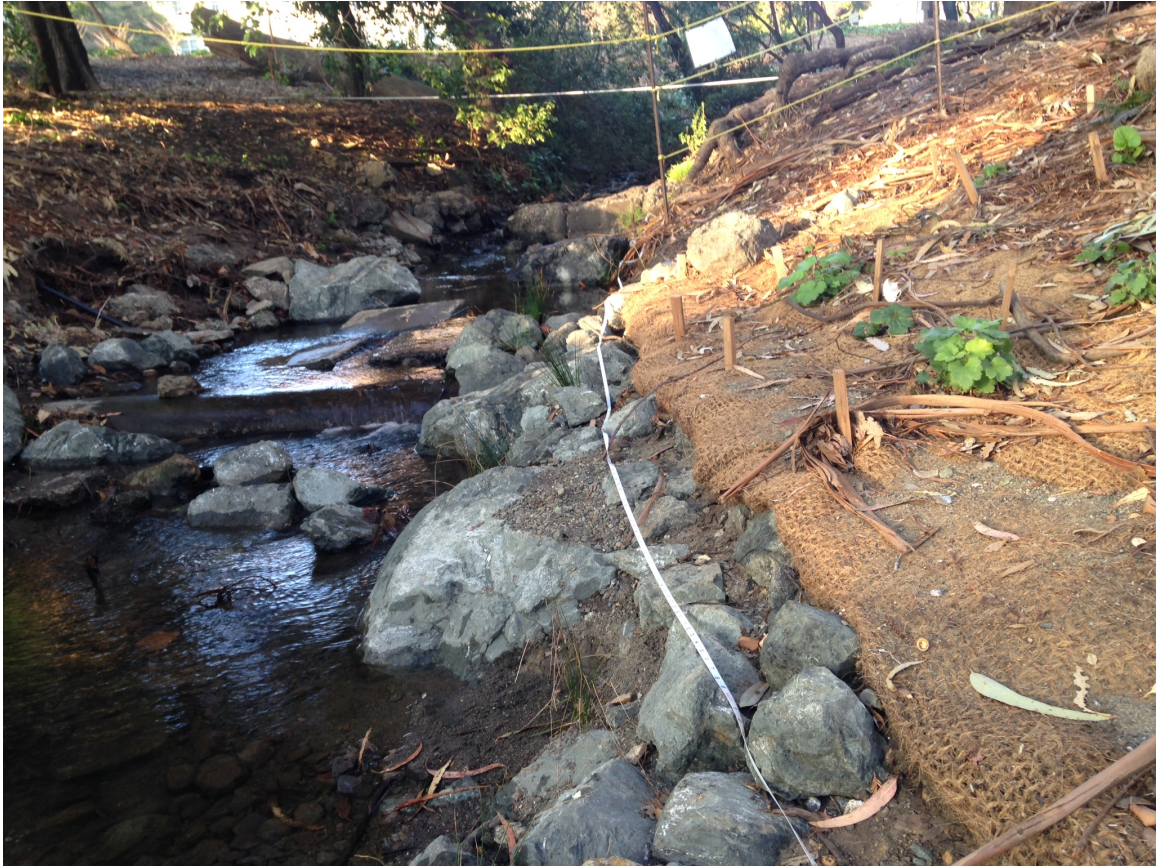
Figure 7. The restored section of the creek that was surveyed reveals a “step” change in elevation through the use of an embedded log (on the left, middle portion of the photo). The log works to break up energy received from the culvert upstream and also enhances the aquatic ecosystem by mimicking pools found in nature in this type of creek. The banks were stabilized with rocks of varying sizes and vegetation was planted along the banks with staked mats to decrease erosion as plants become established.

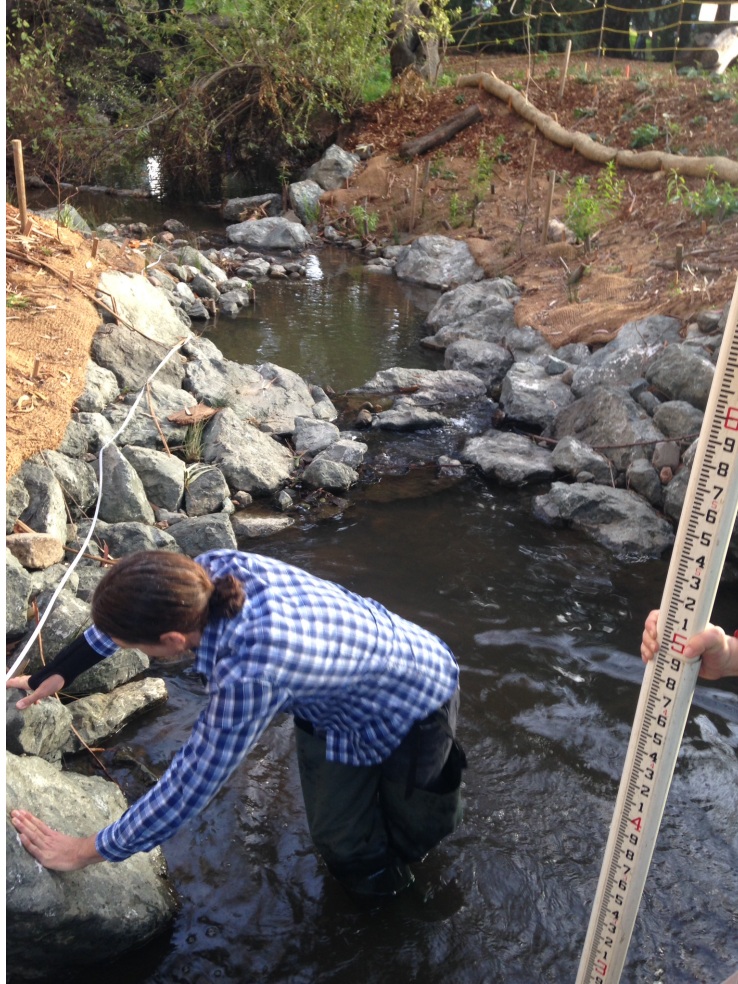
Figure 8. The long profile was surveyed by running the measuring tape along the left stream bank to mark the station while using the survey stick to locate the deepest portion in the creek. Relative elevations were recorded through viewing the numbers on the meter stick through a survey tool which was stationed in a spot without any large obstructions. If we had continued to survey further along the stream, we would have needed to take a turning point elevation measurement to relocate the survey tool to keep the measuring stick within view.

Data was collected between 4:00pm and 5:30pm on February 19, 2015. The benchmark surveyed was approximately 2.5 feet high and the elevation of the instrument is assumed to be 100 feet, therefore the height of the instrument was 102.5 feet. All surveyed elevations were adjusted to reflect this assumption. The creek was surveyed by placing a tape measure along the left bank over a 110-foot section upstream of the confluence between the North Fork and the South Fork of Strawberry Creek at the University of California Berkeley. The measurements made along the long profile were concentrated on the deepest points along the channel. The aim was to account for any breaks in elevation such as the point of the highest elevation of a rock and the bottom of the drop immediately after. The same logic was followed for surveying of the cross sections.
