Year 2 Annual Monitoring Report

North Fork Mitigation Project (2016)

University of California, Berkeley

Submitted January 25, 2017

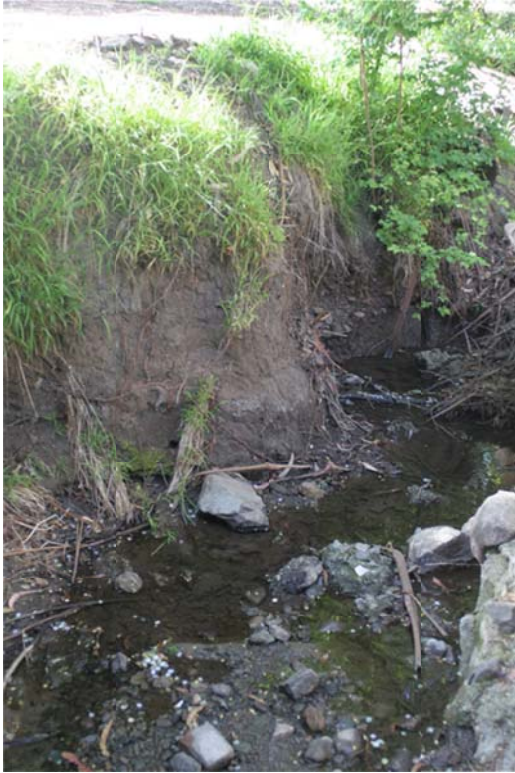
Photo 3: Right bank at the confluence continues to be eroded, leading to a 6-foot scarp.

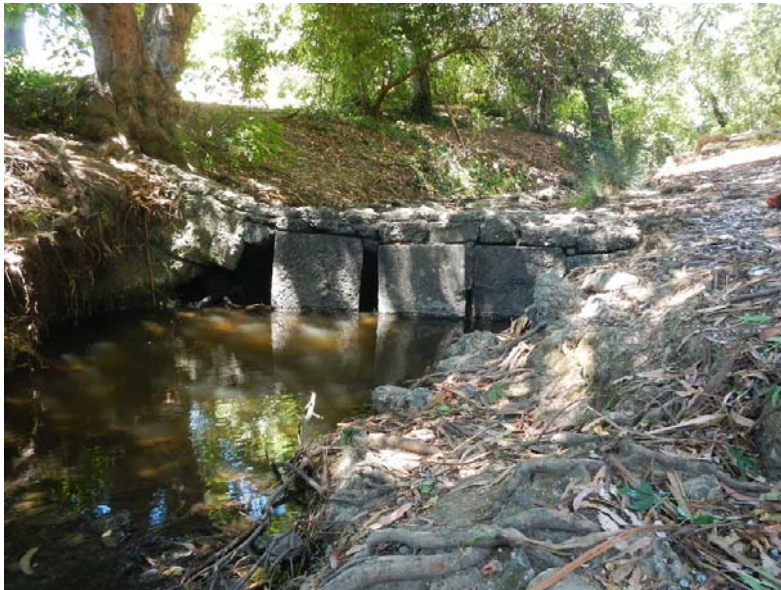
Photo 4: Check dam 2 (CD2) is about 35 feet upstream of CD1 on the North Fork. Notice instability on the right bank (left side of picture).

CD1 is a decades-old check dam constructed on the north fork of Strawberry Creek, located immediately upstream of the confluence of the north and south forks. The failure of this check dam in 2002 caused the main concrete body of the dam to orient stream-wise in the center of the channel (See Photos 1 and 2 in Attachment D to this Certification). Additionally, remnants of CD1 deflect flow into the right bank at the confluence, causing the creation of a near vertical 6-foot tall scarp (See Photo 3 in Attachment D to this Certification). The failure of CD1 has caused the channel bed to incise upstream, undermining CD2 which is located 35 feet upstream of CD1 (See Photo 4 in Attachment D to this Certification). CD2 is at risk of failure due to undercutting of the support structure on the right bank (left side of Photo 4) and due to water piping through the dam.

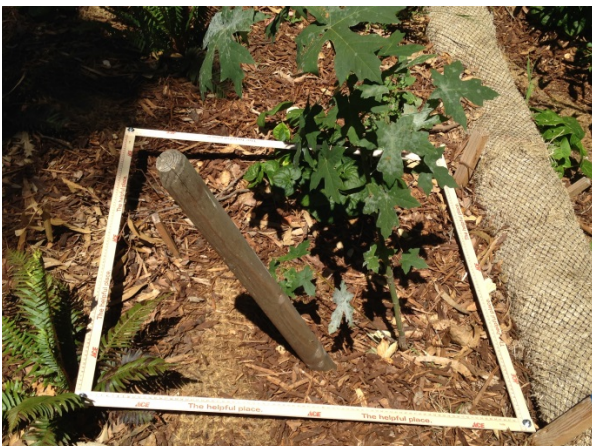
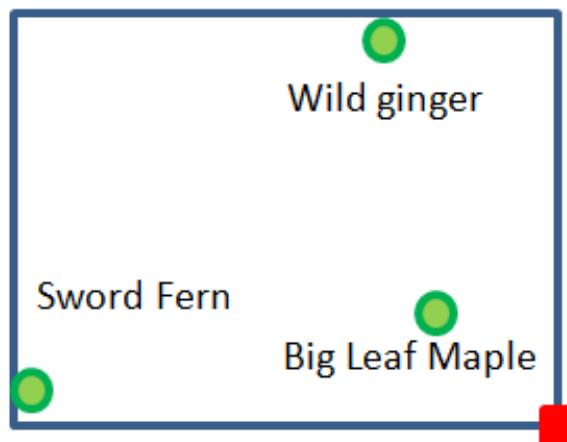
Year 1: 30% Cover – no invasive species

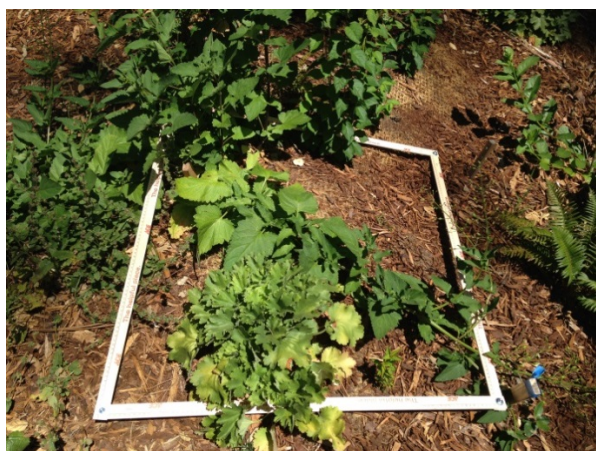
Year 1: 60% Cover Total - 10% invasive (plum), 30% native volunteer (figwort), 20% native planted

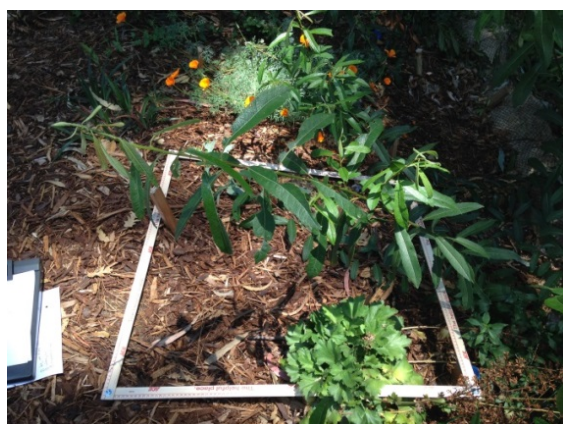
Year 1: 20% cover

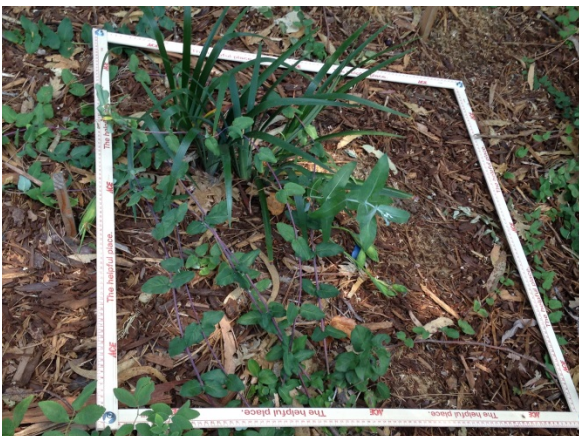
Year 1: 50% Cover – no invasive species

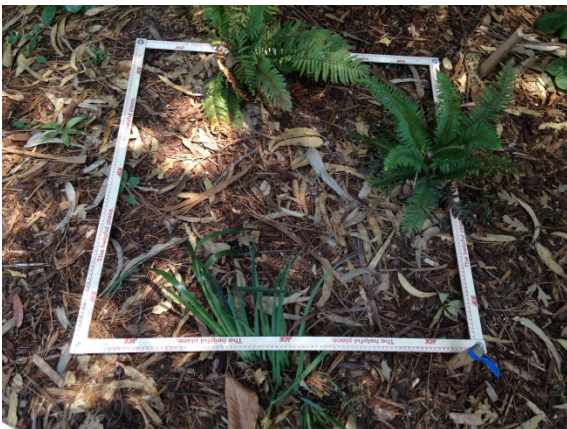
Year 1: 30% Cover – no invasive species

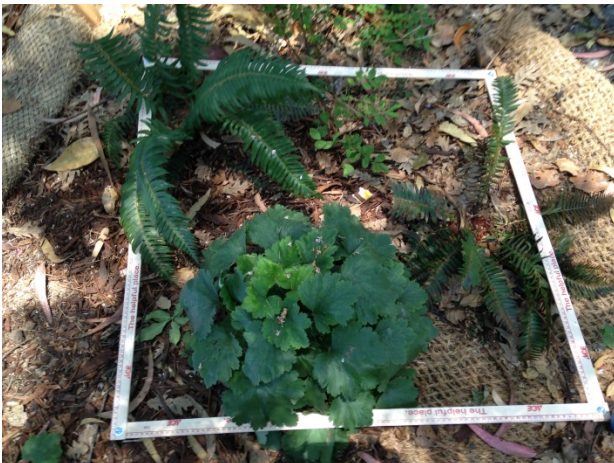
80% Cover – no invasive species

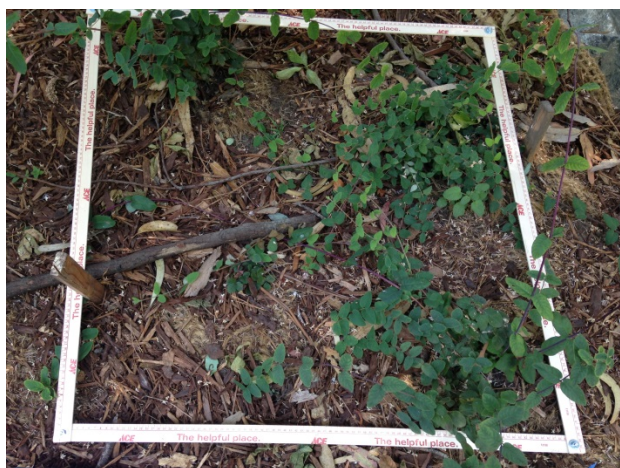
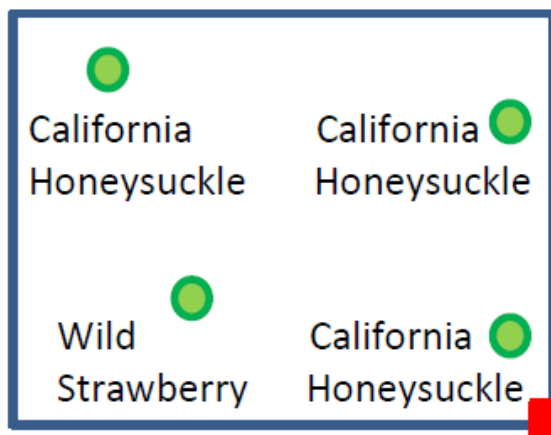
Year 1: 60% Cover – no invasive species

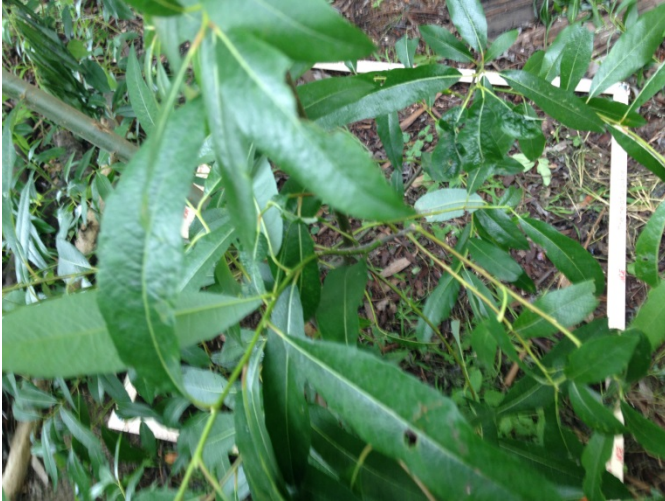
Plot 8

Year 2: Overstory - 95% shaded by willows

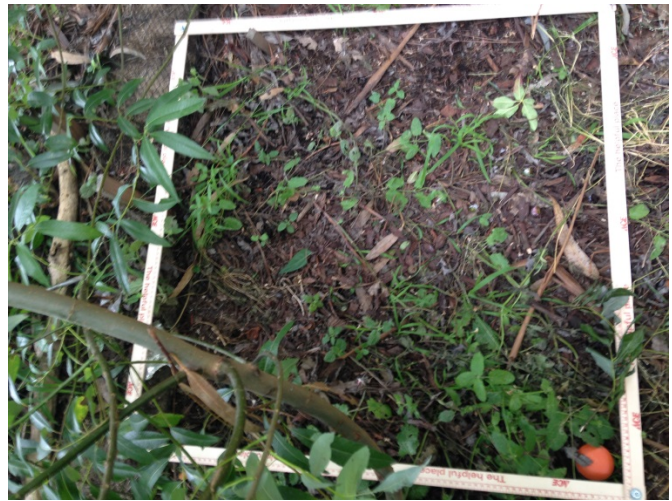
Understory – 10% invasive grass, 5% native volunteers

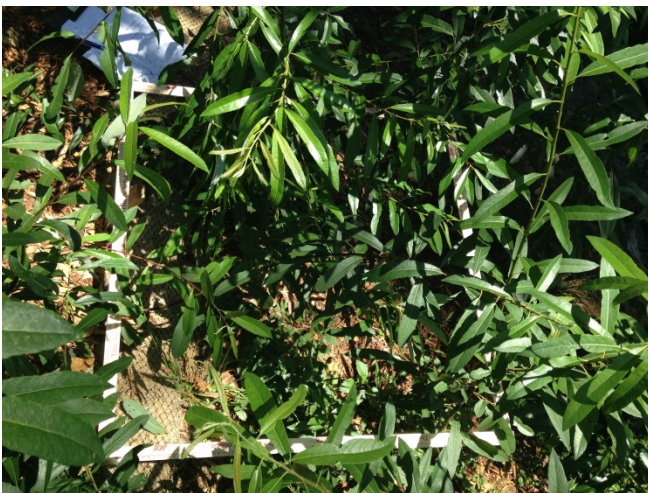
Year 1: 90% Cover total - 85% Red Willow shade, 5% Invasive grass

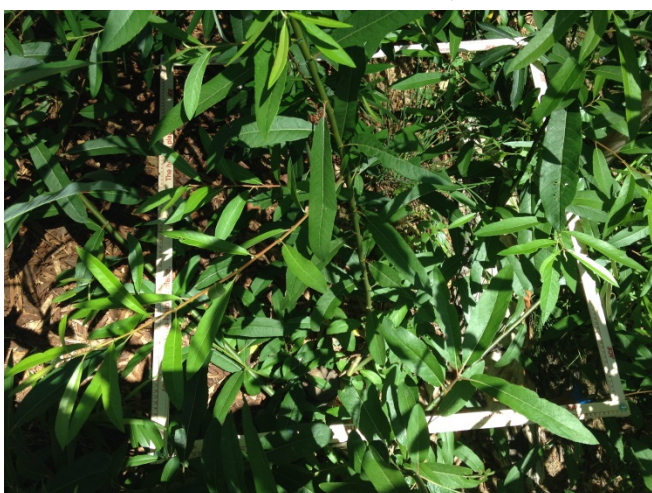
Year 1: 90% Cover total - 85% Natives, 5% invasive weeds

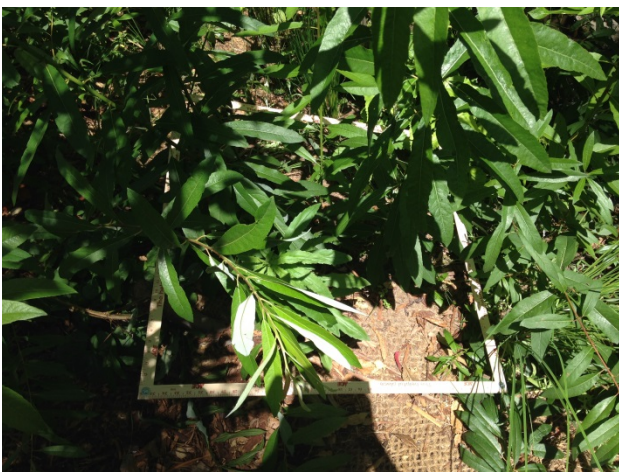
Year 1: 80% Cover - no invasive species
