Year 3 Annual Monitoring Report

Strawberry Creek

North Fork Mitigation Project

University of California, Berkeley

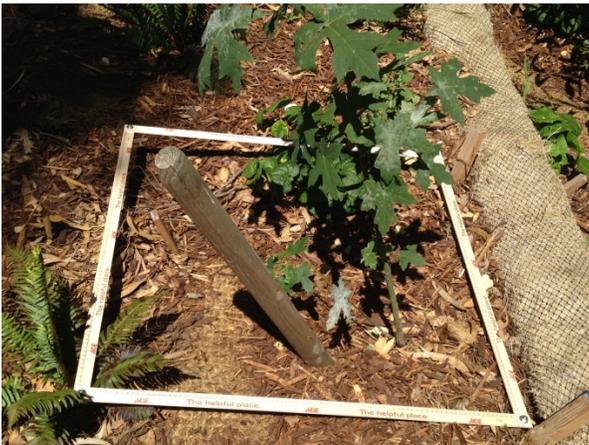
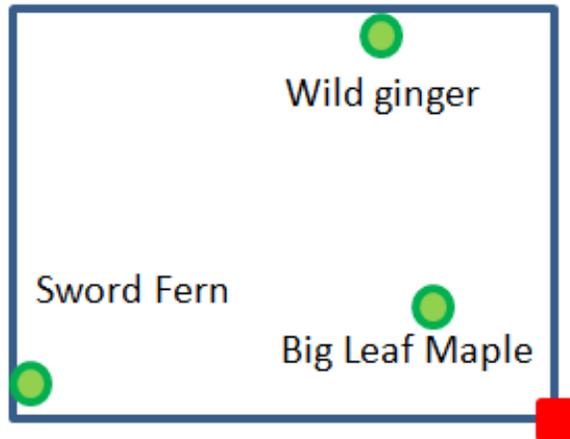
Year 1: 30% Cover – no invasive species

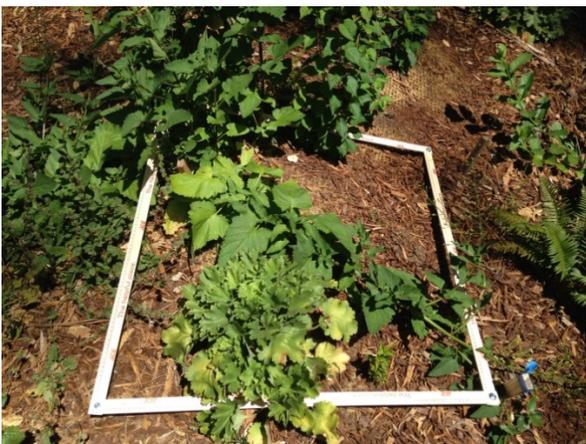
Year 1: 60% Cover Total - 10% invasive (plum), 30% native volunteer (figwort), 20% native planted

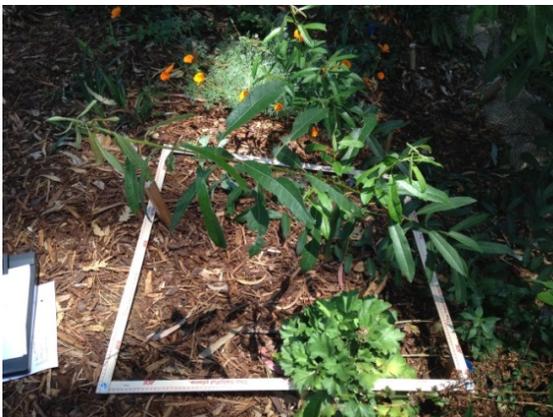
Year 1: 20% cover

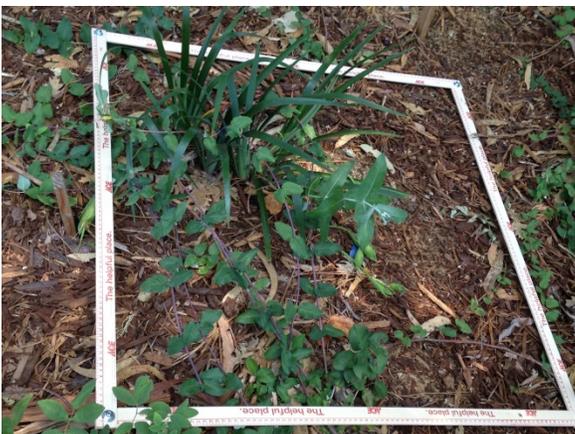
Year 1: 50% Cover – no invasive species

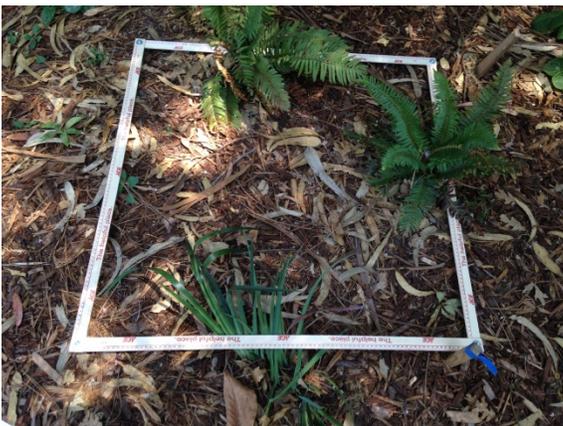
Year 1: 30% Cover – no invasive species

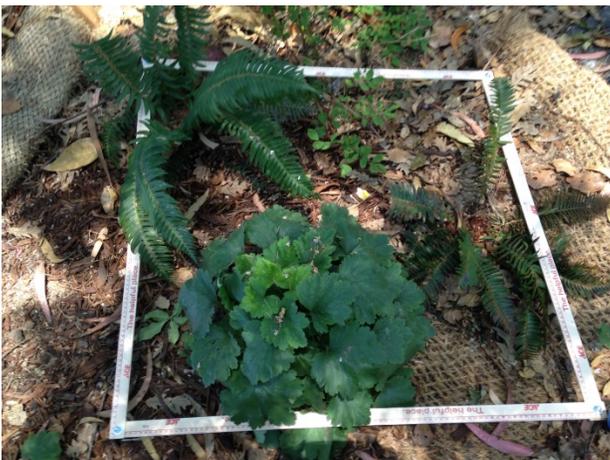
80% Cover – no invasive species

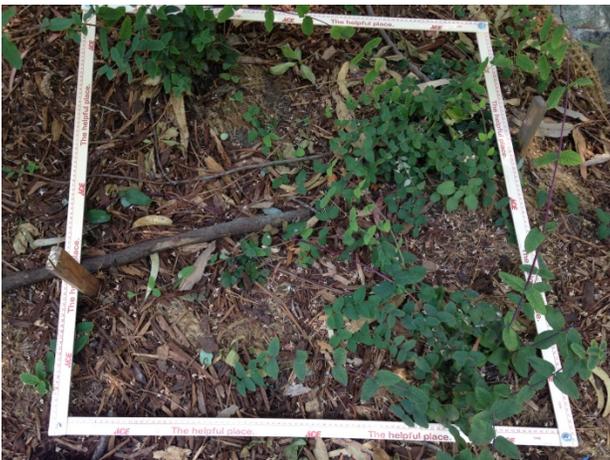
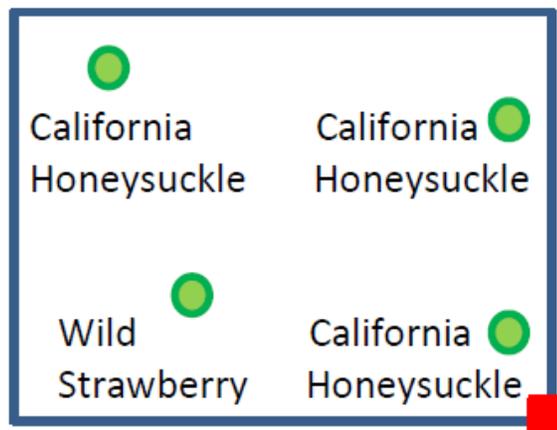
Year 1: 60% Cover – no invasive species

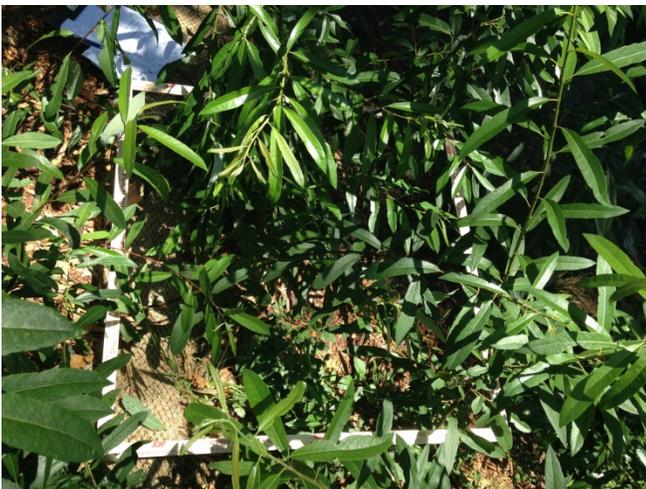
Year 1: 90% Cover total - 85% Red Willow shade, 5% Invasive grass

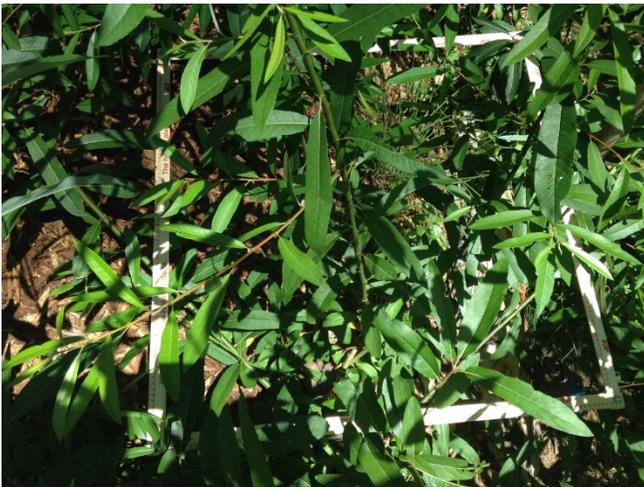
Year 1: 90% Cover total - 85% Natives, 5% invasive weeds

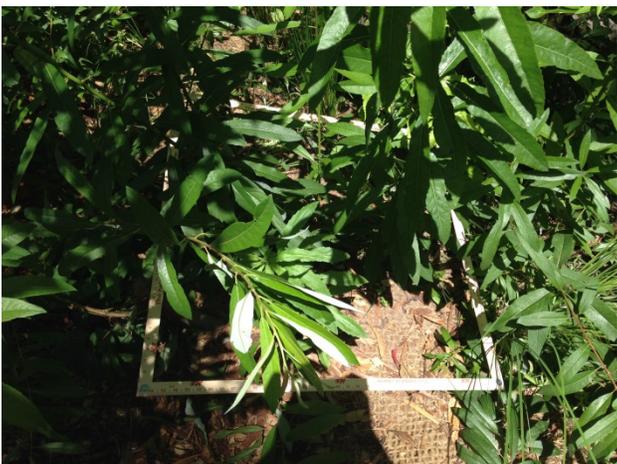
Year 1: 80% Cover - no invasive species
